Mount Thorley Warkworth 2018 Annual Review

Mount Thorley Warkworth (MTW) is an integrated operation of two open cut coal mines, Warkworth Mining Limited (WML) and Mount Thorley Operations (MTO). This Annual Review reports on the environmental performance of Mount Thorley Warkworth (MTW) for the period 1 January 2018 to 31 December 2018.

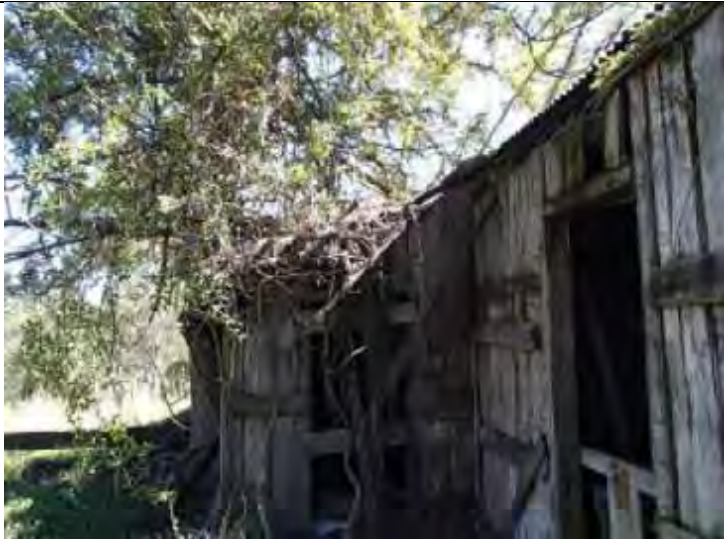
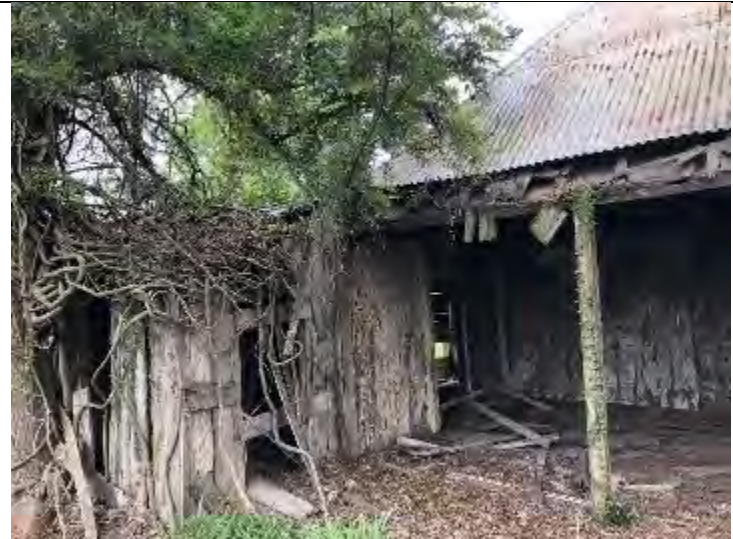
South-west corner: shows removal of vertical slabs from southern wall.

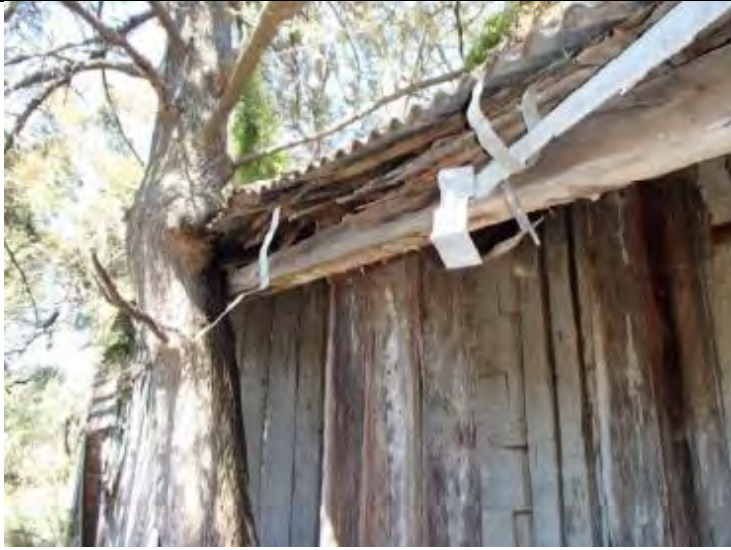
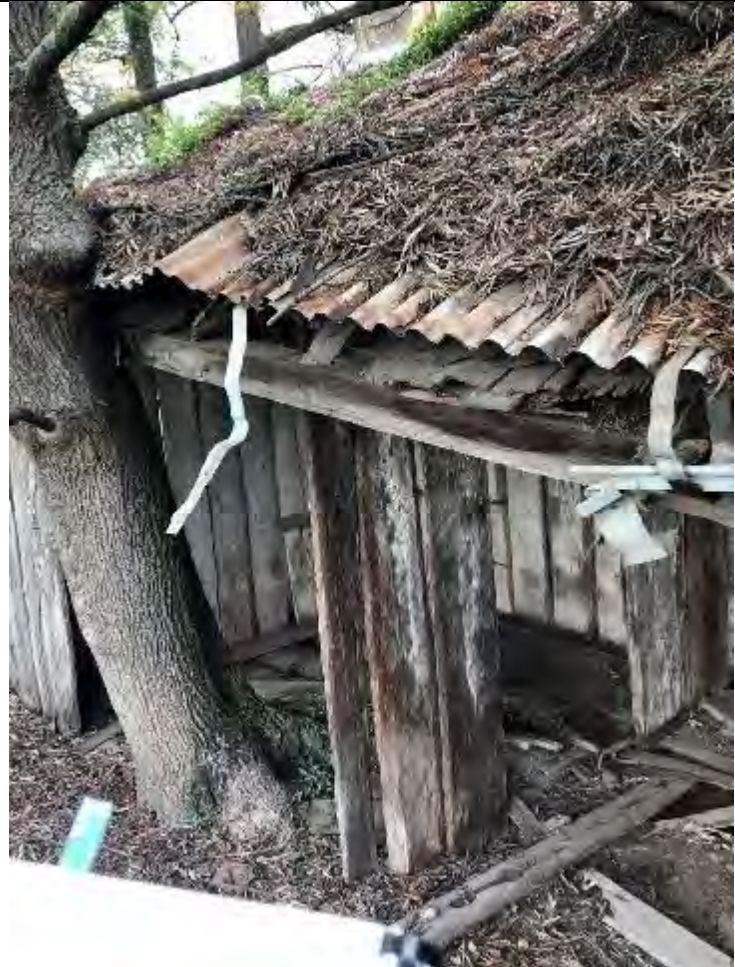
South-east corner: shows removal of vertical slabs from southern wall and further collapse of roof.

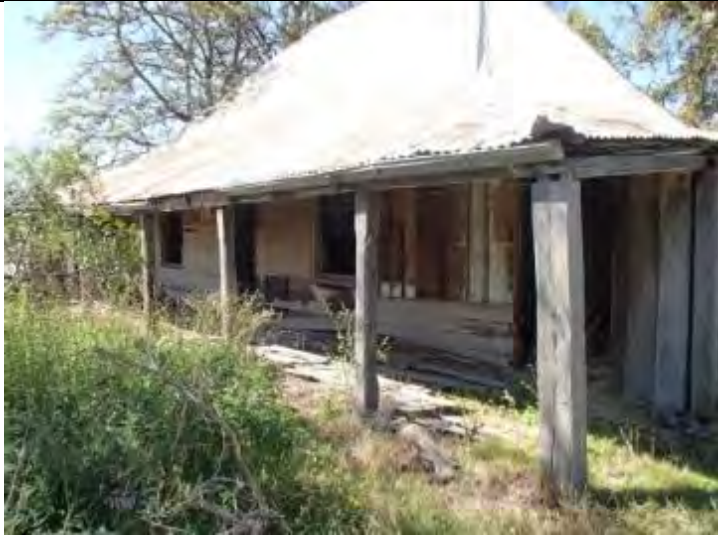
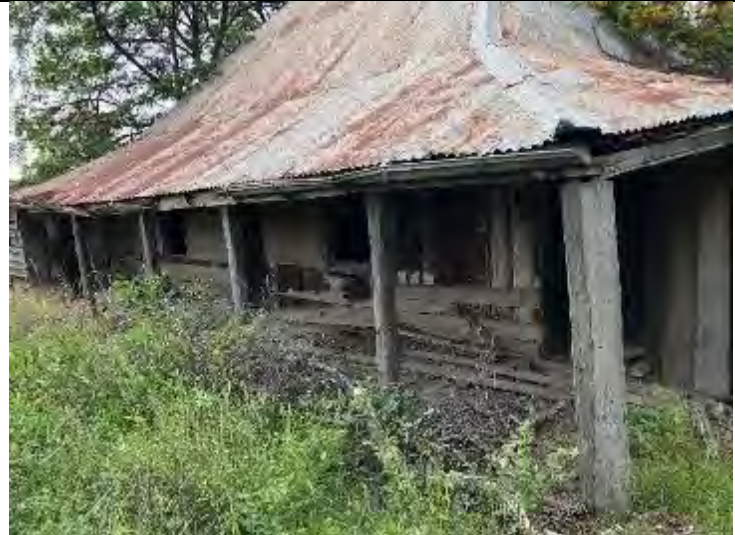
Eastern elevation: possible further collapse of crossbeam and guttering.

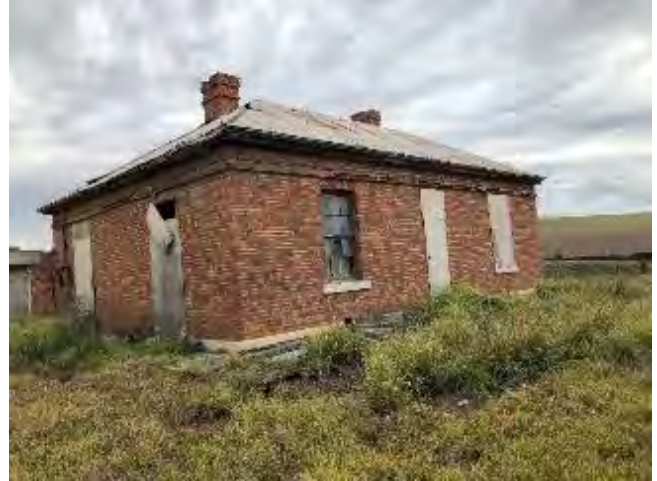
1. Remove partially collapsed verandah entirely to prevent further stress and damage to the building where it remains connected. Store verandah elements on site so they are protected from the weather and off the ground away from the threat of termites **(complete)**;

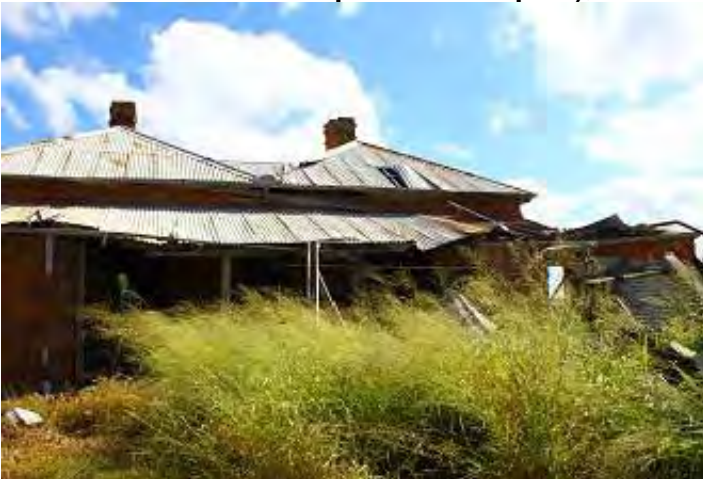
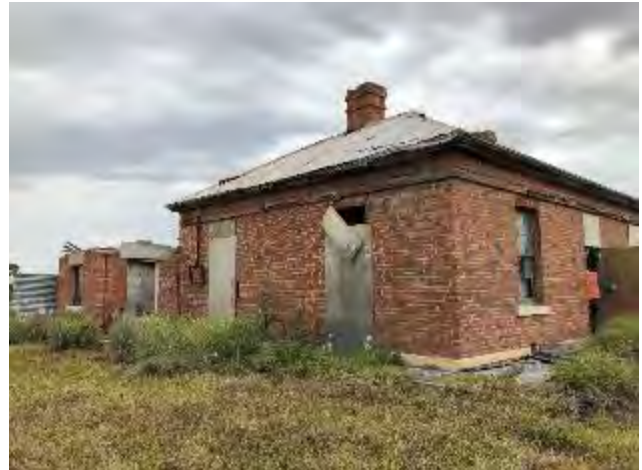
2. Ensure that vegetation is cut back and away from structures on a regular basis **(has been completed in the past)**;

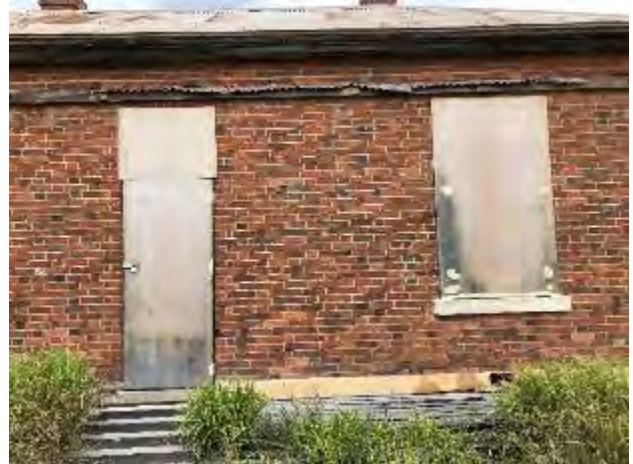
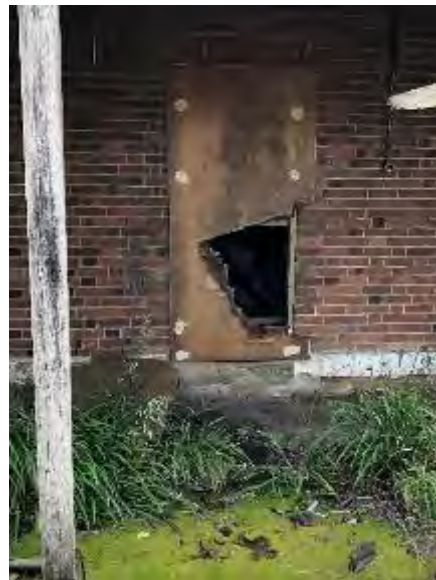
- Place 12mm painted maritime grade plywood sheeting over all window and door openings and ensure all openings are weather tight and vermin proof (**complete, however some panels require maintenance**).

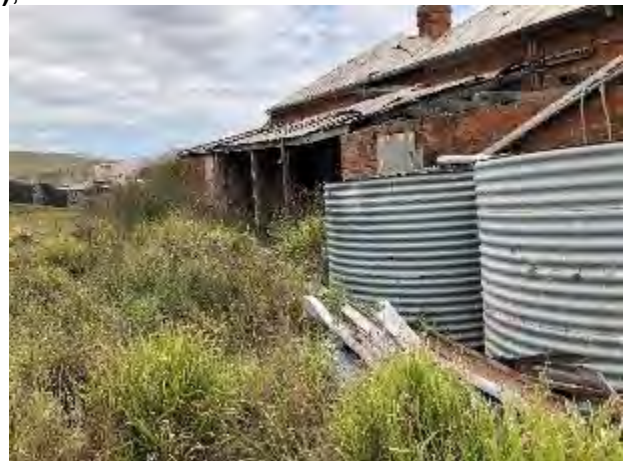
- Have an asbestos removalist take samples of broken fibrous cement sheeting to test for the presence of asbestos, and remove as required (**possibly complete as clean-up of debris appears to have occurred**);

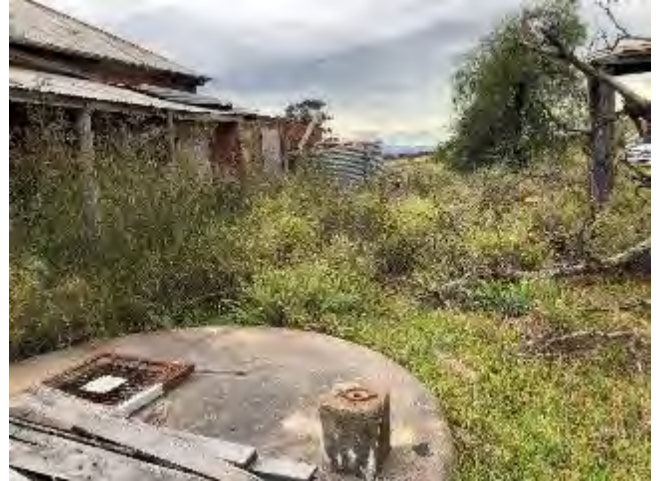
2. Implement an annual termite inspection regime and treat as required (**unsure if has occurred**);
3. Remove all debris, ensuring an archaeologist is on hand to identify and catalogue any early architectural fittings or rare pieces of joinery that should be retained for future restoration purposes (**appears to have occurred, however overgrowth will need removing to confirm**);

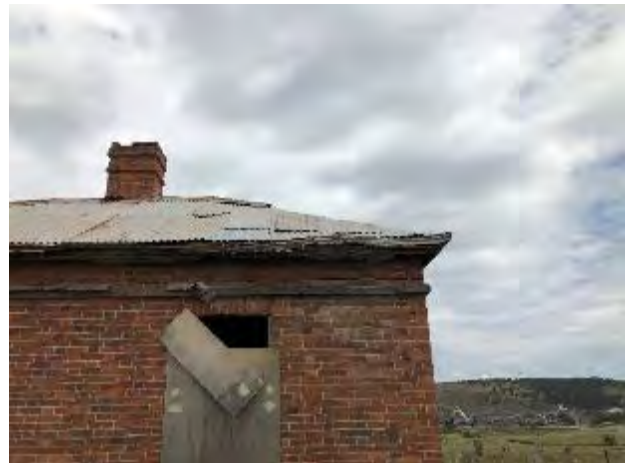
4. Assess any damage to rafters/joists/battens where roof sheeting is missing on main roof, and replace to match existing. Replace any damaged soffit or fascia boards at the same time (**as roof has been repaired this may have occurred**);

Undertake patch repairs to roof and replace missing roof sheeting to match existing. Refix loose sheets and flashings. Replace roof screws with new galvanized screws (**complete**);

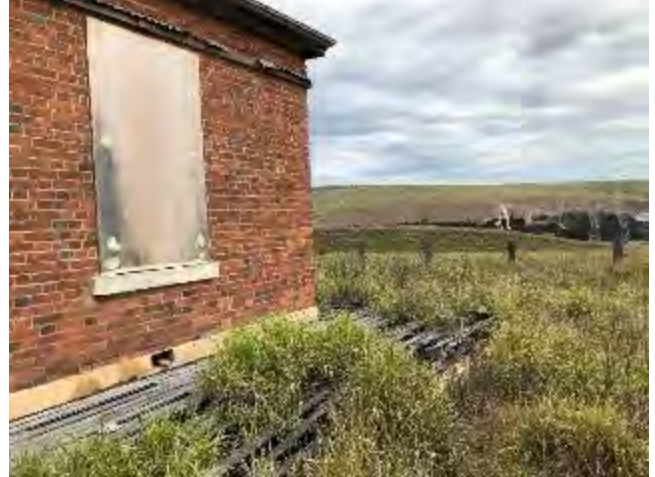
5. After completely detaching verandah from the building, restore verandah roof frame by re-using original fabric where possible including wall plate, battens and rafters (**not complete**);

Repair verandah posts with damaged lower sections by removing these sections and splicing new pieces of timber to match existing (**not complete**);

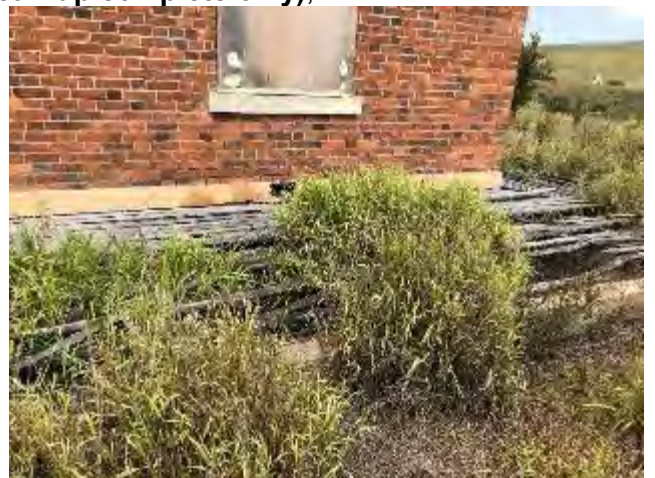
Re-install verandah roof with corrugated galvanized iron to match existing bull-nosed profile (**not complete**);

6. Remove all debris from verandah and assess extent of damage to verandah boards and joists. Replace to match existing (**clean-up complete only**);

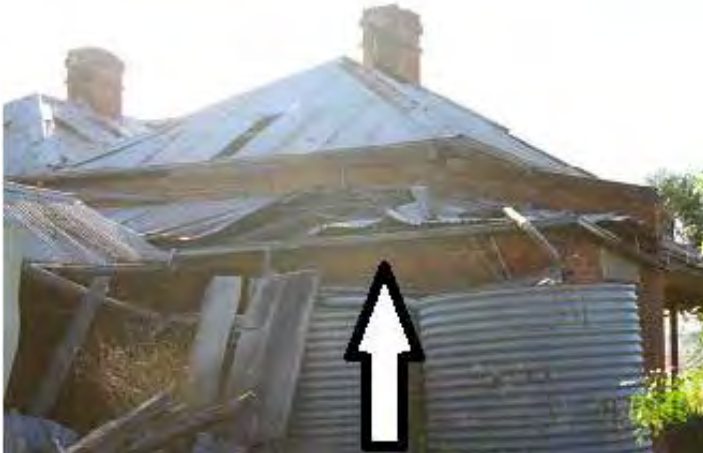
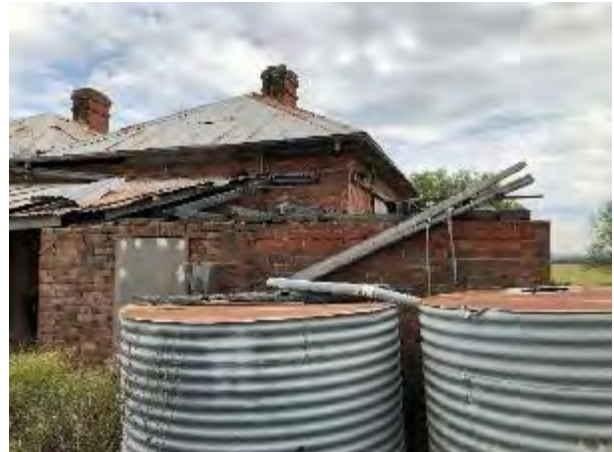
7. Replace damaged timber members and install new roof sheeting on southern skillion roof to match existing **(not complete)**;

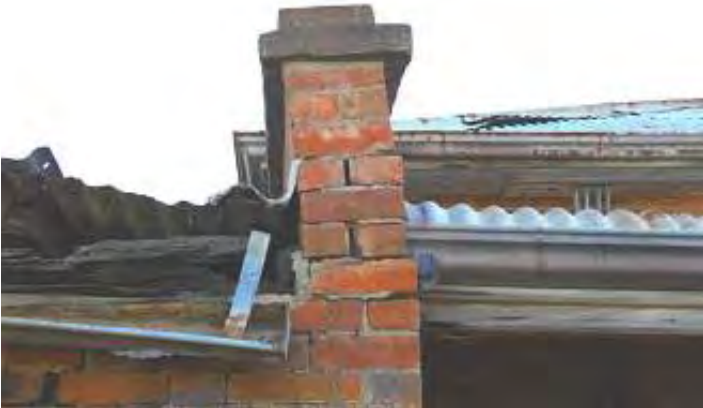
8. Rebuild northern brick wall of room 6 and repoint mortar joints **(not complete – wall element has collapsed)**;

6. Reinstall verandah, including verandah decking and northern brick dwarf wall, re-using original material where possible, as per recommendations M5, M6 and L1 in the CMP conservation works schedule;

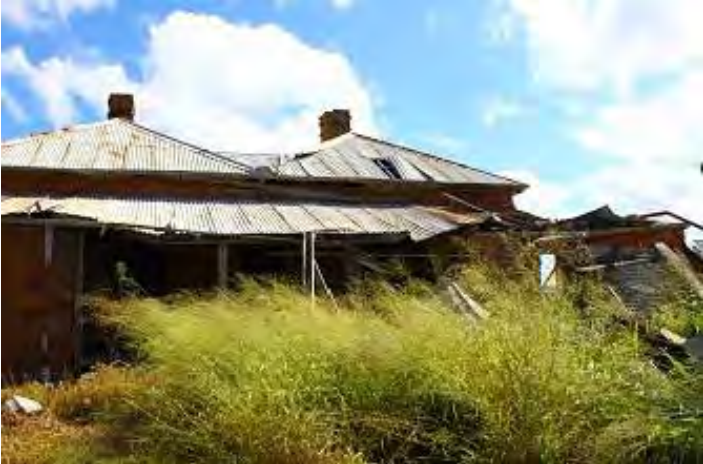
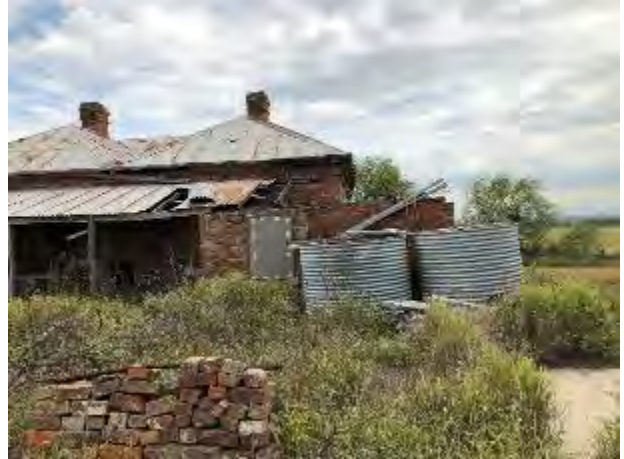
10. Replace gutters to match existing materials and ogee profile. Install new down-pipes and ensure they are discharging away from the building (**not complete**);

8. Replace gutters around the house to match existing materials and ogee profile. Install new down-pipes and ensure they are discharging away from the building.

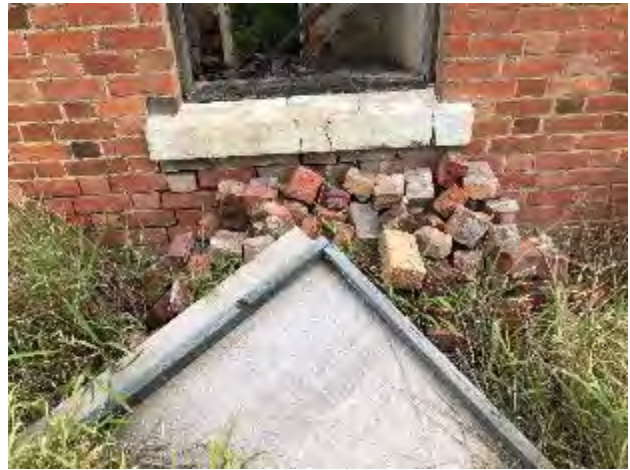
11. Repoint mortar joints with lime based mortar on brickwork below Room 6 eastern elevation window sill (**not complete**);

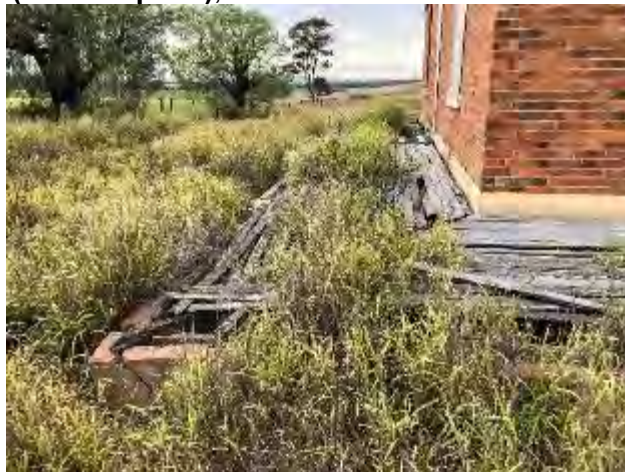
1. Reconstruct cement rendered brick dwarf wall on northern elevation verandah and undertake patch repairs to cement render (**not complete**);

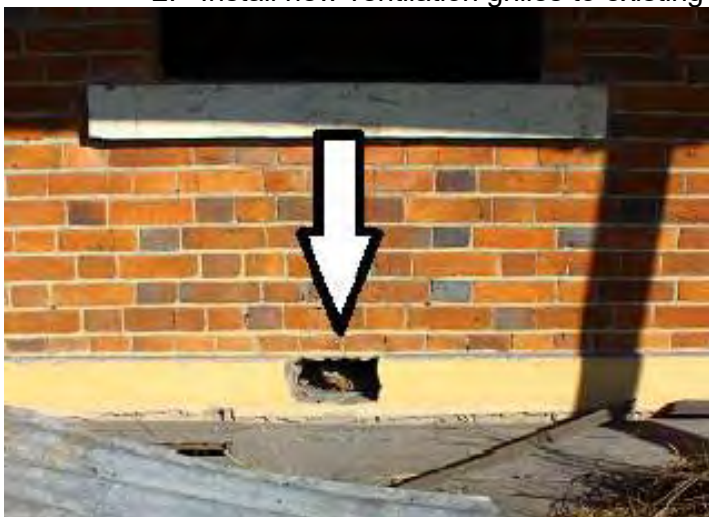
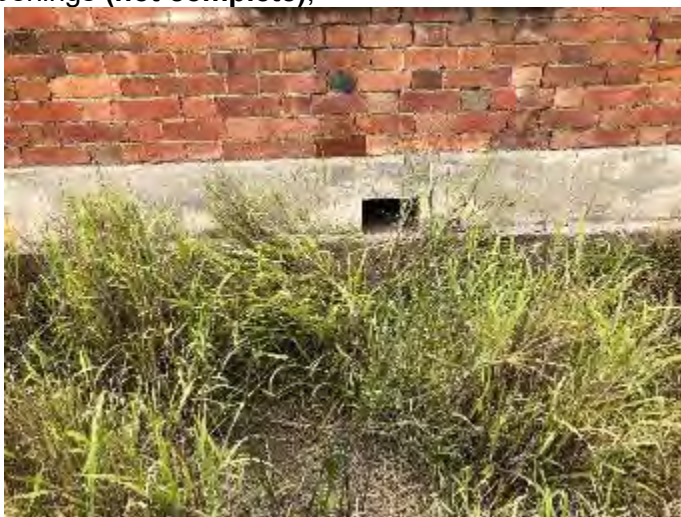
2. Install new ventilation grilles to existing openings (**not complete**);

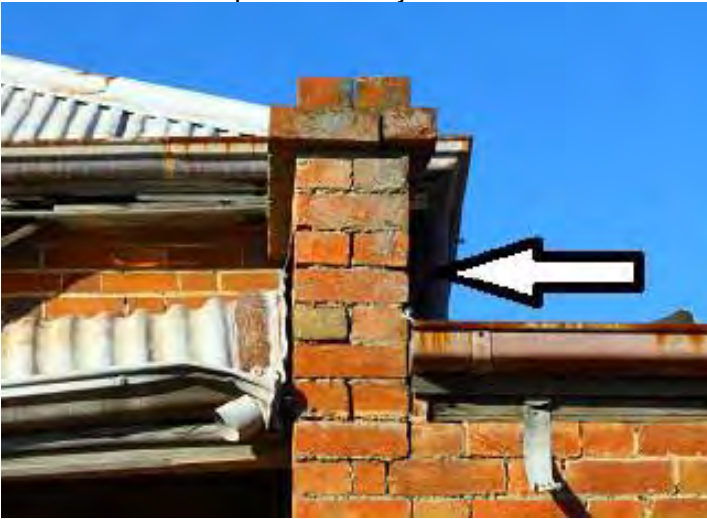
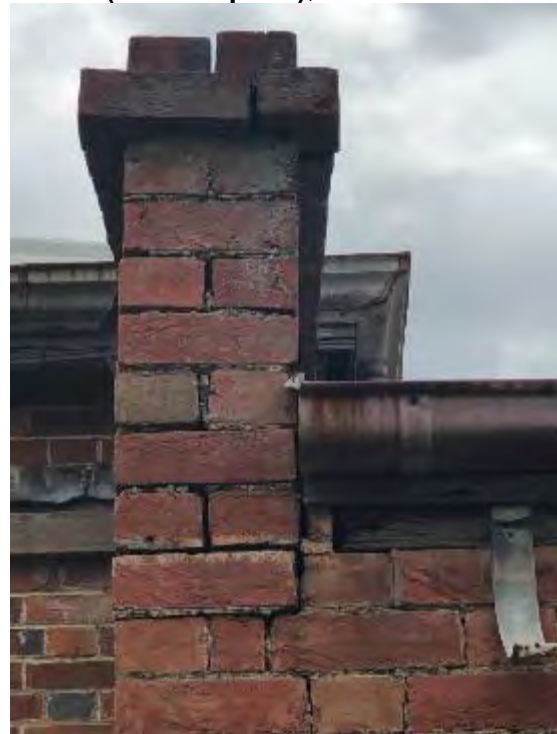
3. Repoint mortar joints on northern wall of Room 5 (**not complete**); and

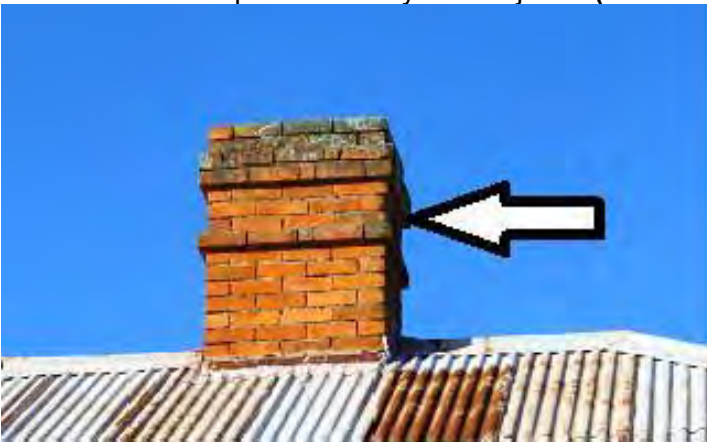
4. Repoint chimney mortar joints (**not complete**).

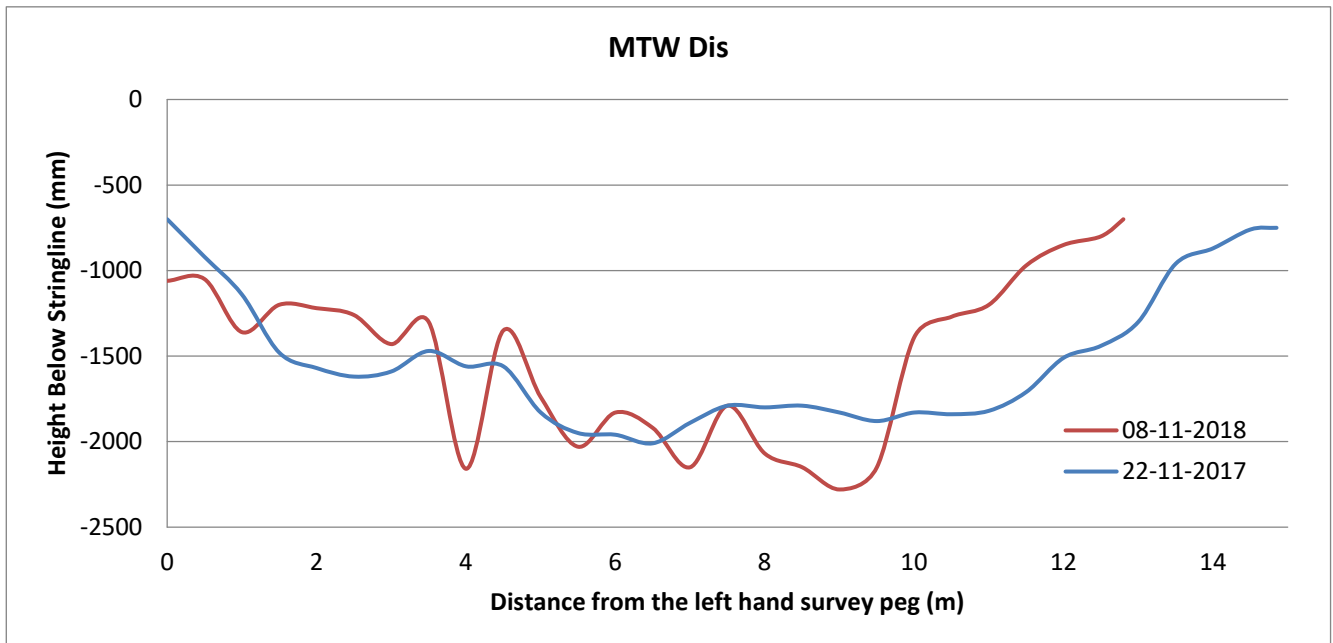
Figure 2 MTW Dis Transect Results

For the purpose of monitoring any changes to the creek, a creek line transect was established. The transect is shown in **Figure 2** and was taken from left to right looking downstream. It can be seen from this transect that the channel has changed significantly since the previous monitoring cycle. This is a result of the upgrade work done at this monitoring point including rock armouring of the creek bed explaining the elevation changes on the below graph. It should also be noted that as part of the upgrade works, the peg on the left bank was removed which explains why this round of monitoring shows a shorter length of transect.

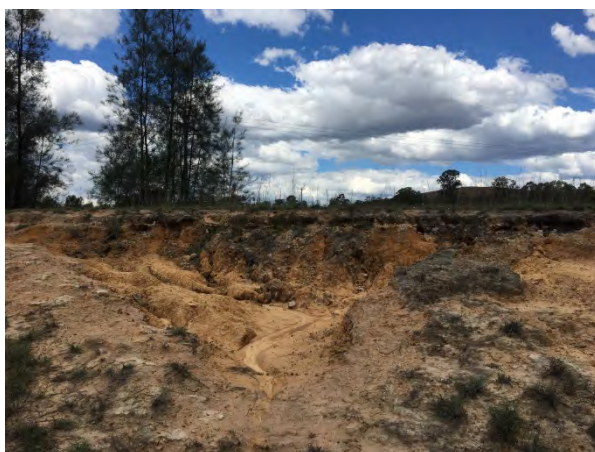
Plate 9 Erosion (top of right bank)

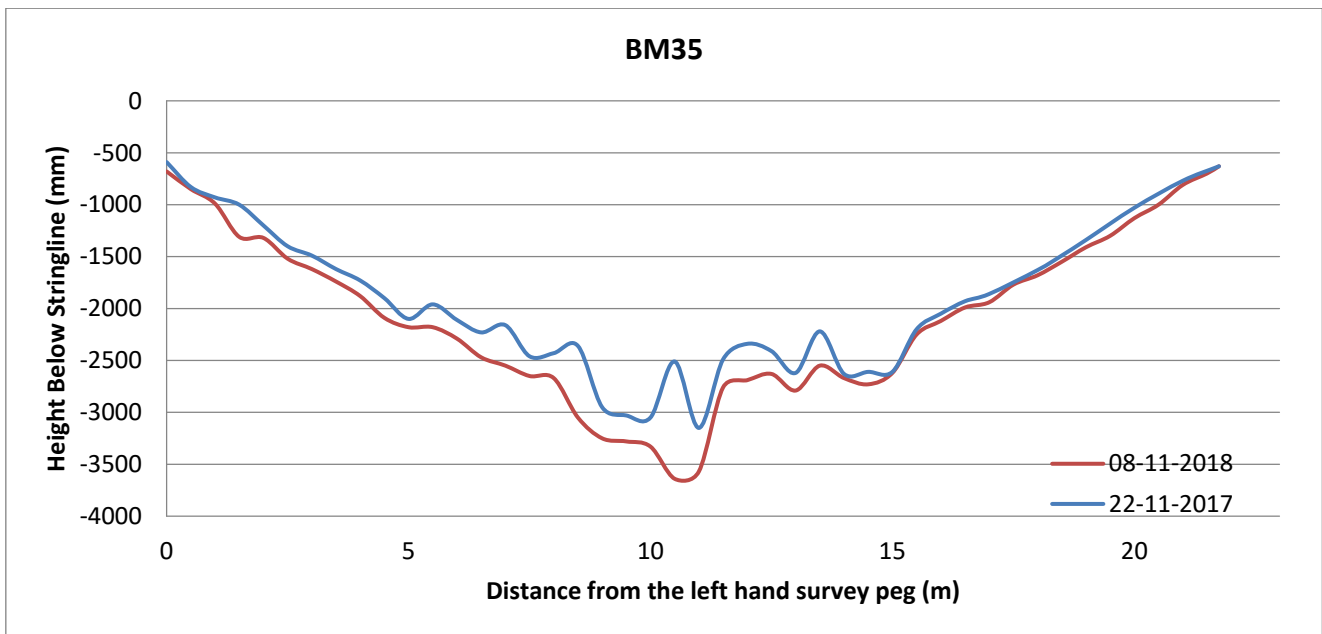
Figure 3 BM35 Transect Results

For the purpose of monitoring any changes of the creek, a creek line transect was established. The transect is shown in **Figure 3** and was taken from left to right looking downstream. It suggests that some scouring has occurred on the left bank and creek bed since the previous monitoring cycle.

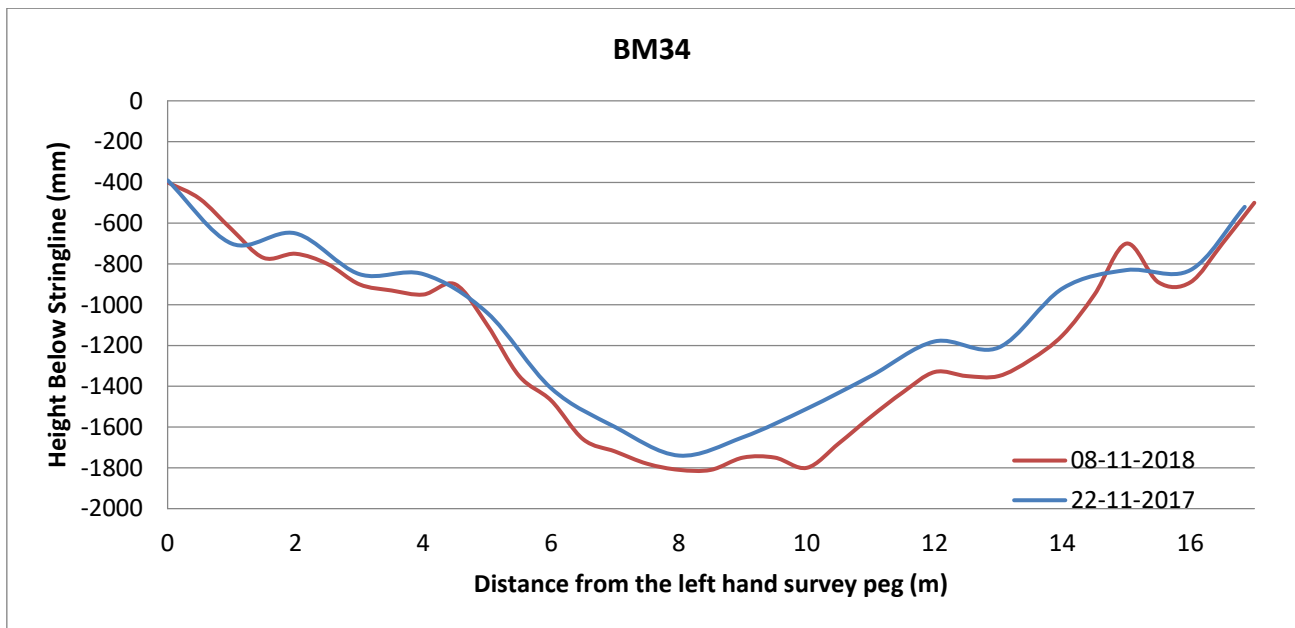
Figure 4 BM34 Transect Results

For the purpose of monitoring any changes of the creek, a creek line transect was established. The transect is shown in **Figure 4** and was taken from left to right looking downstream. It suggests that some scouring has occurred on the entire cross section of the creek since the previous monitoring cycle although this monitoring site didn't appear to have changed significantly since the December 2017 monitoring cycle.

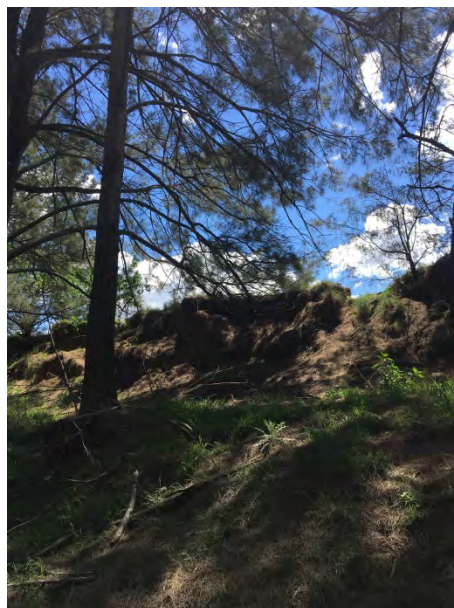
Plate 18 Erosion

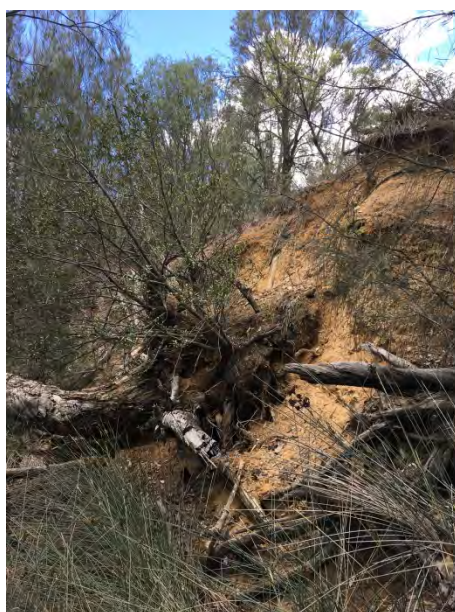
Plate 26 Erosion

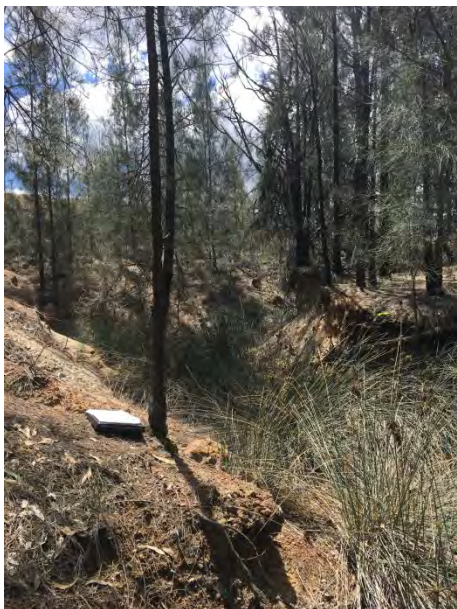
Plate 29 Erosion

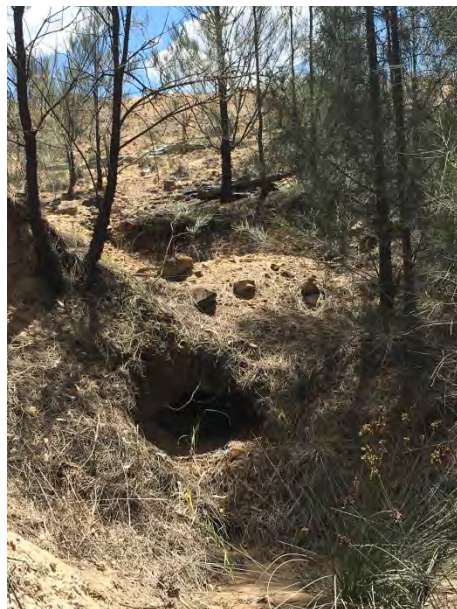
Plate 30 Tunnel Erosion

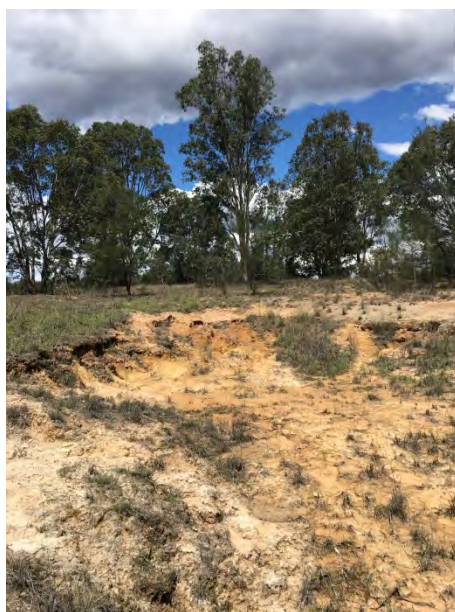
Plate 39 Erosion (top of right bank)

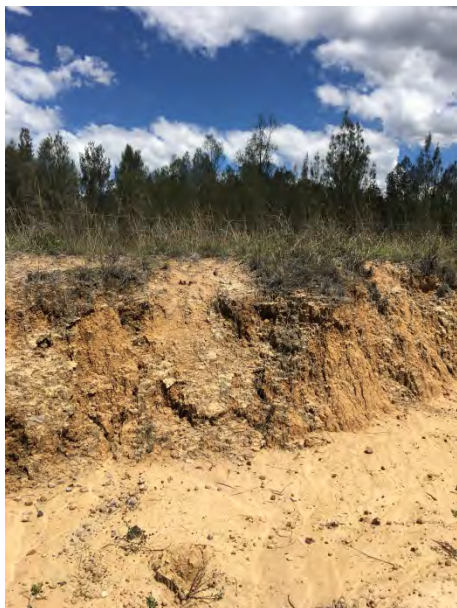
Plate 44 Erosion

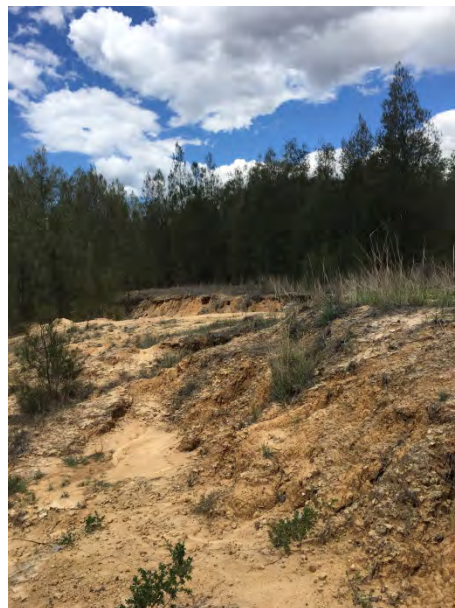
Plate 45 Erosion

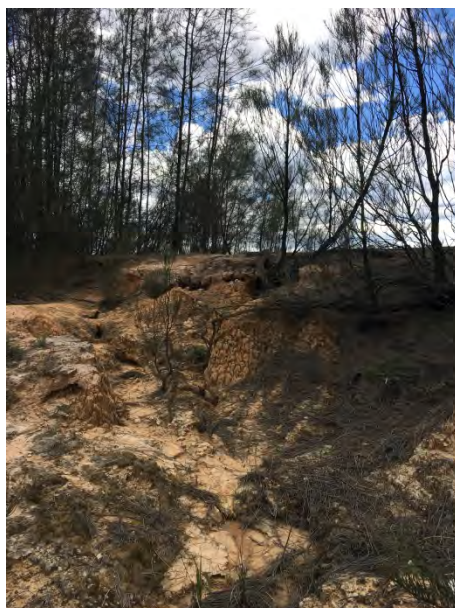
Plate 50 Erosion

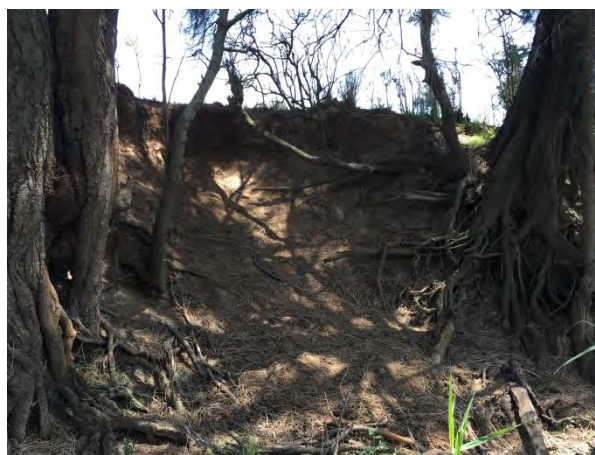
Plate 54 Left Bank

The erosion observed at LC8 included significant erosion of the left bank (approximately 0.8m high with the overall bank at approximately 2.5m high) at a location with a slight meander in the creek as shown on Plate 54. The erosion has some minor undercutting with a section of vertical banks partly stabilised by tree roots. The soil appears to be alluvial and not particularly dispersive. Trees at this location are at risk of falling over due to loss of support. The creek bed and right bank appear to be stable. Overall, this monitoring location has shown similar conditions to the previous monitoring cycle.

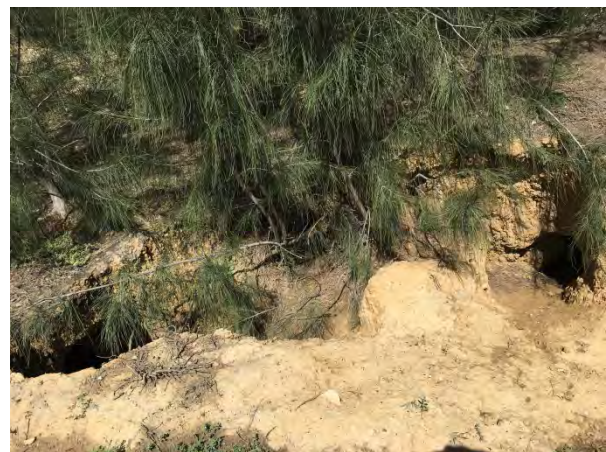
Plate 67 Erosion

The erosion observed at LC12 includes some erosion (approximately 2m high) on the left bank with exposed vertical dispersive soil. It is likely that this erosion was at least partially caused by a fallen tree at the monitoring point location. The left bank at the monitoring point is significantly higher than the right bank. The creek bed and the right bank both show stable conditions. Overall, this monitoring location has shown similar conditions to the previous monitoring cycle.

It is recommended that MTW adopt a risk based approach to determine whether mitigation measures and/or improvement works are required at the monitoring points where erosion was observed. Different remediation measures may be utilised depending on the type of erosion that has occurred (as listed in **Section 4**).

For example, erosion caused by lateral flows and unstable wall materials may be remediated by re-grading the batter slope (as required) to a maximum gradient of 3(H):1(V), ripping the soil and then seeding with a suitable vegetation species. Gypsum may also be used as a soil ameliorant and applied at a rate of 1kg/m². Bunding may also be used to control upslope lateral flows. Creek erosion caused by the shear stresses associated with the upstream flows may be remediated by armouring of the creek bed / banks (i.e. rock, jute mesh, erosion blanket etc), as was observed to have been implemented by MTW at location MTW Dis during the 2018 survey.

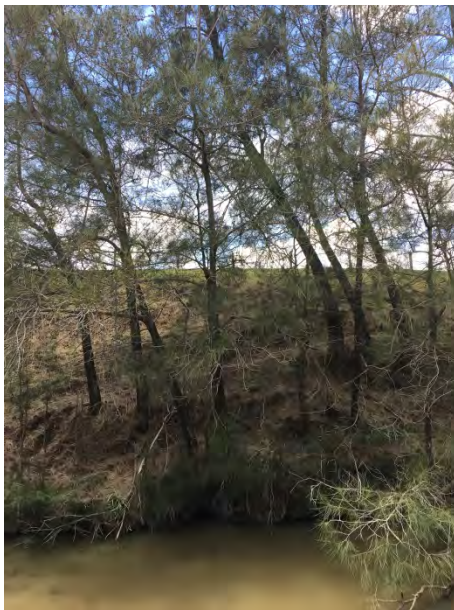
Plate 72 Right Bank

LC13 includes some erosion extending for approximately 5m on the steep left bank with exposed soil which doesn't appear to be highly dispersive. This erosion was most likely caused by livestock tracks observed upstream and downstream of the monitoring location or a localised slope failure. The creek and the right bank both show stable conditions. Overall, this monitoring location has shown similar conditions to the previous monitoring cycle.

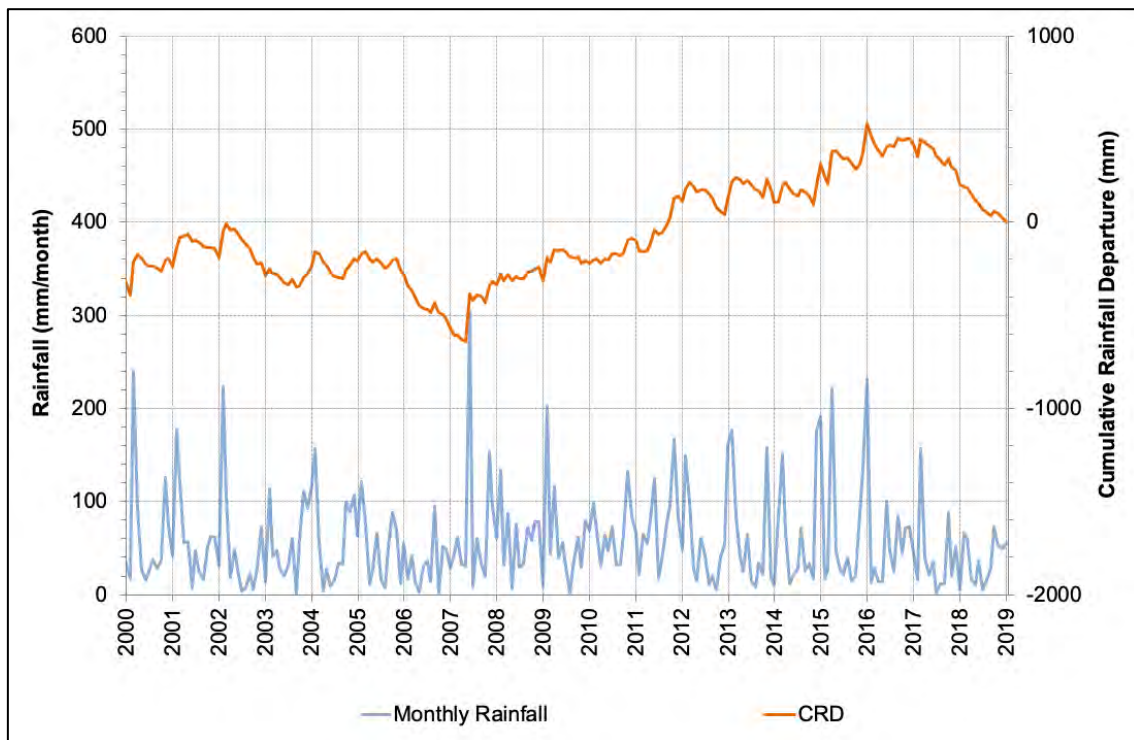
Figure 3-1 Cumulative Rainfall Departure and Monthly Rainfall

As shown in **Figure 3-1**, the region has generally experienced below average rainfall from 2016. Over 2018 there were generally no above average rainfall events, except for October where 82 mm of rain was recorded.

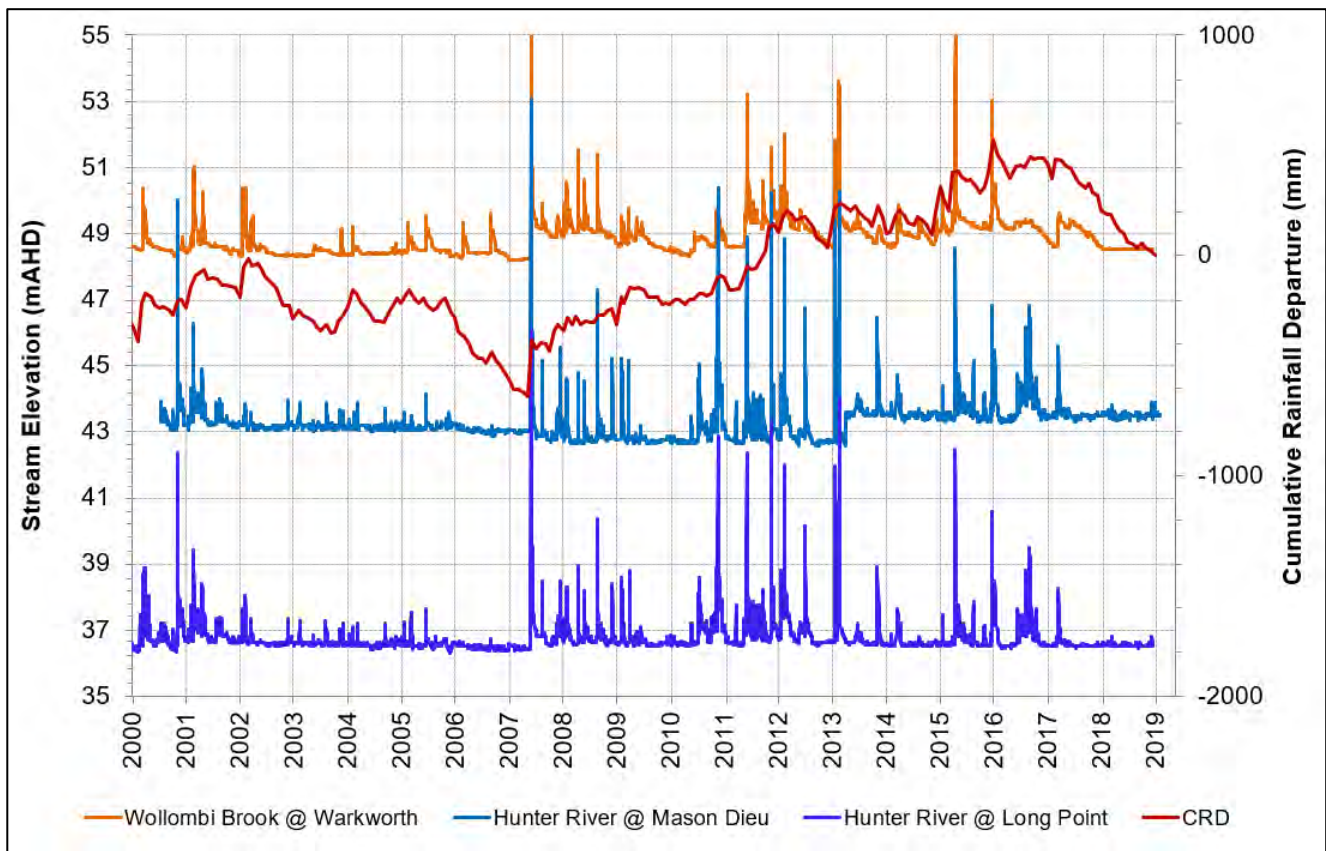
Figure 3-2 Surface Water Levels

As shown in **Figure 3-2**, over 2018 stream elevations within the Hunter River remained stable ranging between 36.44 mAHD and 36.80 mAHD at Long Point and between 43.35 mAHD and 43.91 mAHD at Mason Dieu. Glenbawn Dam is located approximately 135 km upstream of the project area. Daily regulated releases of the dam storage are undertaken to maintain flow and environmental quality of the Hunter River. Given the low rainfall recorded over 2018, the consistent elevations observed at both gauging stations are likely to be largely due to these storage releases.

Figure 3-2 shows that over 2018, stream elevations within Wollombi Brook were recorded between 48.5 mAHD and 48.7 mAHD. The zero gauge for Warkworth station (Station 210004) is 47.755 mAHD, meaning that water levels recorded above zero gauge over 2018 ranged between 0.75 m and 0.95m, but this may reflect pooled water. Time series data of total rainfall against discharge volumes for Wollombi Brook is presented in **Figure 3-3**. The graph shows that since August 2017 no discharge volumes have been recorded within the brook, suggesting that that over 2018 Wollombi Brook did not flow.

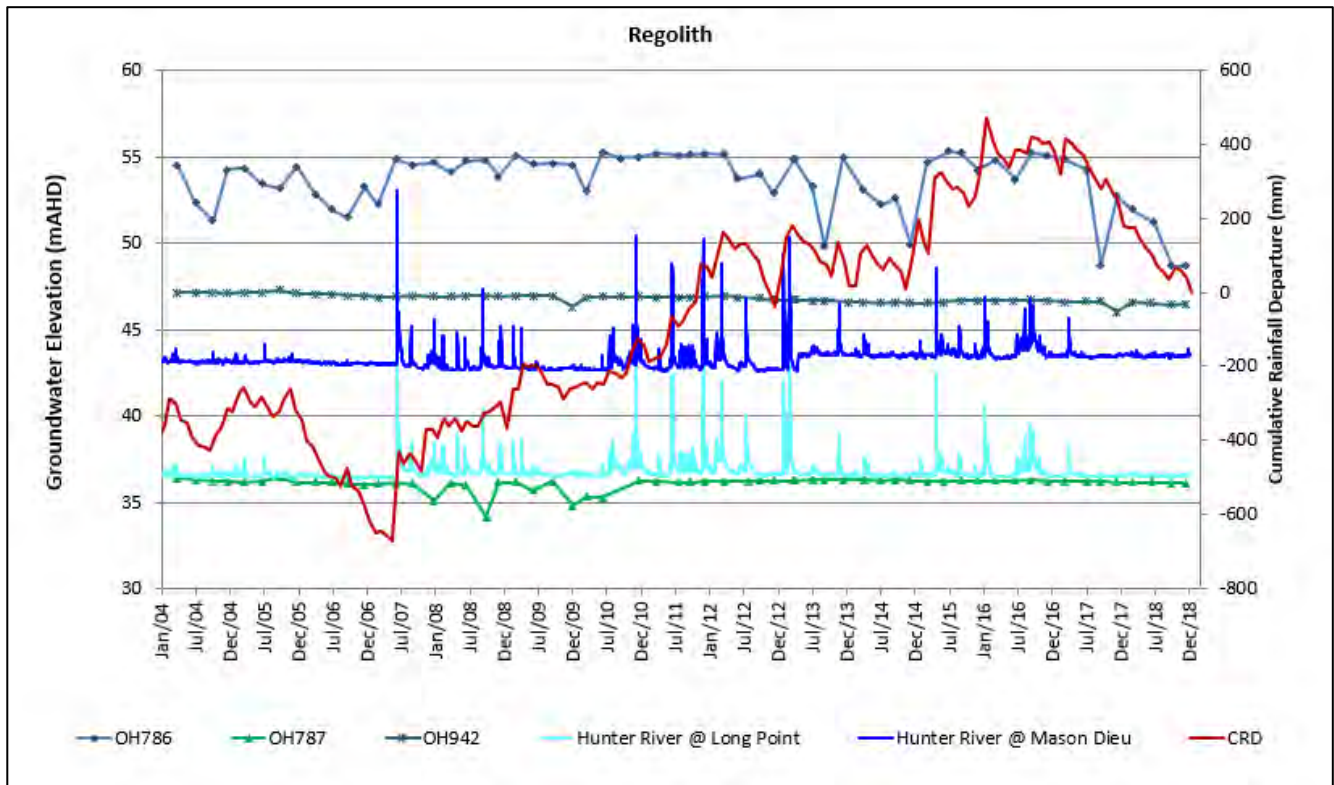
Figure 5-1 Groundwater Levels – Regolith

Over 2018, groundwater within the regolith bores occurred at depths of between 3.71 m and 13.87 m below surface. **Figure 5-4** presents the historical groundwater levels for all three regolith bores, along with rainfall trends (CRD) and stream elevations recorded at the Hunter River stream gauges at Mason Dieu and Long Point.

The greatest fluctuations in water level were recorded for bore OH786 which intersects the shallow regolith east of TD1. Flunctuations in groundwater levels within OH786 appear to follow changes in rainfall suggesting that they are influenced by climatic conditions. The adjacent bore OH942 is installed approximatley 6 m deeper into the weatherd Permian Coal Measures and recorded stable groundwater levels, indicating reduced rainfall recharge with depth.

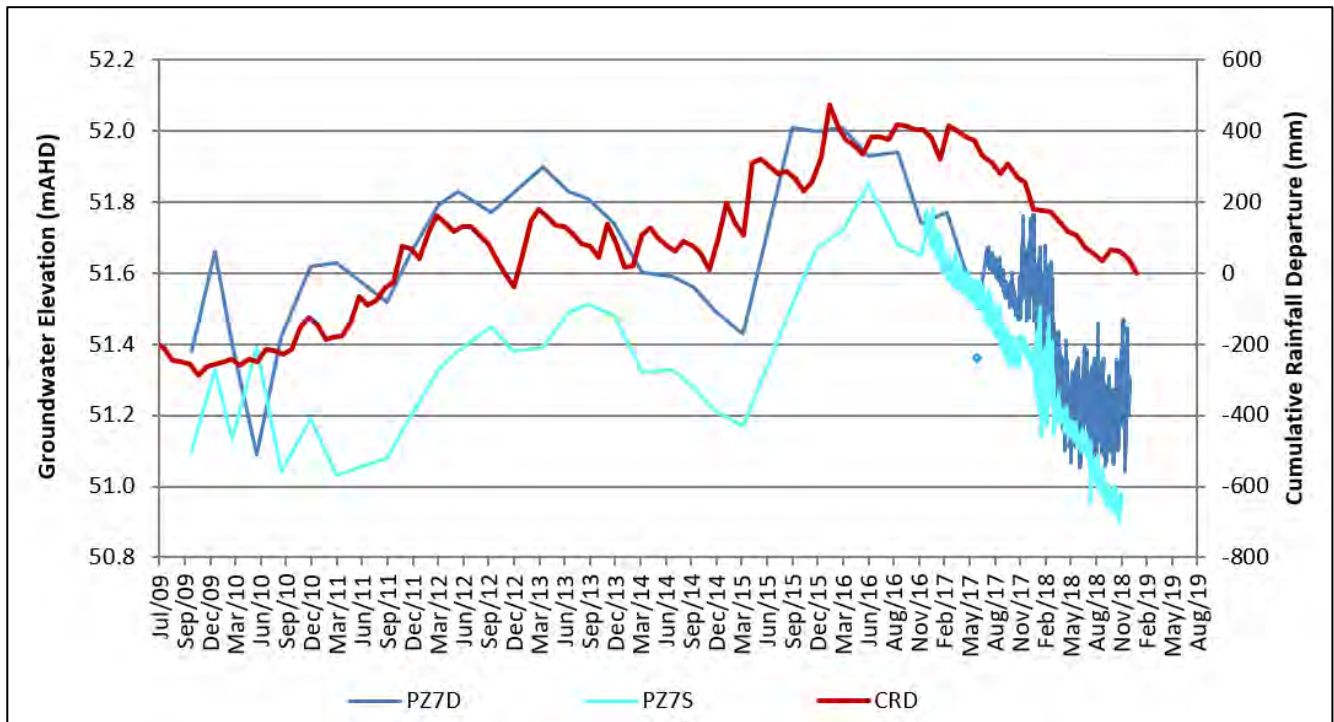
Figure 5-2 Groundwater Levels – Warkworth Sands Bore PZ7S and PZ7D

Bore PZ7 is a nested bore with screen within the Warkworth Sands to 11.1 m depth, and screen within the shallow overburden material at 30.5 m depth. Historical water level data for the bore is presented in **Figure 5-2**. **Figure 5-2** shows a general decline in groundwater levels within the Warkworth Sands and shallow overburden material at PZ7 over 2018. This trend appears to correspond with the general decline in rainfall over this period.
