Mount Thorley Warkworth 2018 Annual Review

Mount Thorley Warkworth (MTW) is an integrated operation of two open cut coal mines, Warkworth Mining Limited (WML) and Mount Thorley Operations (MTO). This Annual Review reports on the environmental performance of Mount Thorley Warkworth (MTW) for the period 1 January 2018 to 31 December 2018.

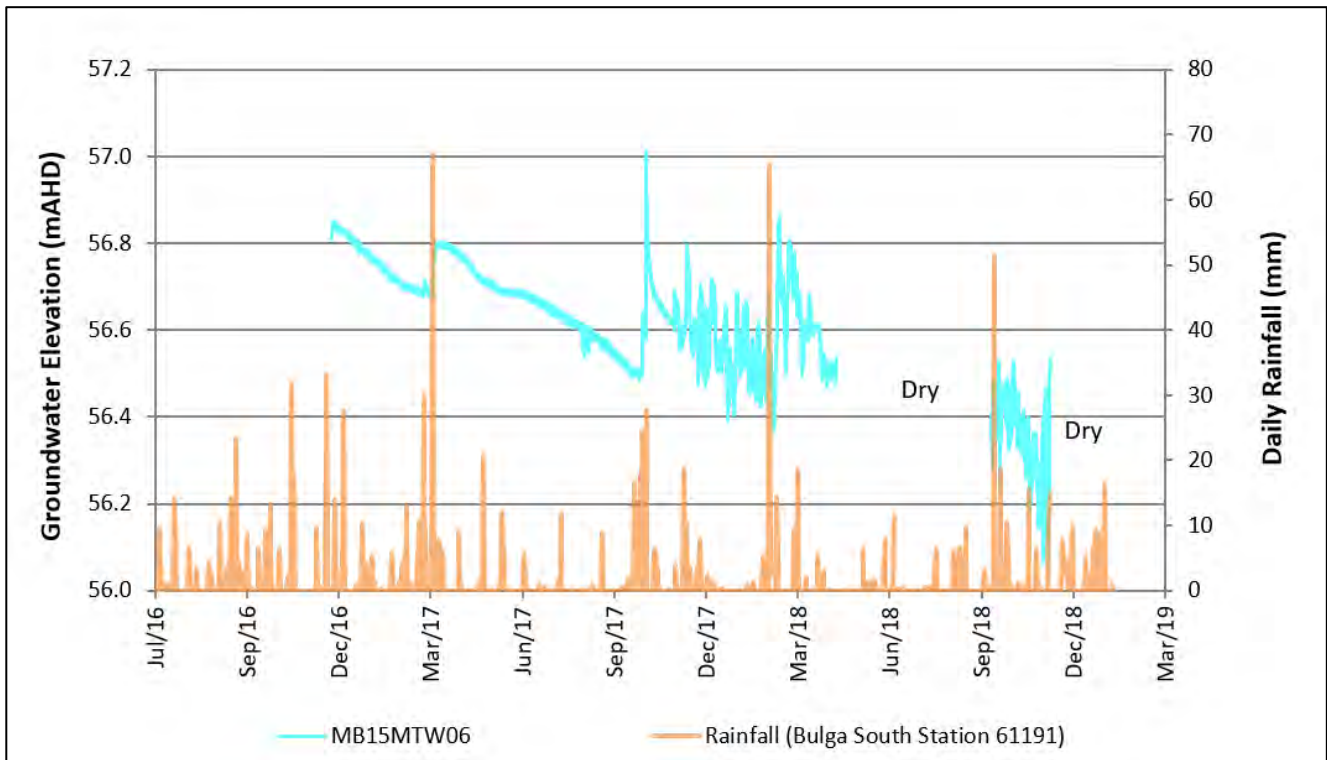
Figure 5-3 Groundwater Levels – Warkworth Sands Bore MB15MTW06

Bores MB15MTW04 to MB15MTW11 were generally recorded as dry since construction in 2016. An exception to this was bore MB15MTW06, which shows groundwater levels that respond to rainfall events (**Figure 5-3**). Over Q2 and Q3 2018 bore MB15MTW06 was recorded as dry, which corresponds with a period of below average rainfall during this period (**Figure 5-3**).

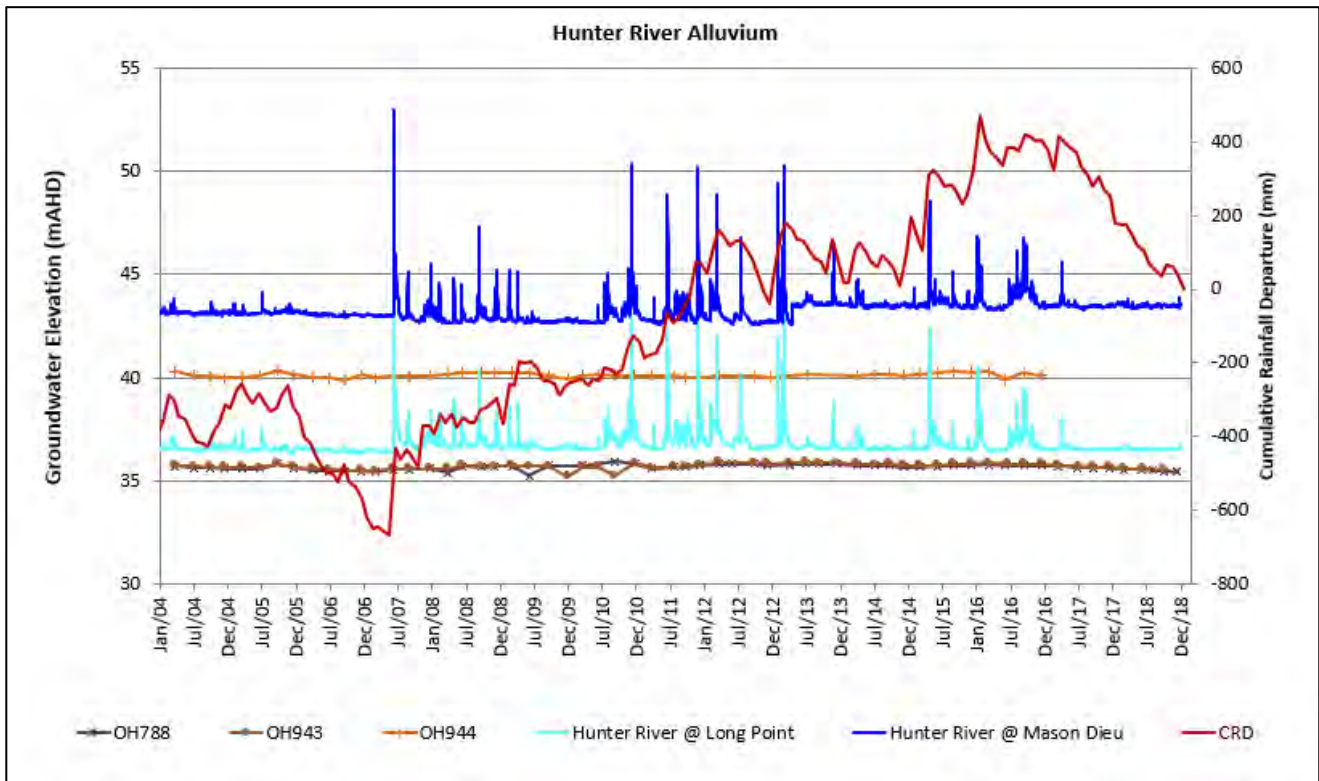
Figure 5-4 Groundwater Levels – Hunter River Alluvium

Of the bores with water present, alluvial groundwater occurred at depths of between 9.5 m and 9.9 m below surface over 2018. **Figure 5-4** presents the historical groundwater levels for all three Hunter River alluvium bores, along with rainfall trends (CRD) and stream elevations recorded at the Hunter River stream gauges at Mason Dieu and Long Point. As shown in **Figure 5-4** over 2018, groundwater levels in all Hunter River alluvium bores were relatively stable.

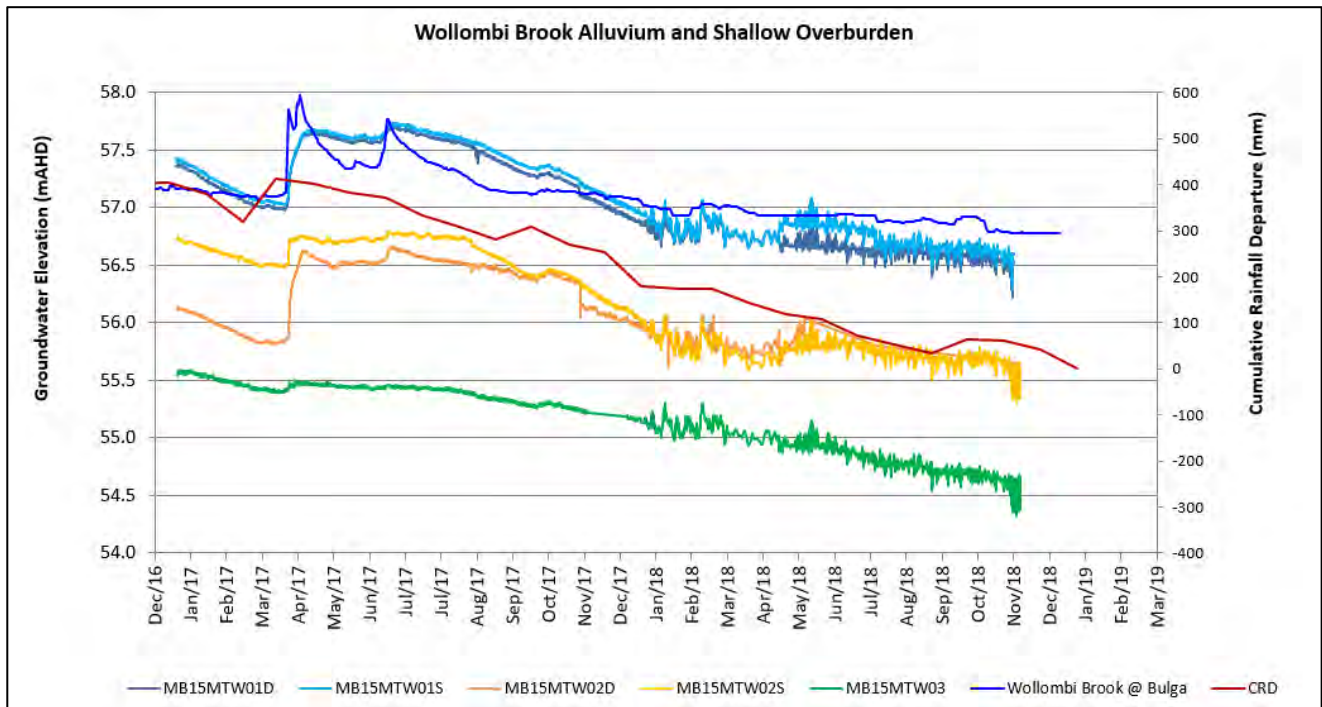
Figure 5-5 Groundwater Levels – Wollombi Brook Alluvium MB15MTW01 and MB15MTW02

Bores MB15MTW01 and MB15MTW02 are located adjacent to Wollombi Brook. **Figure 5-5** shows that over 2018 alluvial groundwater elevations along Wollombi Brook were below stream elevations, indicating losing conditions. Groundwater levels within the alluvium and shallow overburden steadily declined over 2018. Trends between the alluvium and underlying shallow overburden material follow similar trends along Wollombi Brook. This contrasts with observations further away from the Wollombi Brook, as discussed below.

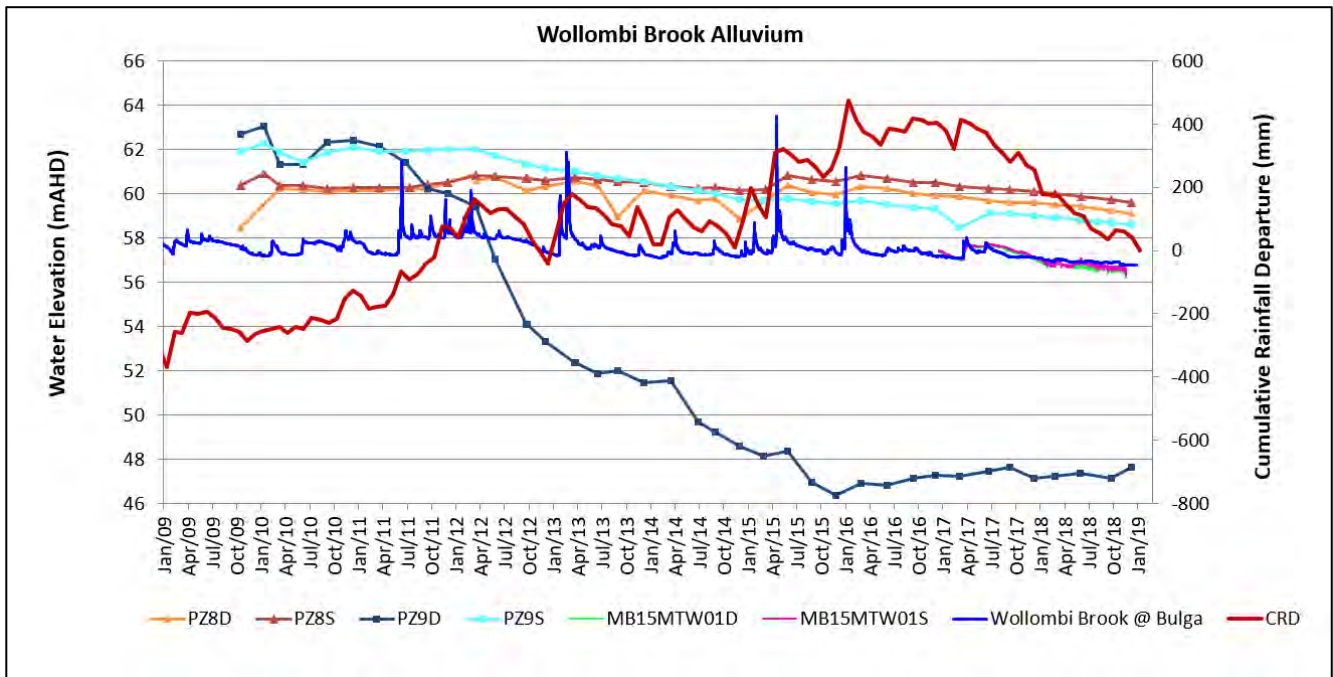
Figure 5-6 Groundwater Levels – Wollombi Brook Alluvium Bores PZ8, PZ9, MB15MTW01 and MB15MTW02

Groundwater level trends for bores over 600 m from Wollombi Brook, at the south-western end of site (PZ8 and PZ9), are presented in **Figure 5-6**. Trends for the MB15MTW alluvial bores are also included for comparison. The graph also includes rainfall trends (CRD) and stream elevations for Wollombi Brook as recorded at Bulga. As with the bores adjacent to Wollombi Brook, **Figure 5-6** shows a general decline in groundwater levels within the alluvium over time.

Figure 5-6 shows that alluvial groundwater elevations are higher than the underlying overburden material, indicating a downward flow gradient. It is also noted that groundwater levels within shallow overburden bore PZ9D declined from commencement of monitoring in 2009 to 2016. Between 2016 and 2017 groundwater levels gradually rose before becoming more stable over 2018. Bore PZ9D is positioned closest to the active operations at Loders Pit. Therefore, the decline in groundwater levels within the shallow overburden material likely reflects depressurisation from mining, as predicted as part of the mine approvals (AGE 2014b). Both PZ9S and PZ9D are shallow, at 7 m and 24 m depth, respectively. Therefore, the difference in groundwater trends highlights limited vertical hydraulic connection between the Permian coal measures and surficial sediments at this location.

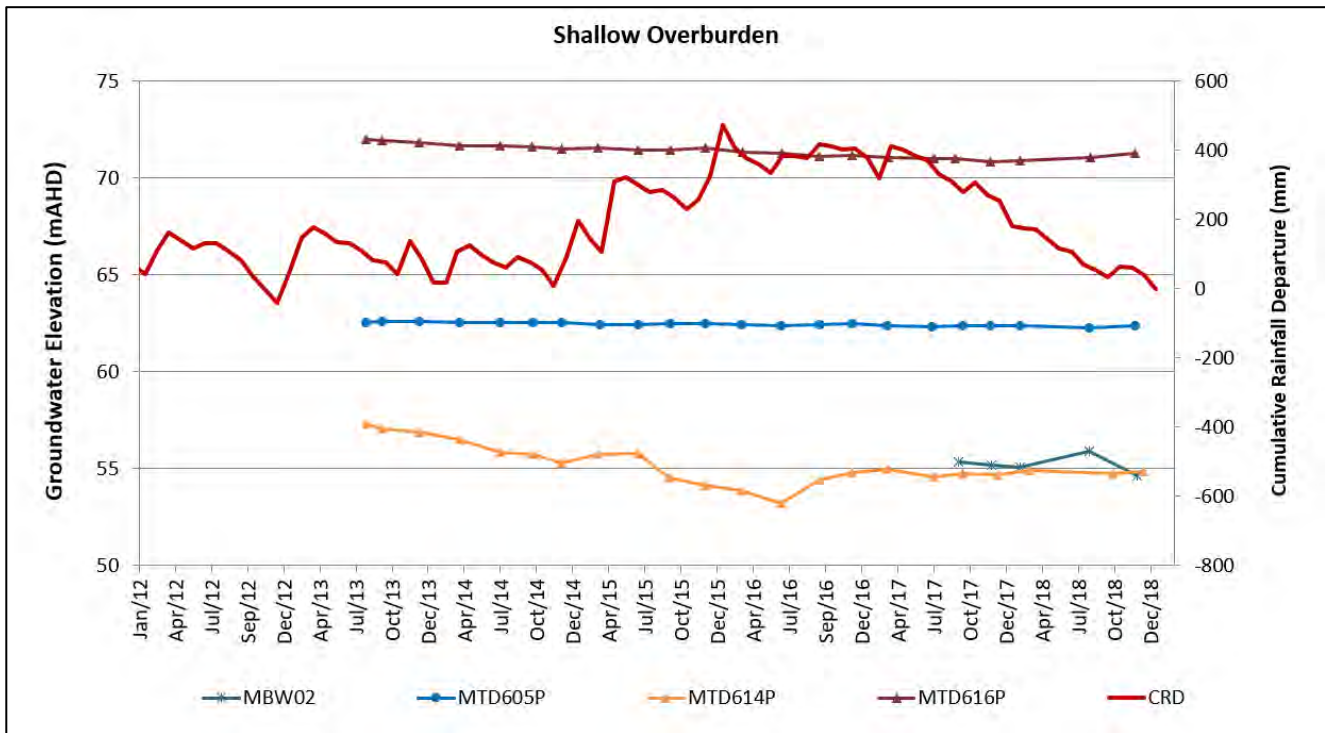
Figure 5-7 Hydrograph of Shallow Permian Coal Measures

Groundwater level trends for bores MTD605P, MTD614P, MTD616P and MBW02 are presented in **Figure 5-7**. **Figure 5-7** shows stable to slightly declining groundwater levels within the shallow overburden material.

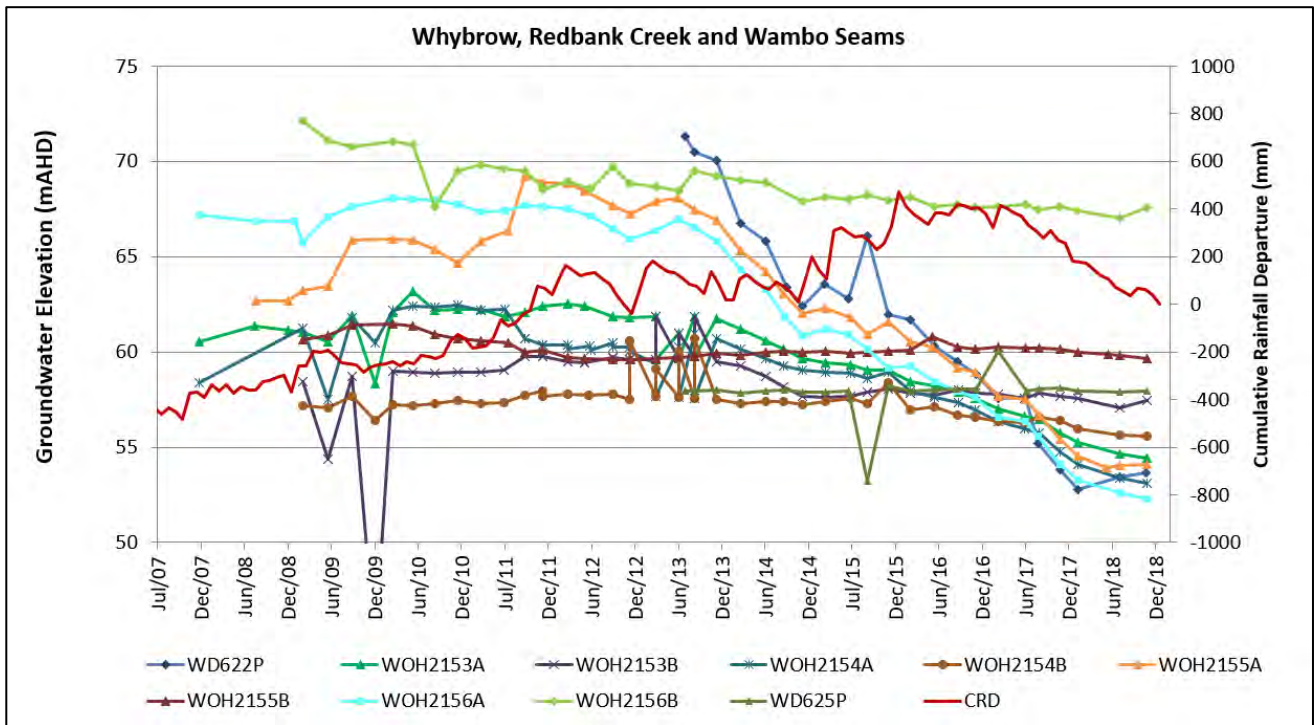
Figure 5-8 Hydrograph of Whybrow, Wambo and Redbank Creek Seams

Historical groundwater level trends for bores intersecting the shallow coal seams (Whybrow, Redbank Creek and Wambo seams) are presented in **Figure 5-8**. **The graph** shows that over 2018 groundwater elevations ranged between 52.3 mAHD and 67.4 mAHD. Over 2018 groundwater levels generally declined in bores WOH2154B, WOH2153A, WOH2154A and WOH2156A. Over 2018 groundwater elevation in WD622P increased from 52.8 m AHD to 53.7 m AHD. WD622P, is located within 300 m of the highwall at West Pit. Groundwater elevations were also found to slightly increase after June 2018 in bores WOH2155A and WOH2156B. Groundwater levels remained relatively stable at bores WOH2153B, WOH2155B and WD625P, which are all located approximately 1 km west of Warkworth operations.

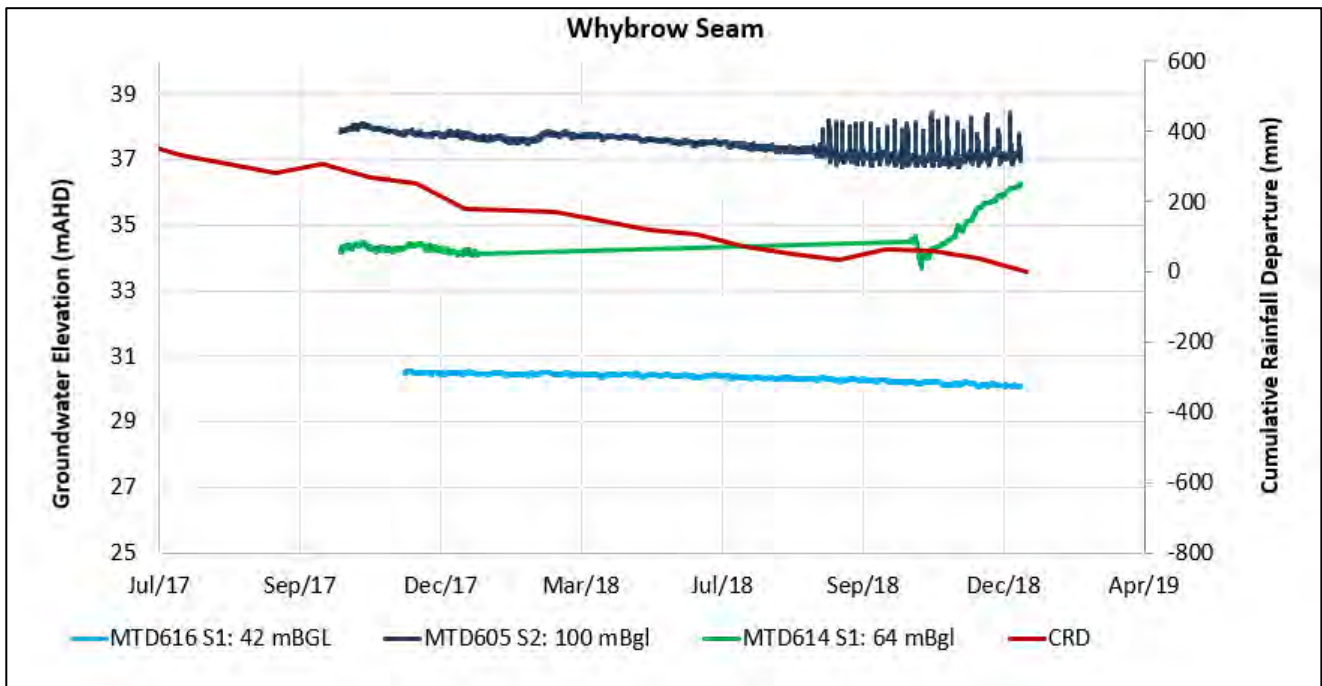
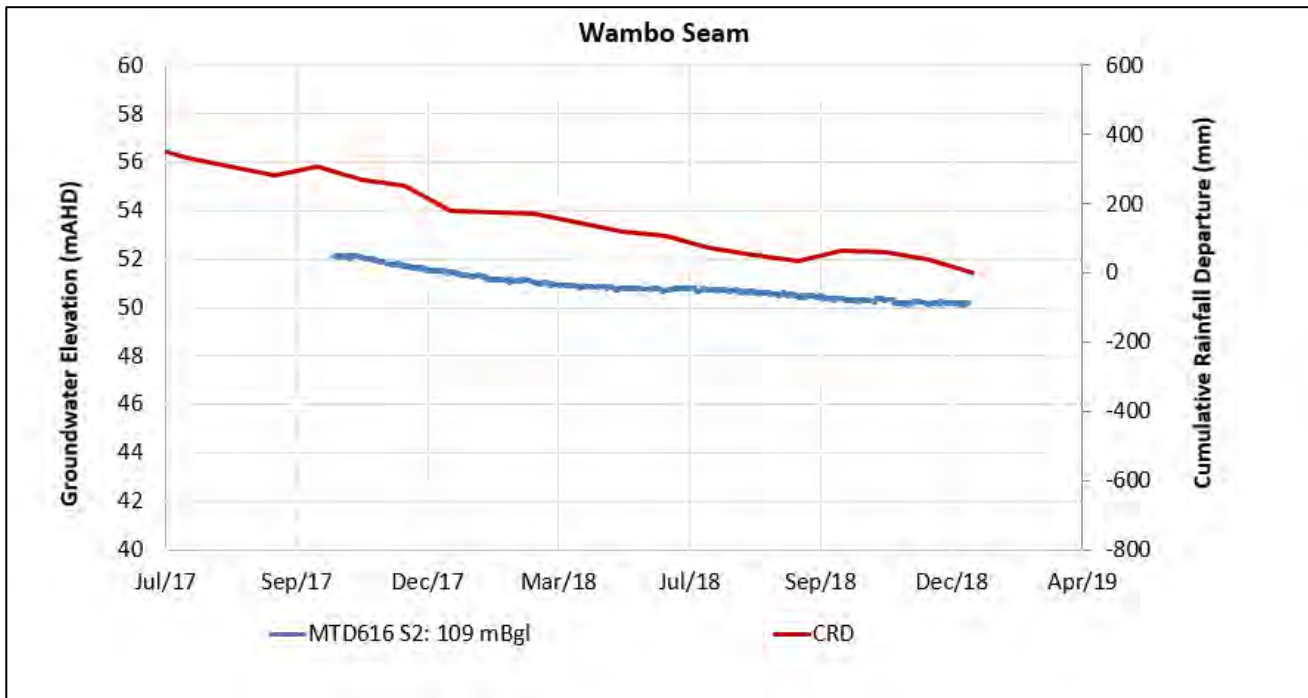
Groundwater level trends for VWP sensors installed within the Whybrow and Wambo seams are presented in **Figure 5-9** and **Figure 5-10** respectively. The graphs show that over 2018 groundwater elevations within both seams slightly declined. This corresponds with the monitoring bore data and is likely due to depressurisation of the seams from mining of West Pit and Loders Pit to the east. The exception to this was seen in the MTD614 sensor installed within the Whybrow Seam (sensor 1) where groundwater elevations were found to increase. MTD614 is located directly to the west of Loders Pit which is actively mined down to the deeper Woodlands Hill Seam. The active mining should in theory result in lowering of groundwater levels through depressurisation, continued monitoring of the sensor should be maintained to ensure it is working correctly and verify this data.

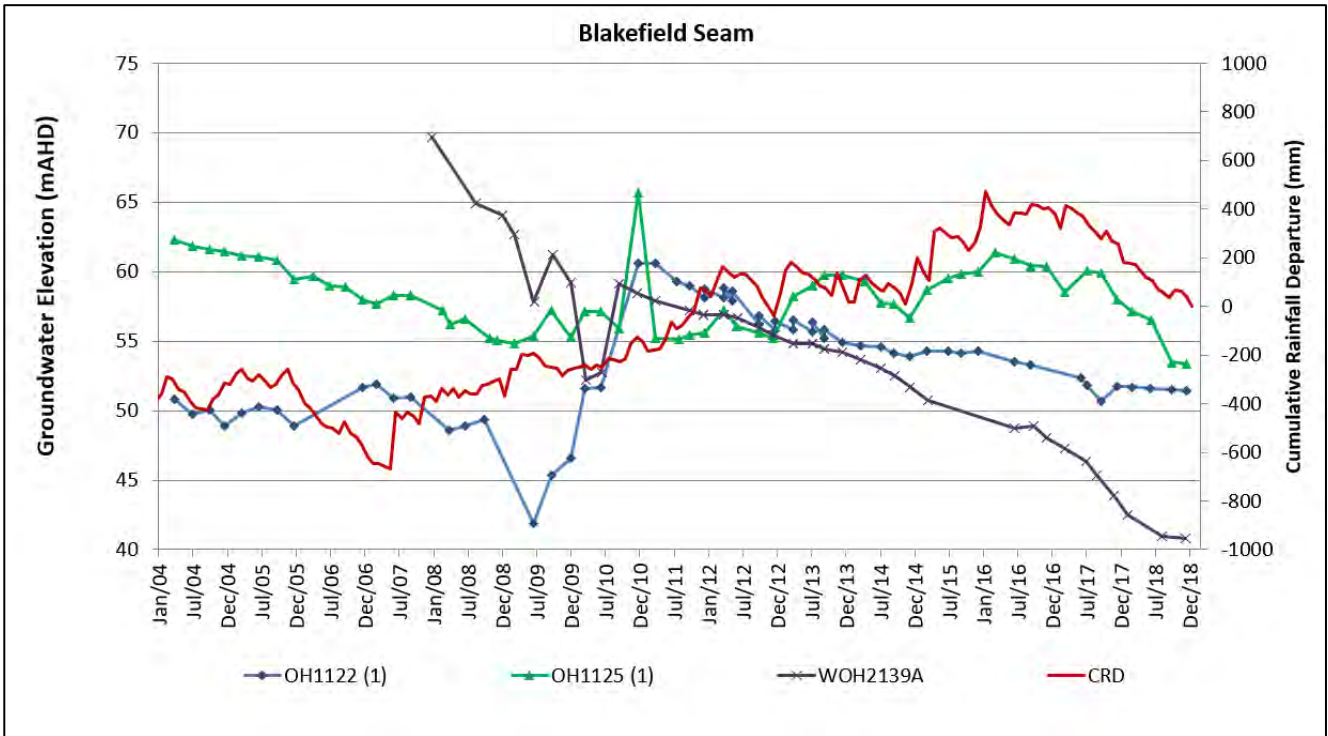
Figure 5-11 Hydrograph of Blakefield Seam

Historical groundwater level trends for bores intersecting the Blakefield Seam are presented in **Figure 5-11**. The graph shows that over 2018 groundwater elevations ranged between 40.8 mAHD and 57.1 mAHD. Groundwater levels generally declined within the Blakefield Seam around site over Q1 to Q3 2018. In Q4 2018 groundwater levels still declined but became more stable. In response to mine progression Bore OH1125(1) recorded a 3.8 m decline, Bore WOH2139A recorded a 1.7 m decline and Bore OH1122(1) recorded a 0.3 m decline over 2018.

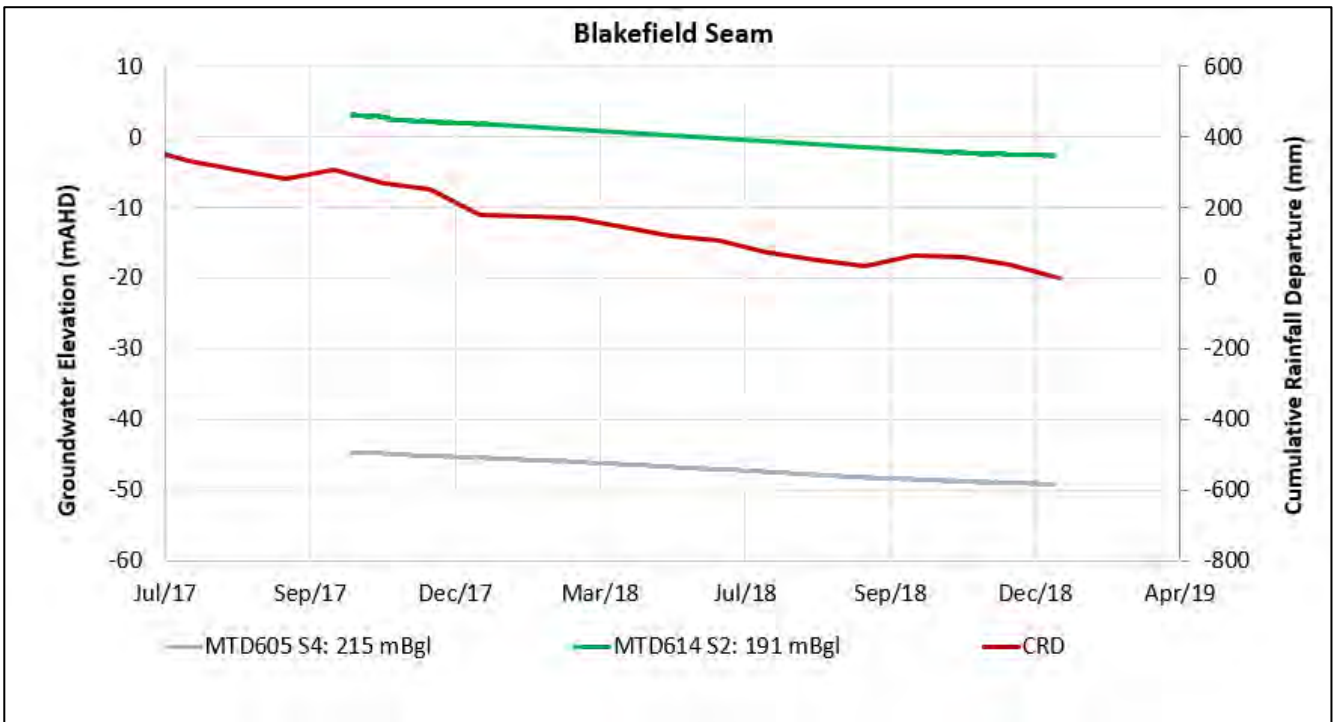
Figure 5-12 VWP Hydrograph of Blakefield Seam

Groundwater level trends for VWP sensors installed within the Blakefield Seam are presented in **Figure 5-12**. The graph shows that over 2018 groundwater elevations within the seam slightly declined. This corresponds with the monitoring bore data and is likely due to depressurisation of the seams from expansion of West Pit and Loders Pit to the east.

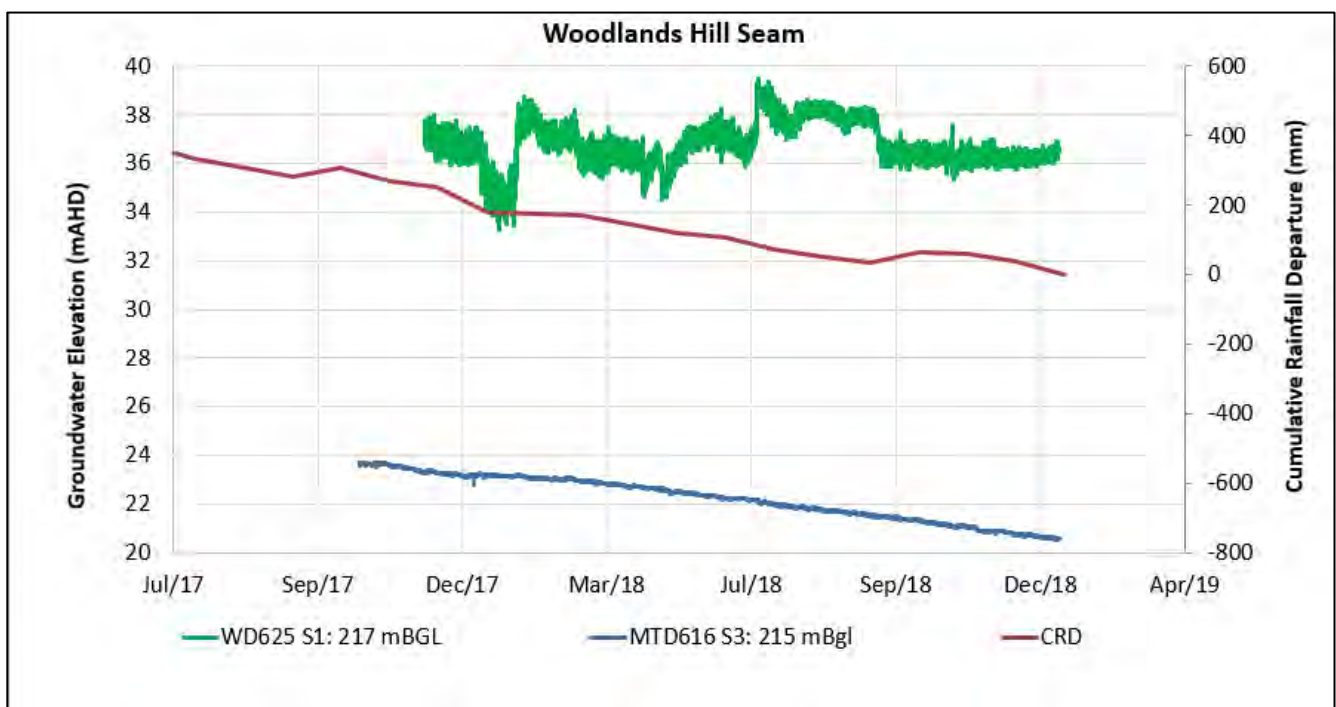
Figure 5-13 VWP Hydrograph of Woodlands Hill Seam

Groundwater level trends for VWP sensors installed within the Woodlands Hill Seam are presented in **Figure 5-13**. The graph shows that over 2018 groundwater elevations within the seam at VWP WD625 were variable, whereas at VWP MTD616 groundwater elevations slightly declined. MTD616 is located to the north west of Loders Pit and west of West Pit. The decreasing groundwater elevations are likely due to dewatering of the coal seam from mining of these pits.

WD625 is located to the west of North Pit and recorded variable groundwater elevations over 2018. The cause of these fluctuations is unclear but may relate to underground mine and water storage activities at Wambo.

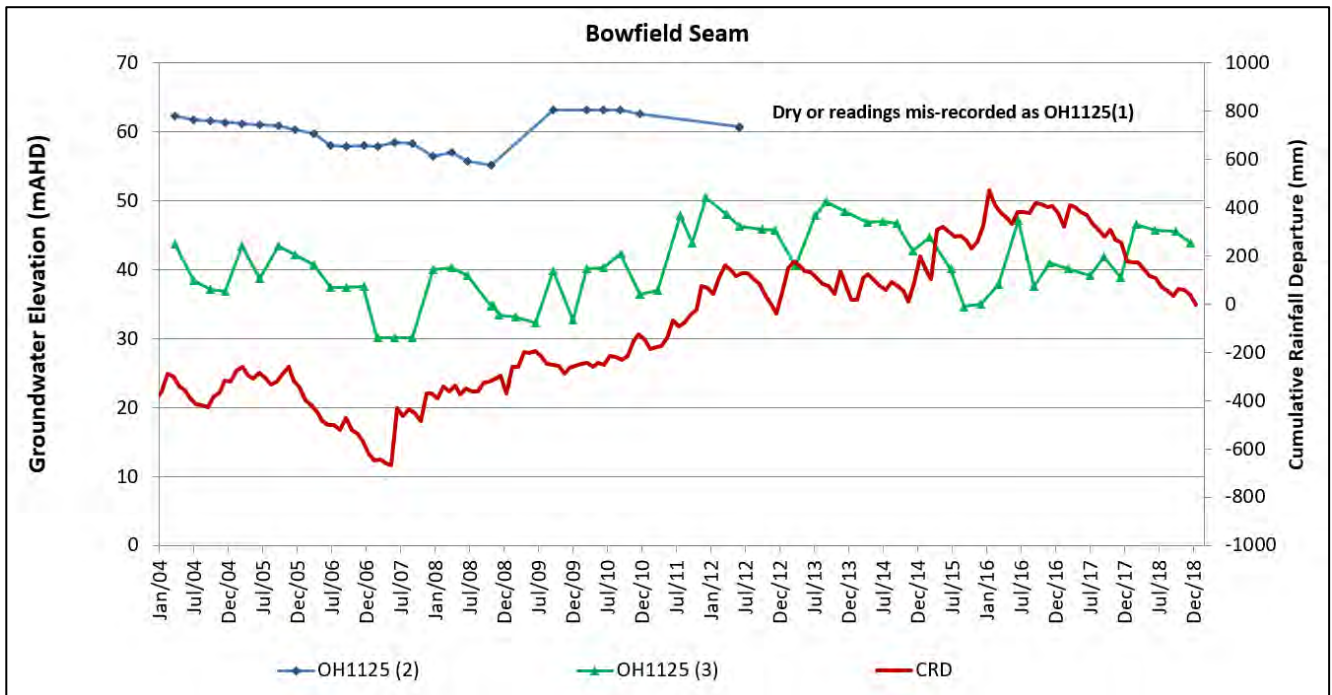
Figure 5-14 Hydrograph of Bowfield Seam

Historical groundwater level trends for bores intersecting the Bowfield Seam are presented in **Figure 5-14**. The graph shows that between December 2017 and March 2018 groundwater elevations in Bore OH1125(3) increased by 7.7 m. Over 2018 groundwater elevations in Bore OH1125(3) decreased from 46.6 mAHD to 43.93 mAHD, corresponding to the decrease in rainfall over this period. Bore OH1125(3) is located directly to the north of North Pit. The increase in groundwater elevation noted between 2017 and 2018 may correspond to recovery with progressive mine rehabilitation or potentially in response to site water storage activities associated in dewatering TD2. Review of available bore details indicates the total depth of the bore is 62.7 m; however, some records indicate the bore was constructed to over 80 m depth. Review of the condition of the bore is recommended.

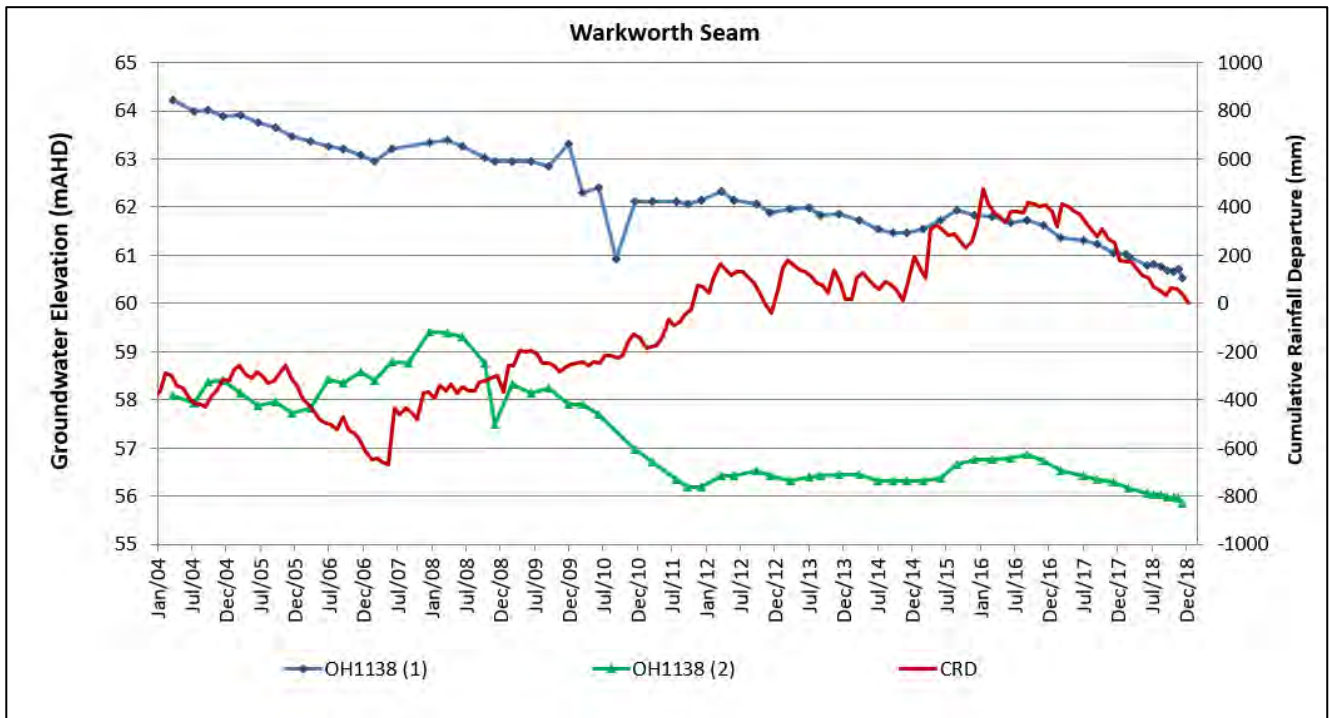
Figure 5-15 Hydrograph of Warkworth Seam

Historical groundwater level trends for bores intersecting the Warkworth Seam at bore OH1138 at two intervals (1 and 2) are presented in **Figure 5-15**. The graph shows that over 2018 groundwater elevations ranged between 55.85 mAHD and 61.06 mAHD and level declined by up to 0.54 m. The bore is located north of North Pit and the decline may relate to drawdown towards active mining within the pit to the south-west. The trend may also be influenced by abstraction from Lemington Underground Bore to the north-west.

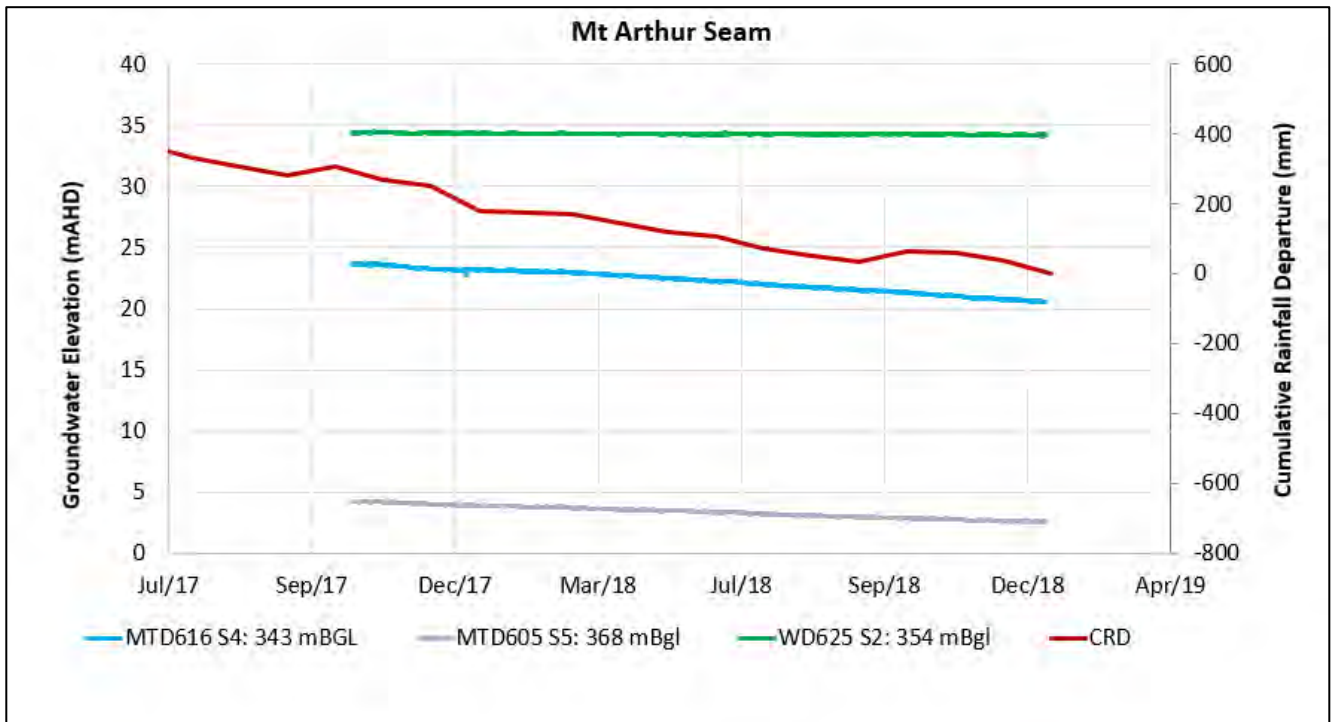
Figure 5-16 VWP hydrograph of Mt Arthur Seam

Figure 5-16 shows that over 2018 groundwater elevations within the Mt Arthur Seam ranged between 2.59 mAHD and 34.35 mAHD and level declined by up to 1.61 m. The large difference in groundwater elevations is related to the difference in sensor elevations across the VWPs. The sensor elevations and construction details for VWP MTD605 should be reviewed to verify the accuracy of the groundwater elevations presented. The decreasing elevations within VWP MTD605 and MTD616 are likely to be due to the depressurisation of coal seams related to West Pit and Lodgers Pit. The stable elevations observed in WD625 suggest that depressurisation of the coal seams associated with North Pit are not influencing groundwater levels within the Mt Arthur seam at this location.
