ASHTON LONGWALL 102 – MID PANEL REPORT

This report has been prepared by Ashton Coal Operations Pty Ltd (ACOL) and RPS Aquaterra.

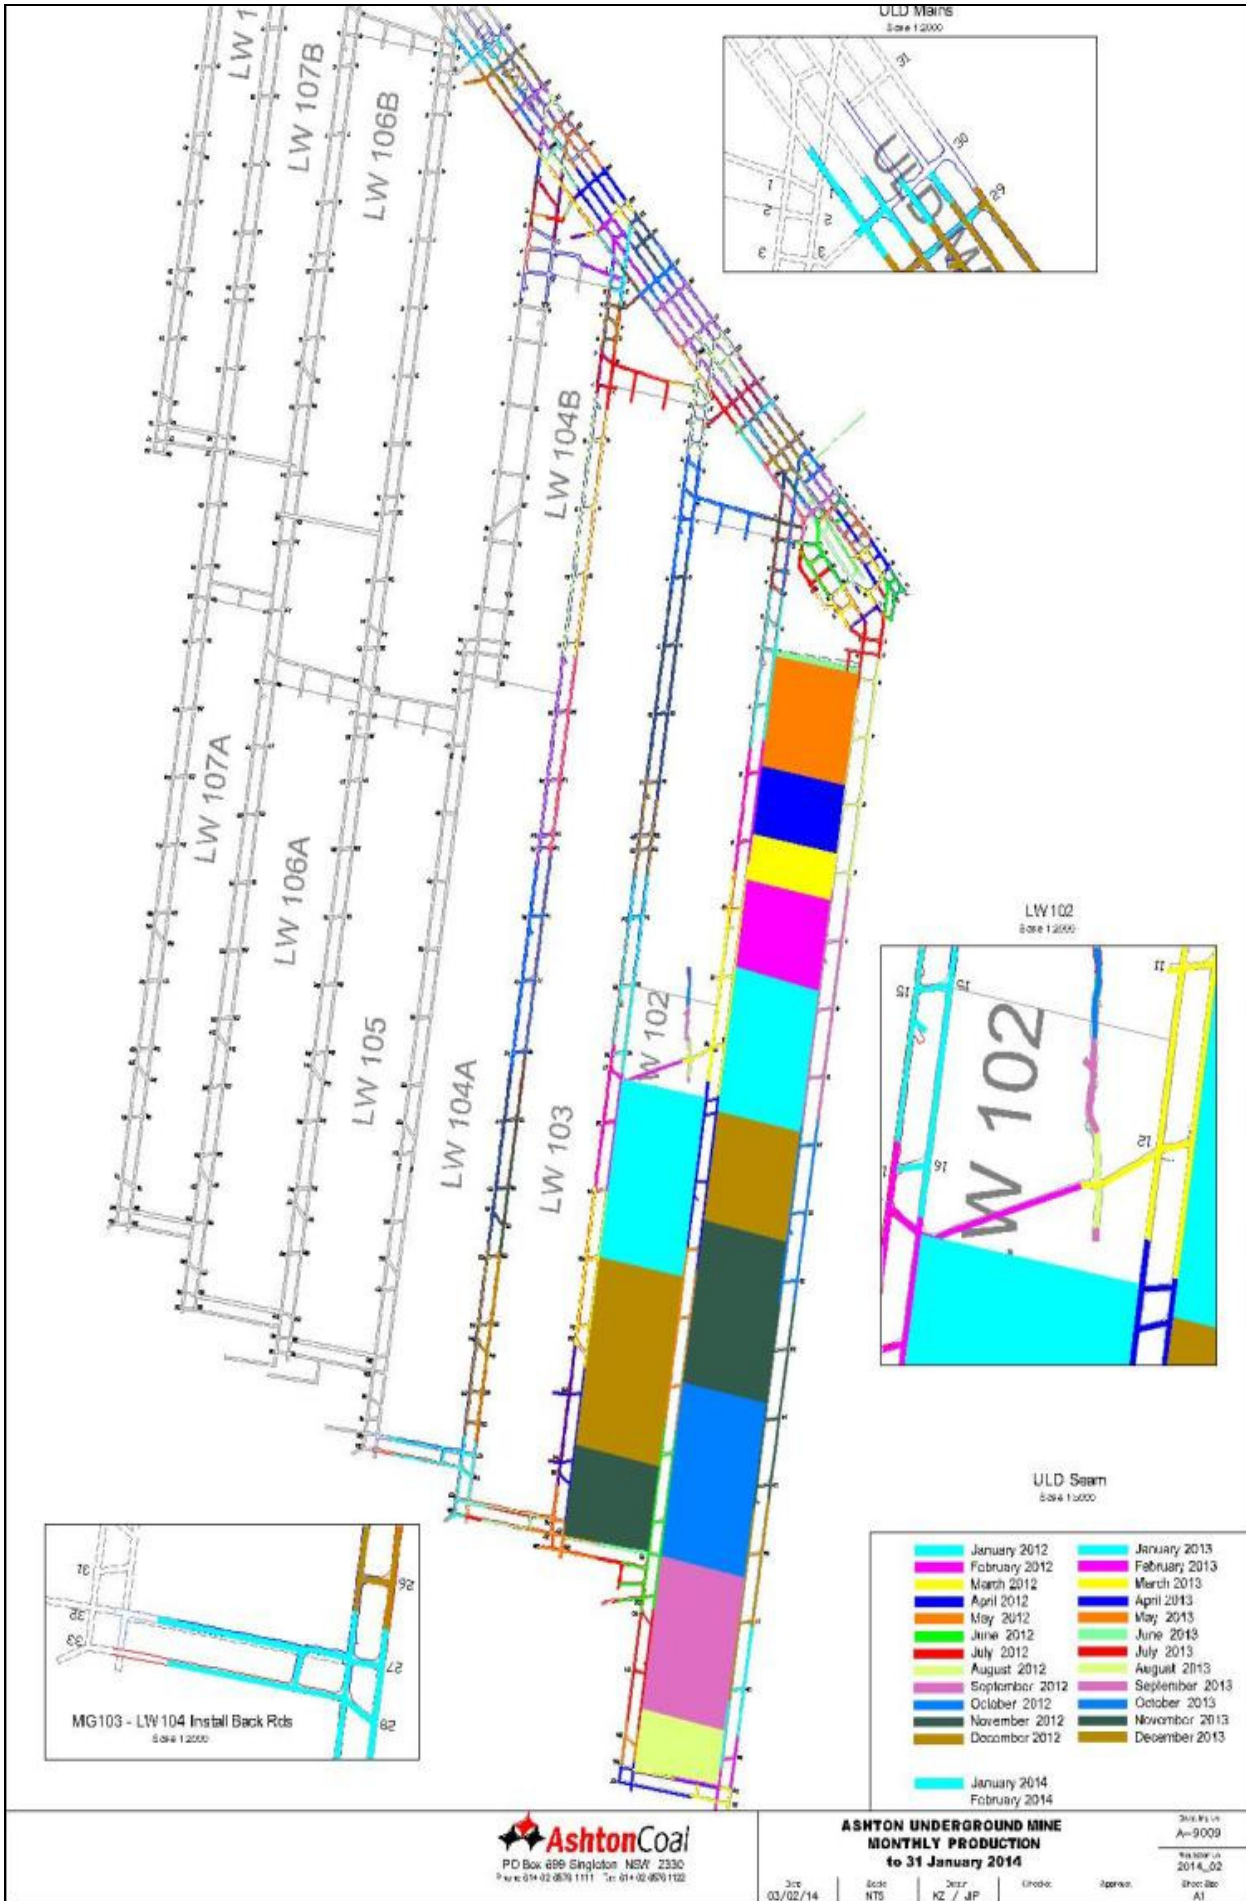
Figure 1: Progression of Longwall Extraction in the Upper Liddell Seam

Ashton’s longwall mining operation commenced in February 2007. Since then 11 panels have been completed. The progress of longwall extraction in the ULD seam is shown in **Figure 1**.

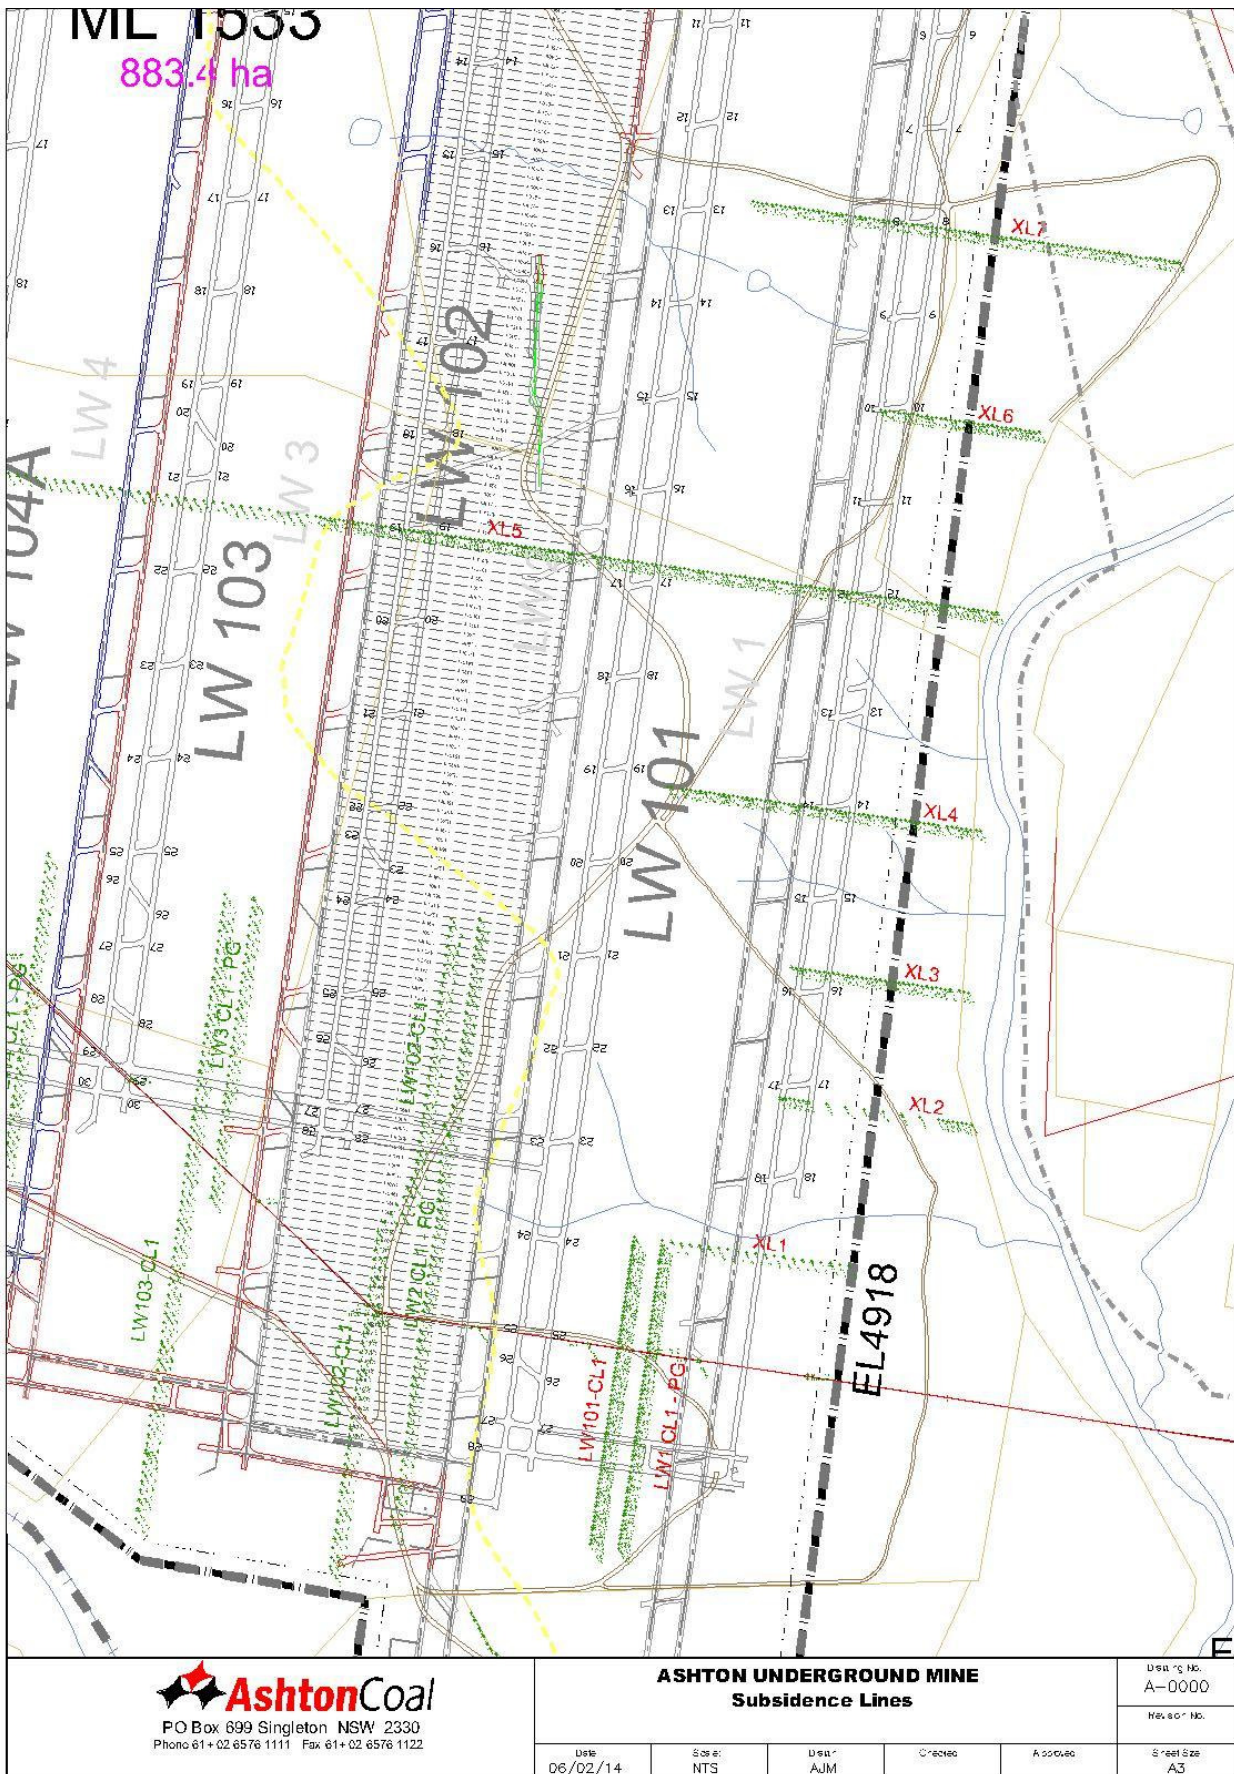
Figure 2: Plan location of Monitoring Cross Lines. Also shown is the 132kV transmission lines.

The Upper Liddell Seam (ULD) Longwall 102 utilises panel centre lines (CL1 and CL2), the Pikes Gully LW2 panel centre lines and the cross block survey monitoring lines that were used for the Pikes Gully Seam (PG) longwalls. The subsidence monitoring lines relevant to LW102 to date are LW102-CL1, LW2-CL1 and XL5 as shown in **Figure 2**.
