ASHTON LONGWALL 7A – END OF PANEL SUMMARY REPORT**1 INTRODUCTION**

End of Panel Report

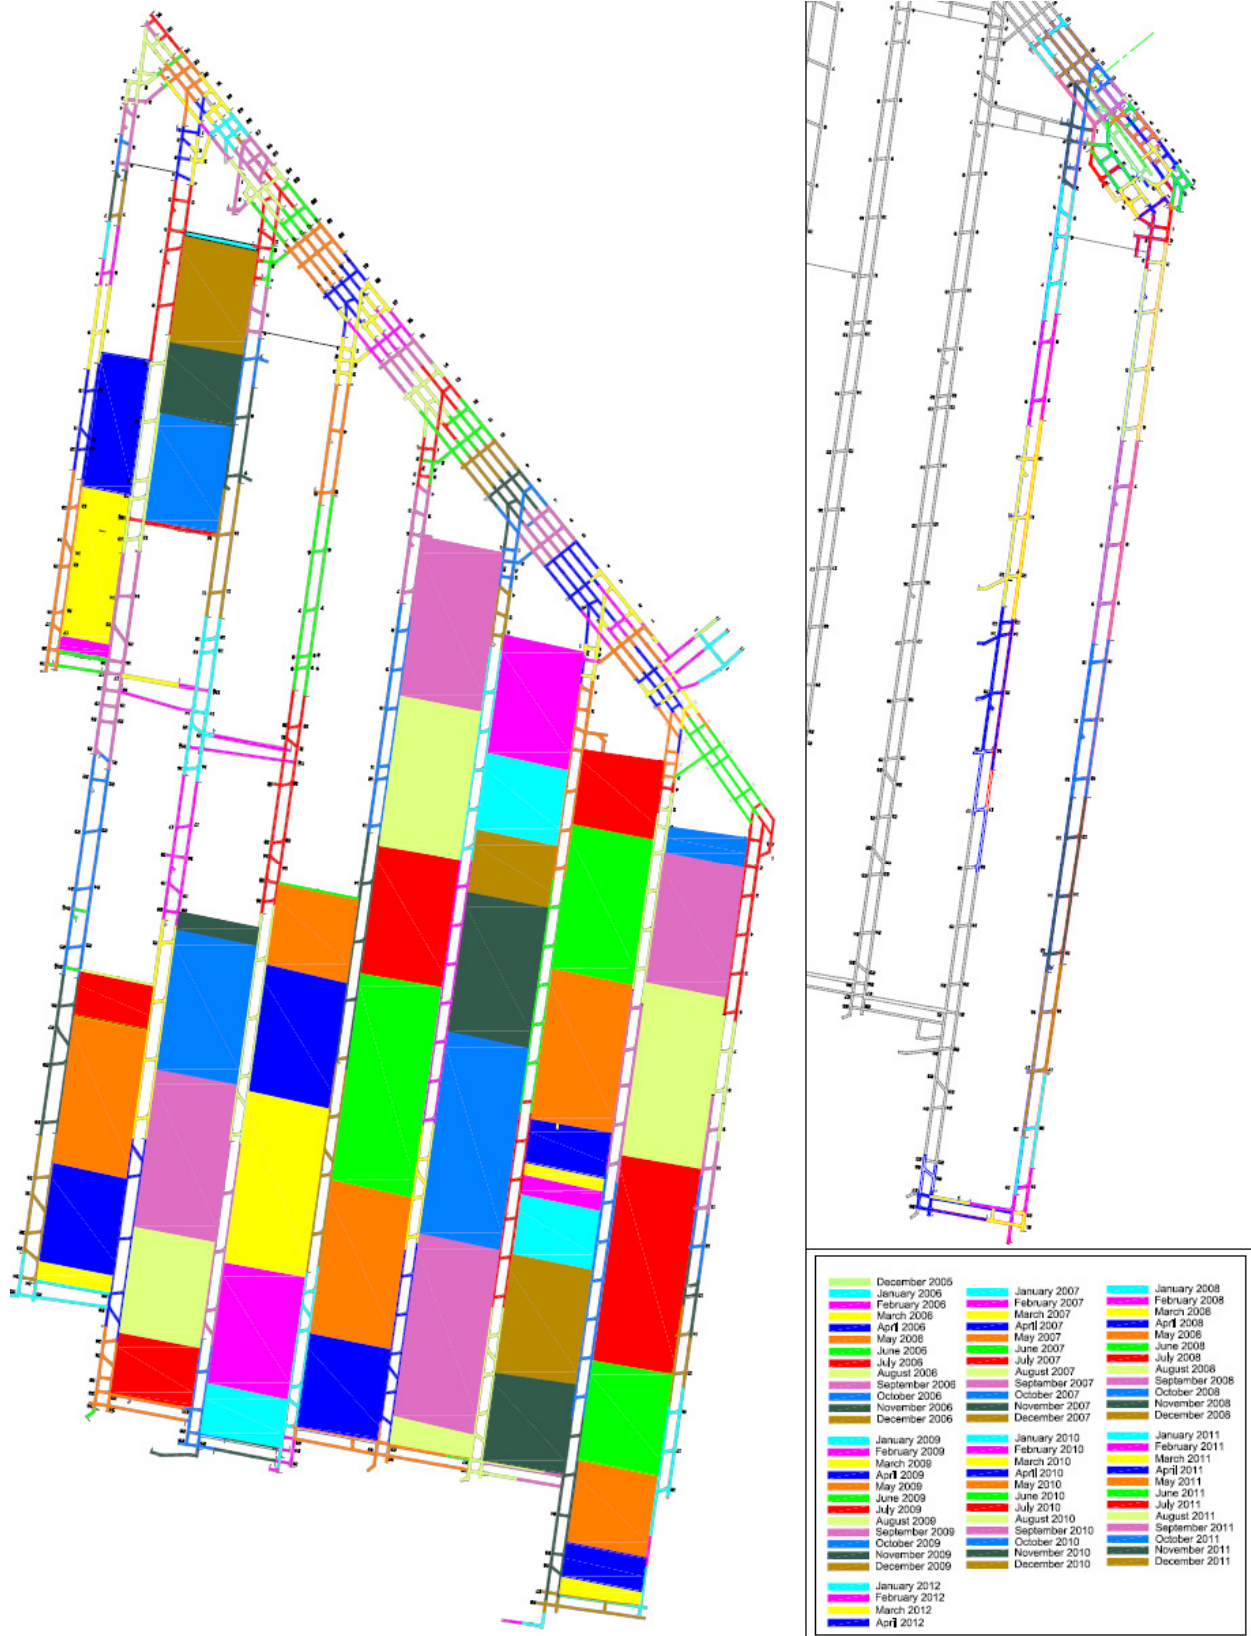
Figure 1: Progression of Longwall Extraction

Ashton’s longwall mining operation commenced in February 2007. Since then 8 panels have been completed with the 9th (Longwall 8 which is located adjacent to Longwall 7B ‘short’) currently being mined. The progress of longwall extraction is shown in **Figure 1**.

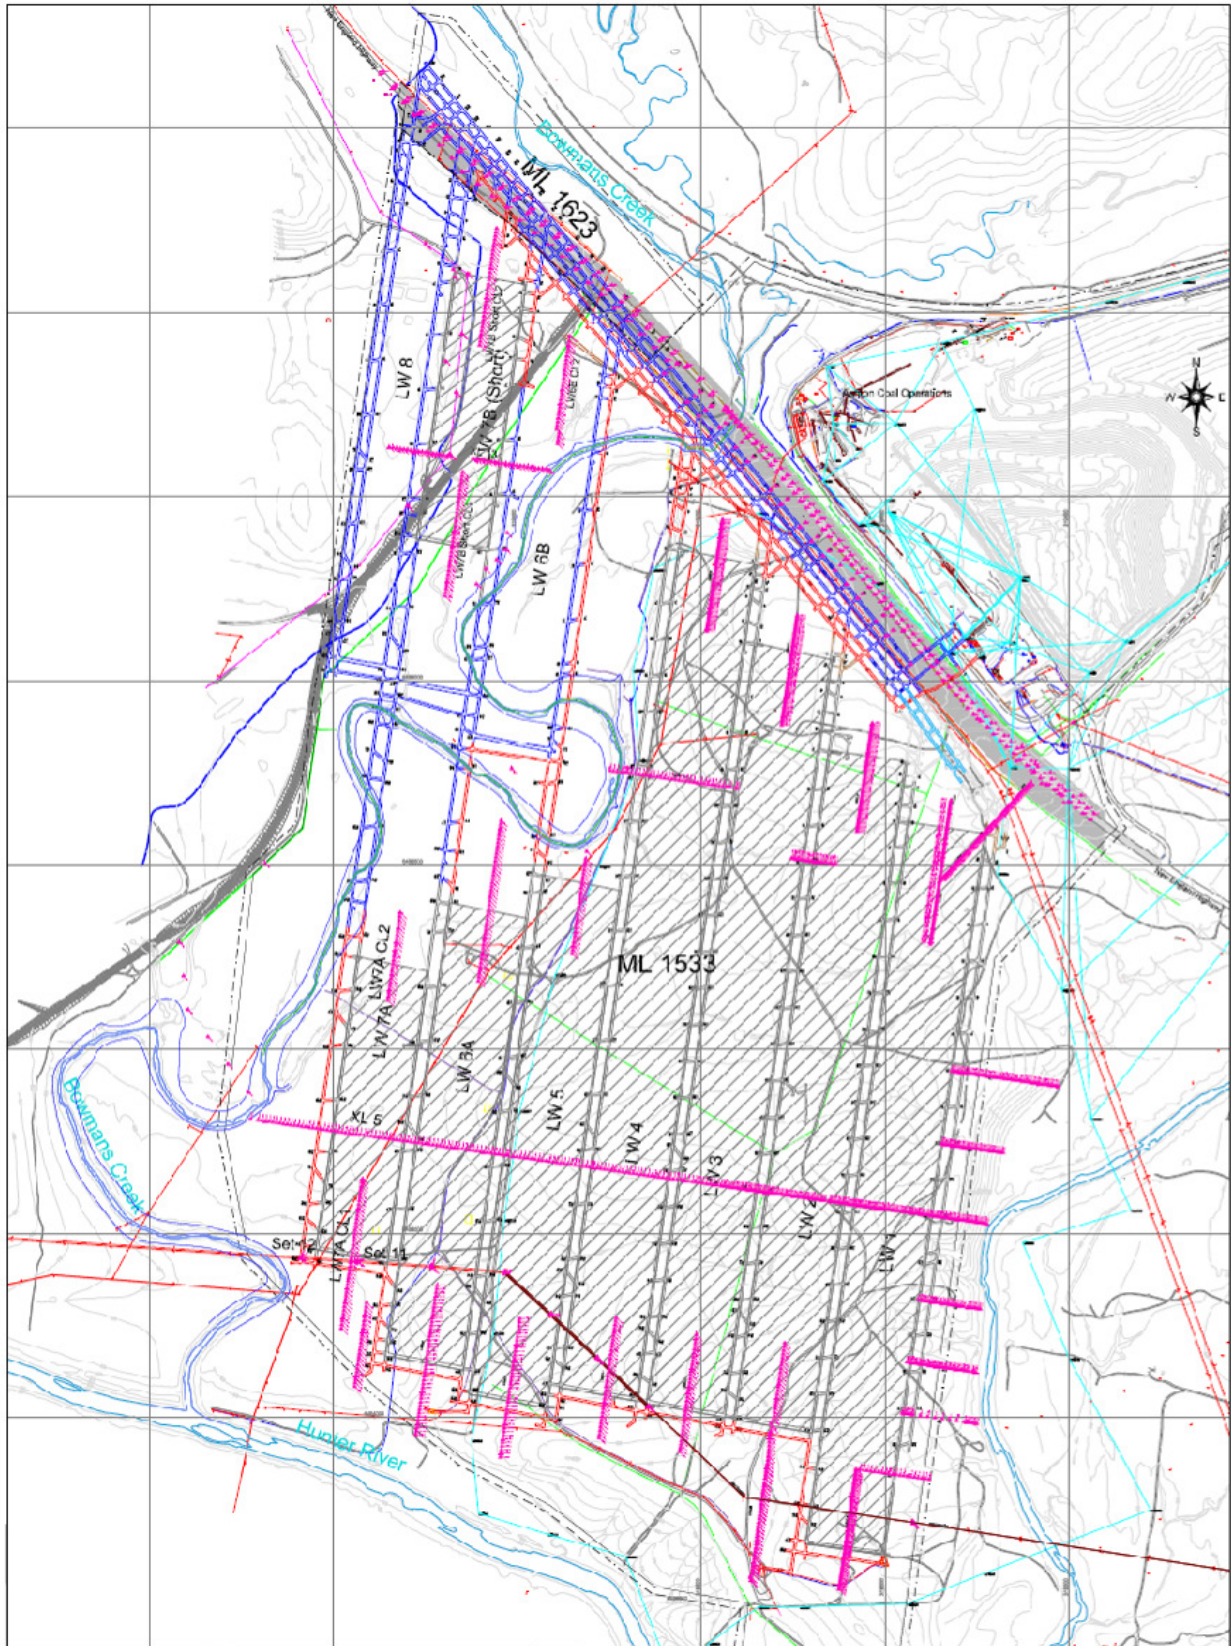
Figure 2: Plan location of Monitoring Cross Lines. Also shown is the 132kV power line monitoring points (pole sets 11 and 12).

Ashton Coal has monitored the subsidence movement on the surface during the extraction of Longwall's 1-8 using longitudinal subsidence lines. These are located over the start and finish lines of each panel and a main cross line extending over all seven panels. All panels have monitoring data for each start and end lines and various cross lines relevant to the panel, surface features or strata features. Several other subsidence lines have been used to monitor the slope leading down to Glennies Creek, closure across the New England Highway, and subsidence across a dyke. These locations can be seen in **Figure 2**.
