ASHTON COAL PROJECT
REHABILITATION MANAGEMENT PLAN

FEBRUARY 2023

Title: Ashton Coal Rehabilitation Management Plan

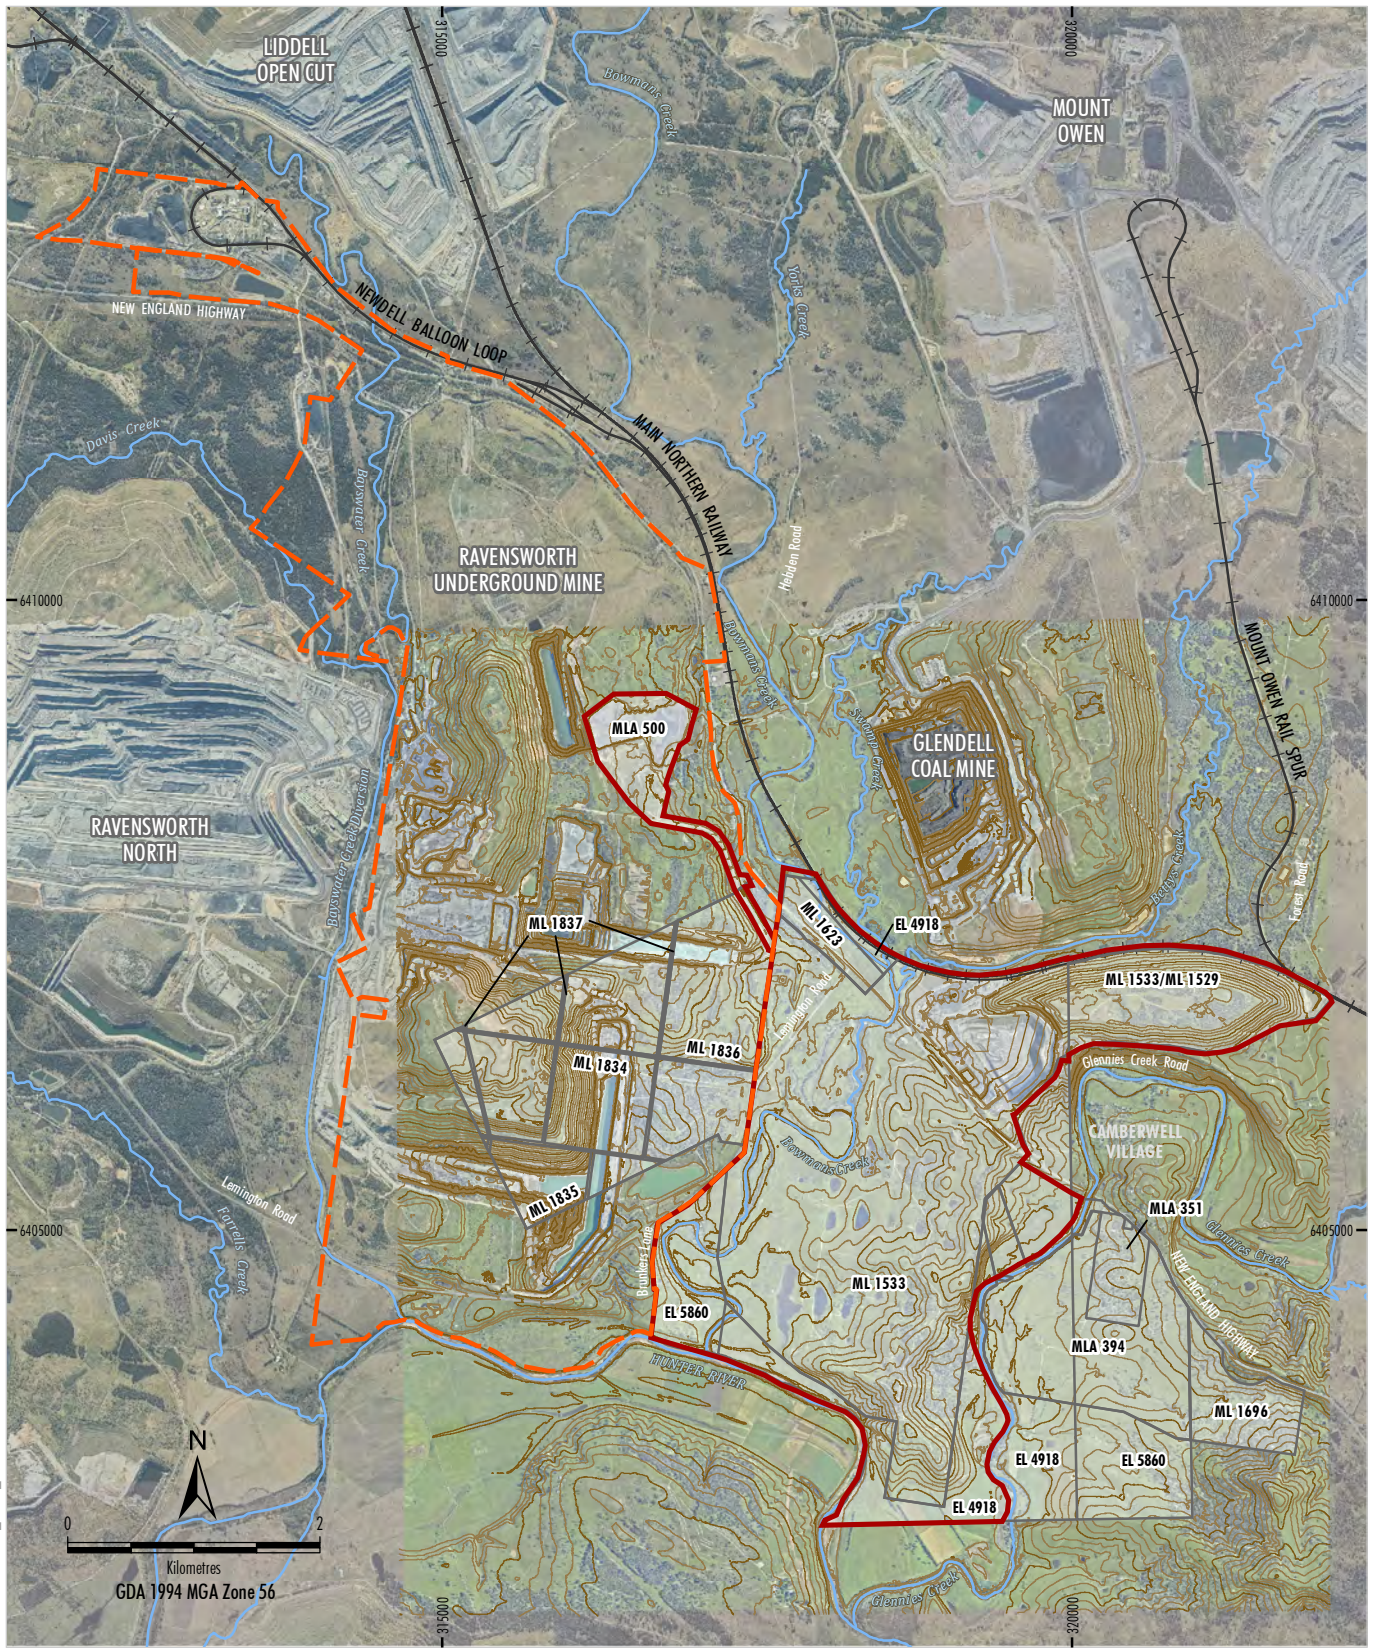
ACO-18-03 RMP 2023 v2 PLAN 2 Rev A

**Final Land Use Domains
 and Landform Features**
