Duralie Coal CCC Meeting

Presentation –
Company Report &
Overview of Activities

August 2021

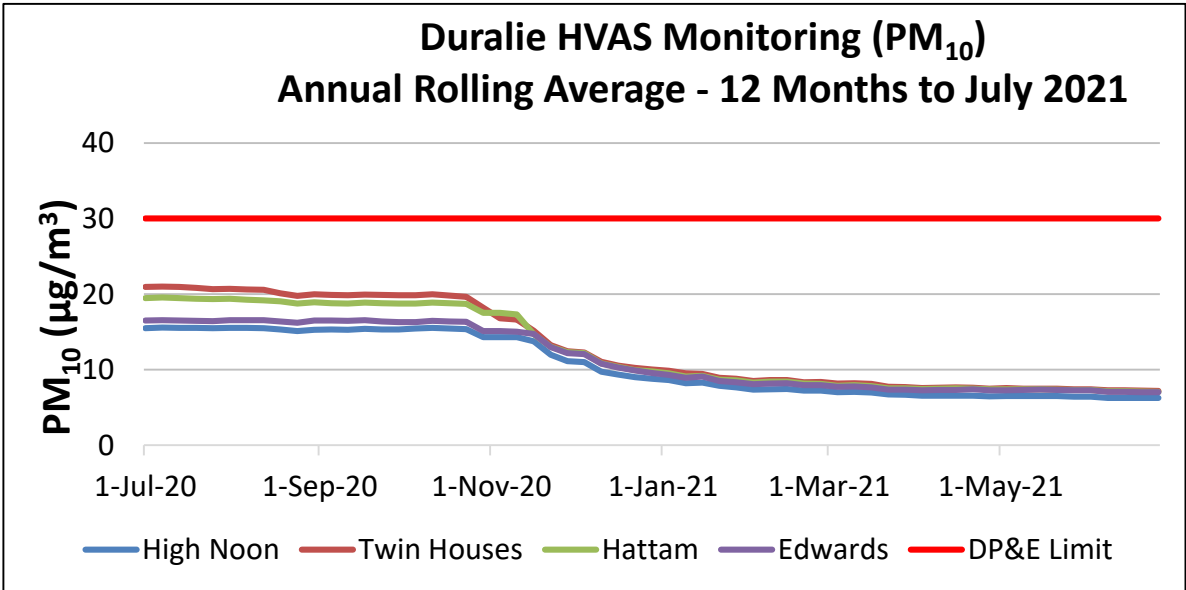
- All sites below DP&E limit. Typically low results during winter and higher during spring/summer.
- Steep decreasing trend during December 2020 due to elimination of bushfire affected results in 2019.
- HVAS results provide more reliable data compared to dust deposition results and should be referred to when interpreting dust emissions.

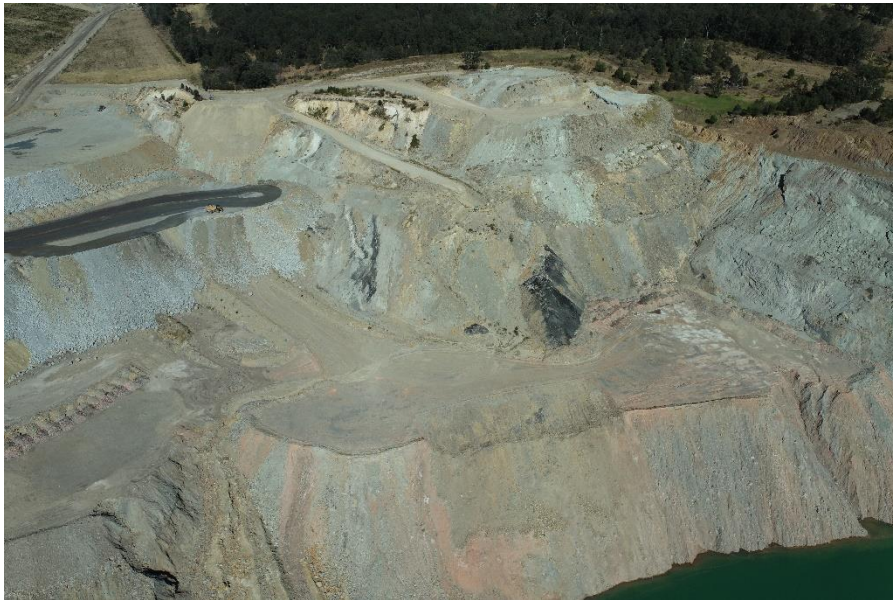
Photo: Rehandle and bulk shaping commencing on the Clareval waste emplacement, July 2021.

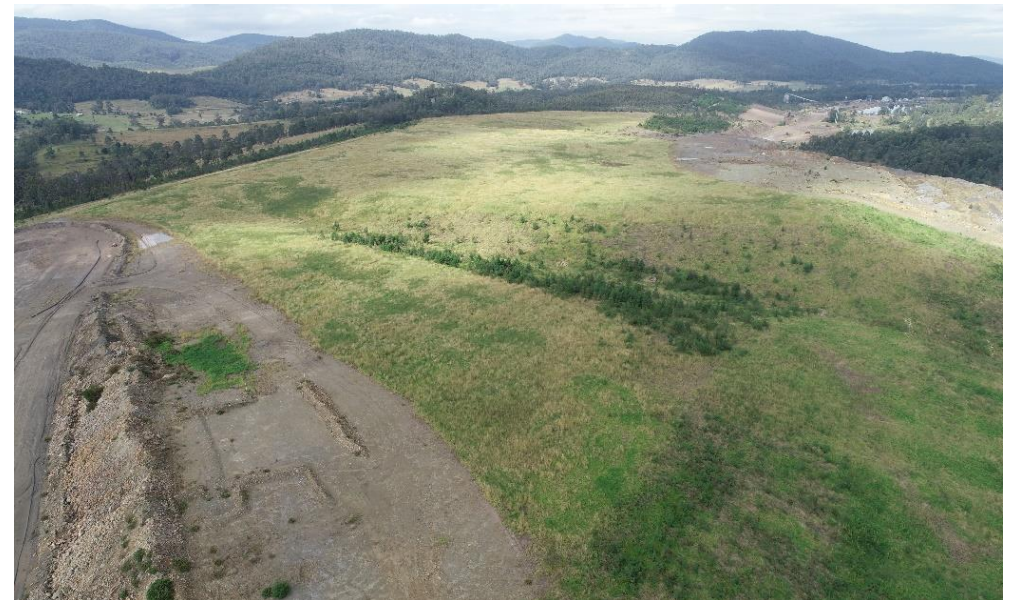
Photo: Completed rehabilitation at Weismantel waste emplacement, taken May 2021.
