Austar Coal Mine

Community Consultative Committee Meeting Minutes

AUSTAR COAL MINE

COMMUNITY CONSULTATIVE MEETING

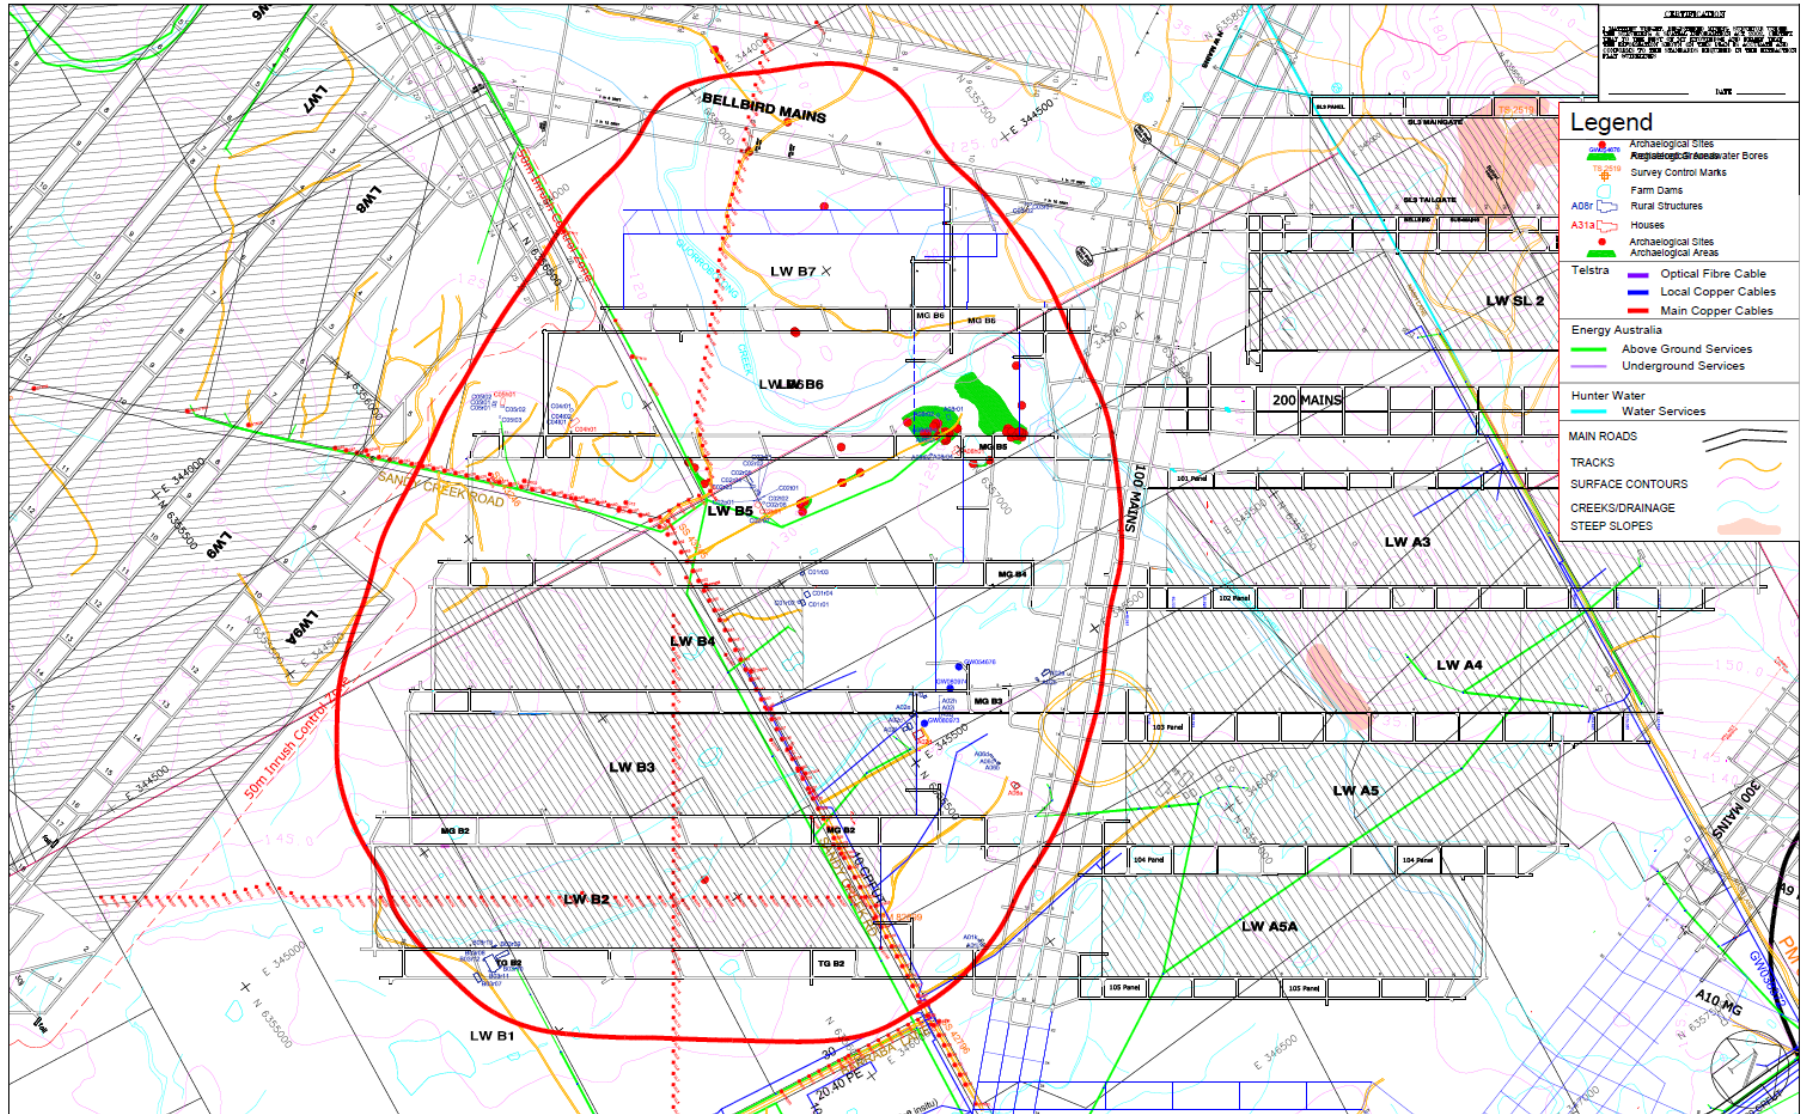
- Subsidence surveys are ongoing along the Sandy Creek Road monitoring line
- Maximum recorded surface level movement on Sandy Creek Road is approximately 489 mm as surveyed 31 October 2018

DRAWN M. WRIGHT REVISION DATE 27/08/2018 MINING ENGINEERING MANAGER DATE	AUSTAR COAL MINE YANCOAL MINING SERVICES PTY LTD
SUBSIDENCE MONITORING SURVEY PLAN	
SCALE 1:5000	DRAWING NO. GEN18029
SHEET NO. 0	AUSTAR COALMINE

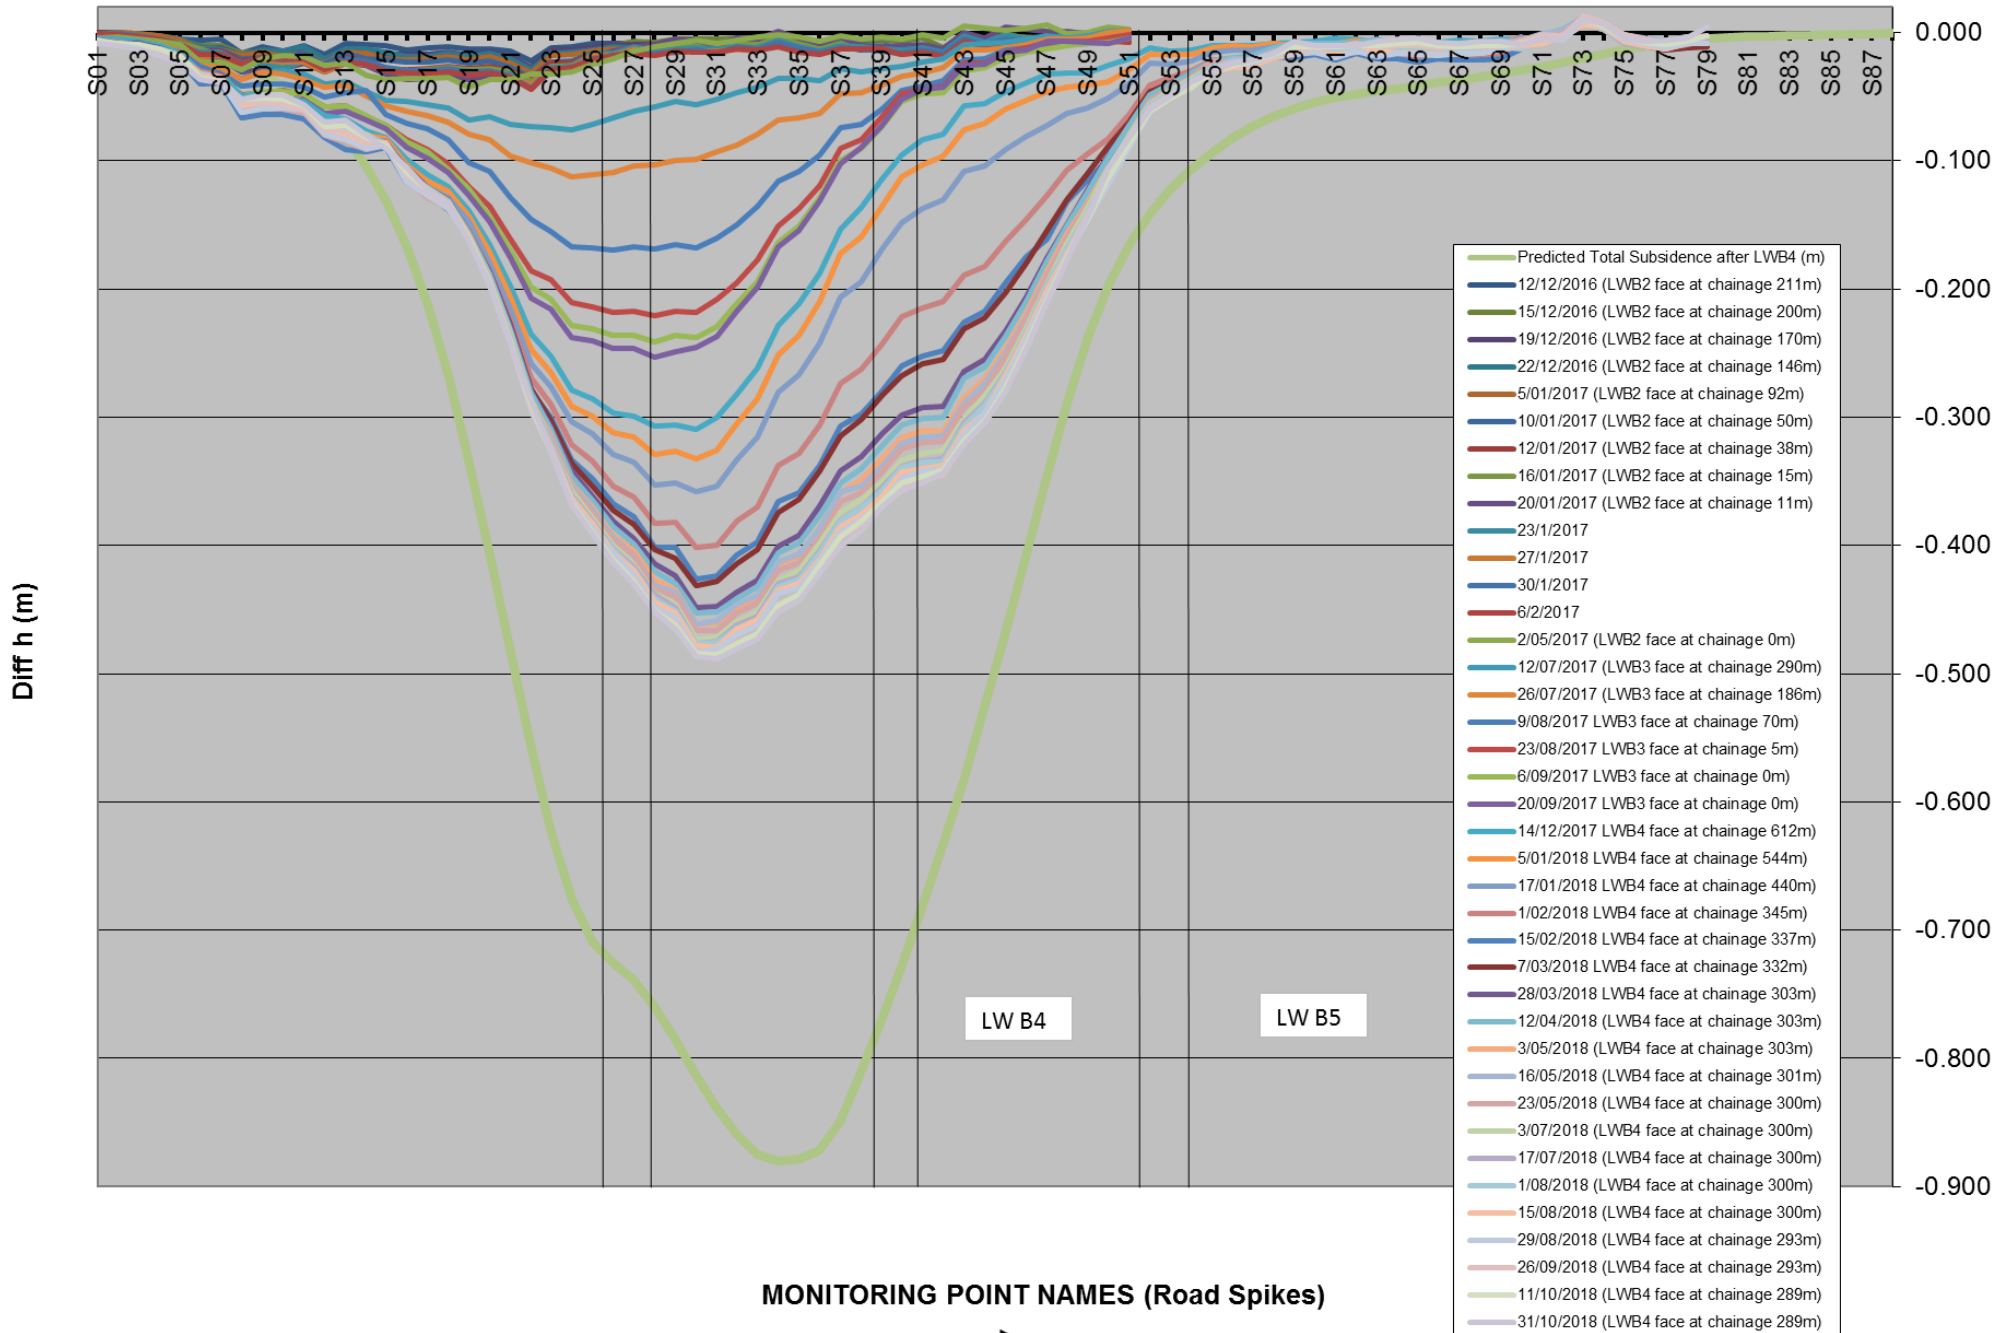
Subsidence- LINE "SCR1"

- Predicted Total Subsidence after LWB4 (m)
- 12/12/2016 (LWB2 face at chainage 211m)
- 15/12/2016 (LWB2 face at chainage 200m)
- 19/12/2016 (LWB2 face at chainage 170m)

- 31/10/2018 (LWB4 face at chainage 289m)

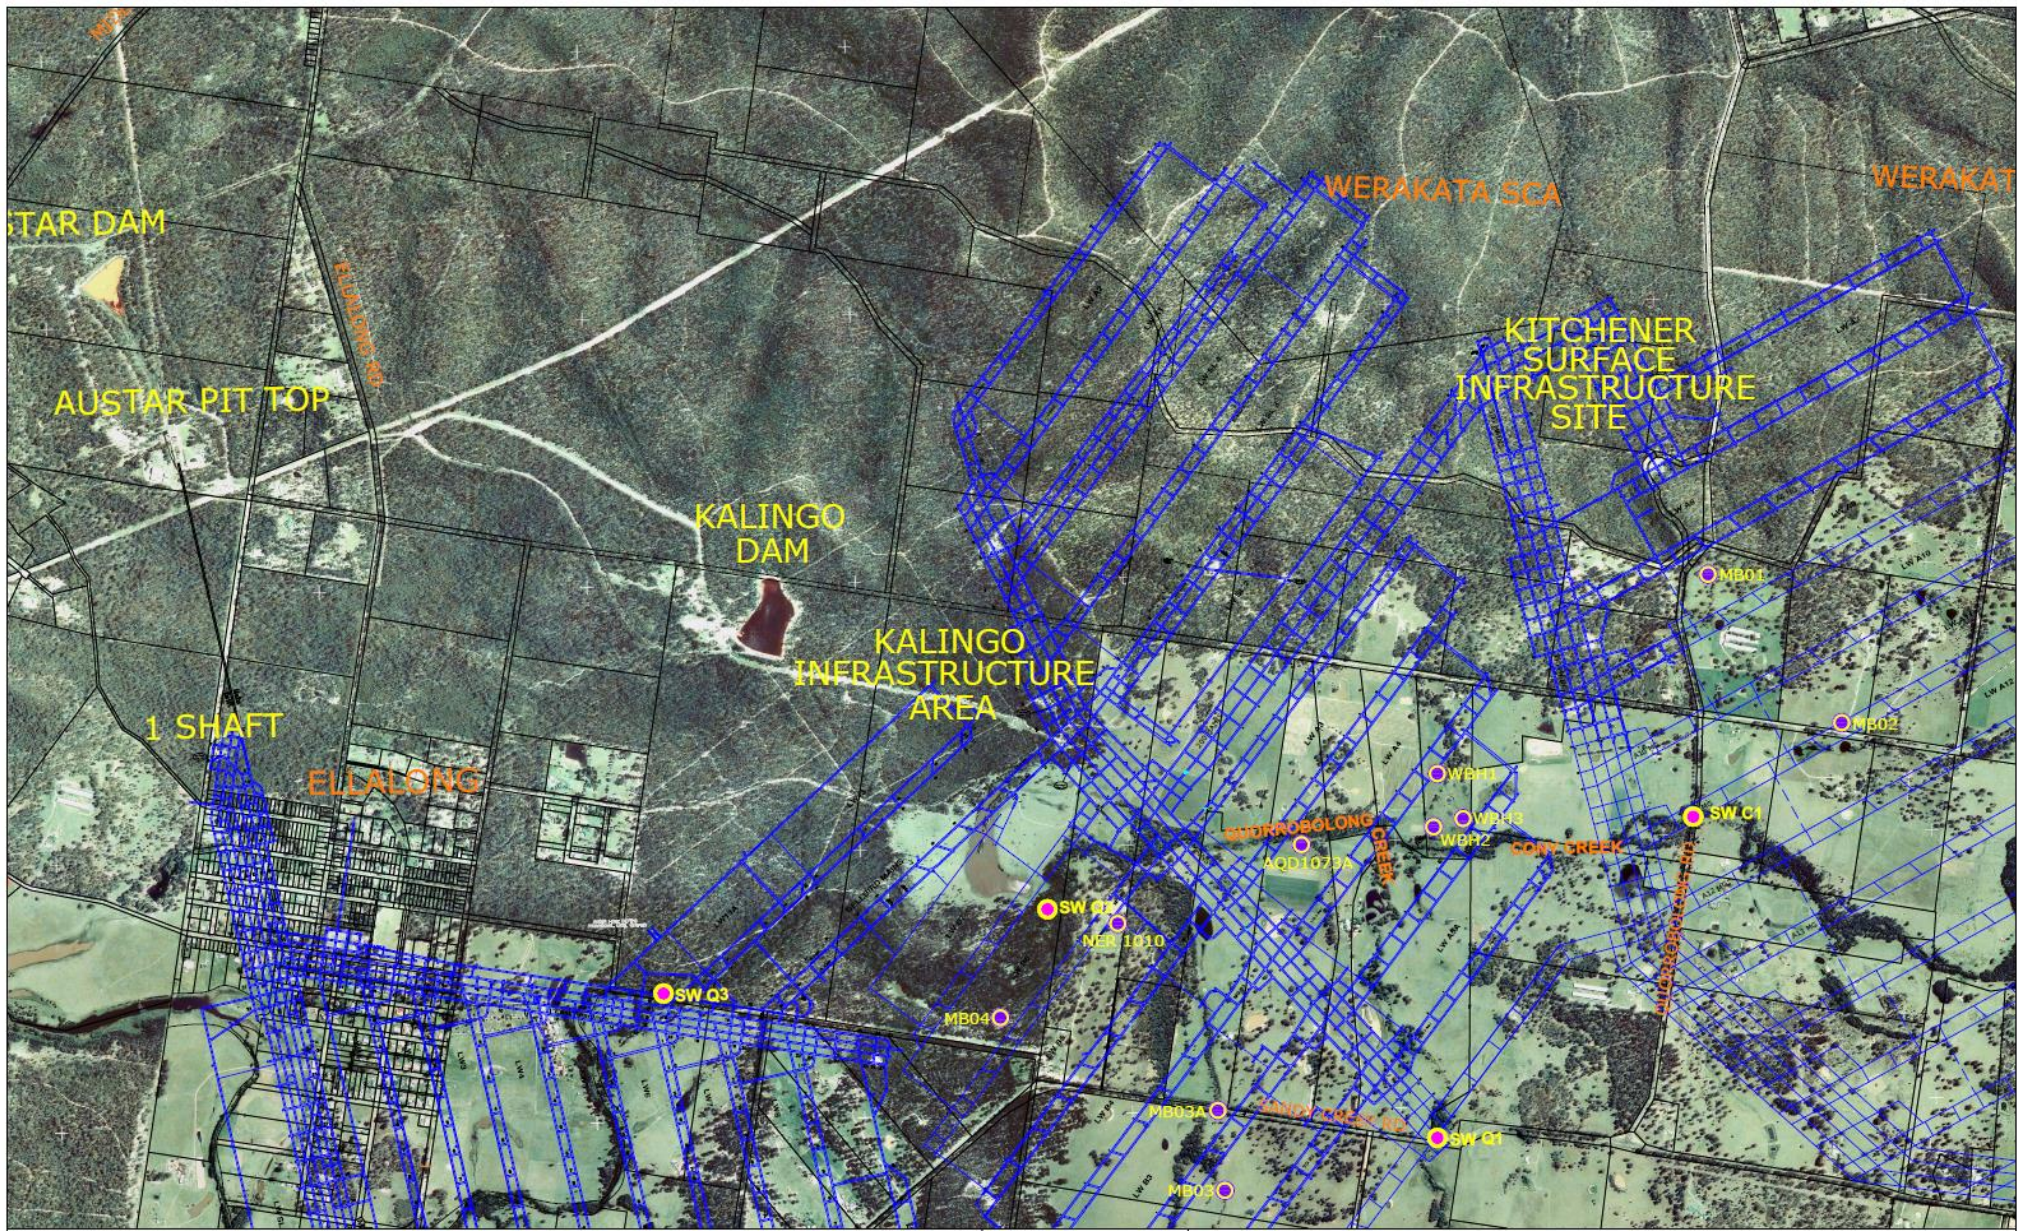
**Austar Surface & Groundwater
Monitoring Locations**

- NER1010 Ground Water Monitor
- SW 2 Surface Water EPL Sample Points
- SW C1 Coney Creek Sample Points
- SW Q1 Quorrobolong Creek Sample Points

- There are no new trends in groundwater quality or water levels since previously reported
- The overall groundwater level decline and minor increases in alluvial monitoring bores are considered to be due to naturally occurring climatic conditions
- NER1010 groundwater levels continue an overall long term declining trend
- Groundwater levels in MB01 continue a slow decline
- Overall, groundwater quality values and levels are generally stable over the reporting period
- A new alluvial monitoring bore MB03A was installed on the north side of Sandy Creek Road, 570m west of Barraba Lane, on 16 October 2018 to monitor water level and quality in the alluvium above the Bellbird South Mining Area, replacing MB03 which is no longer accessible

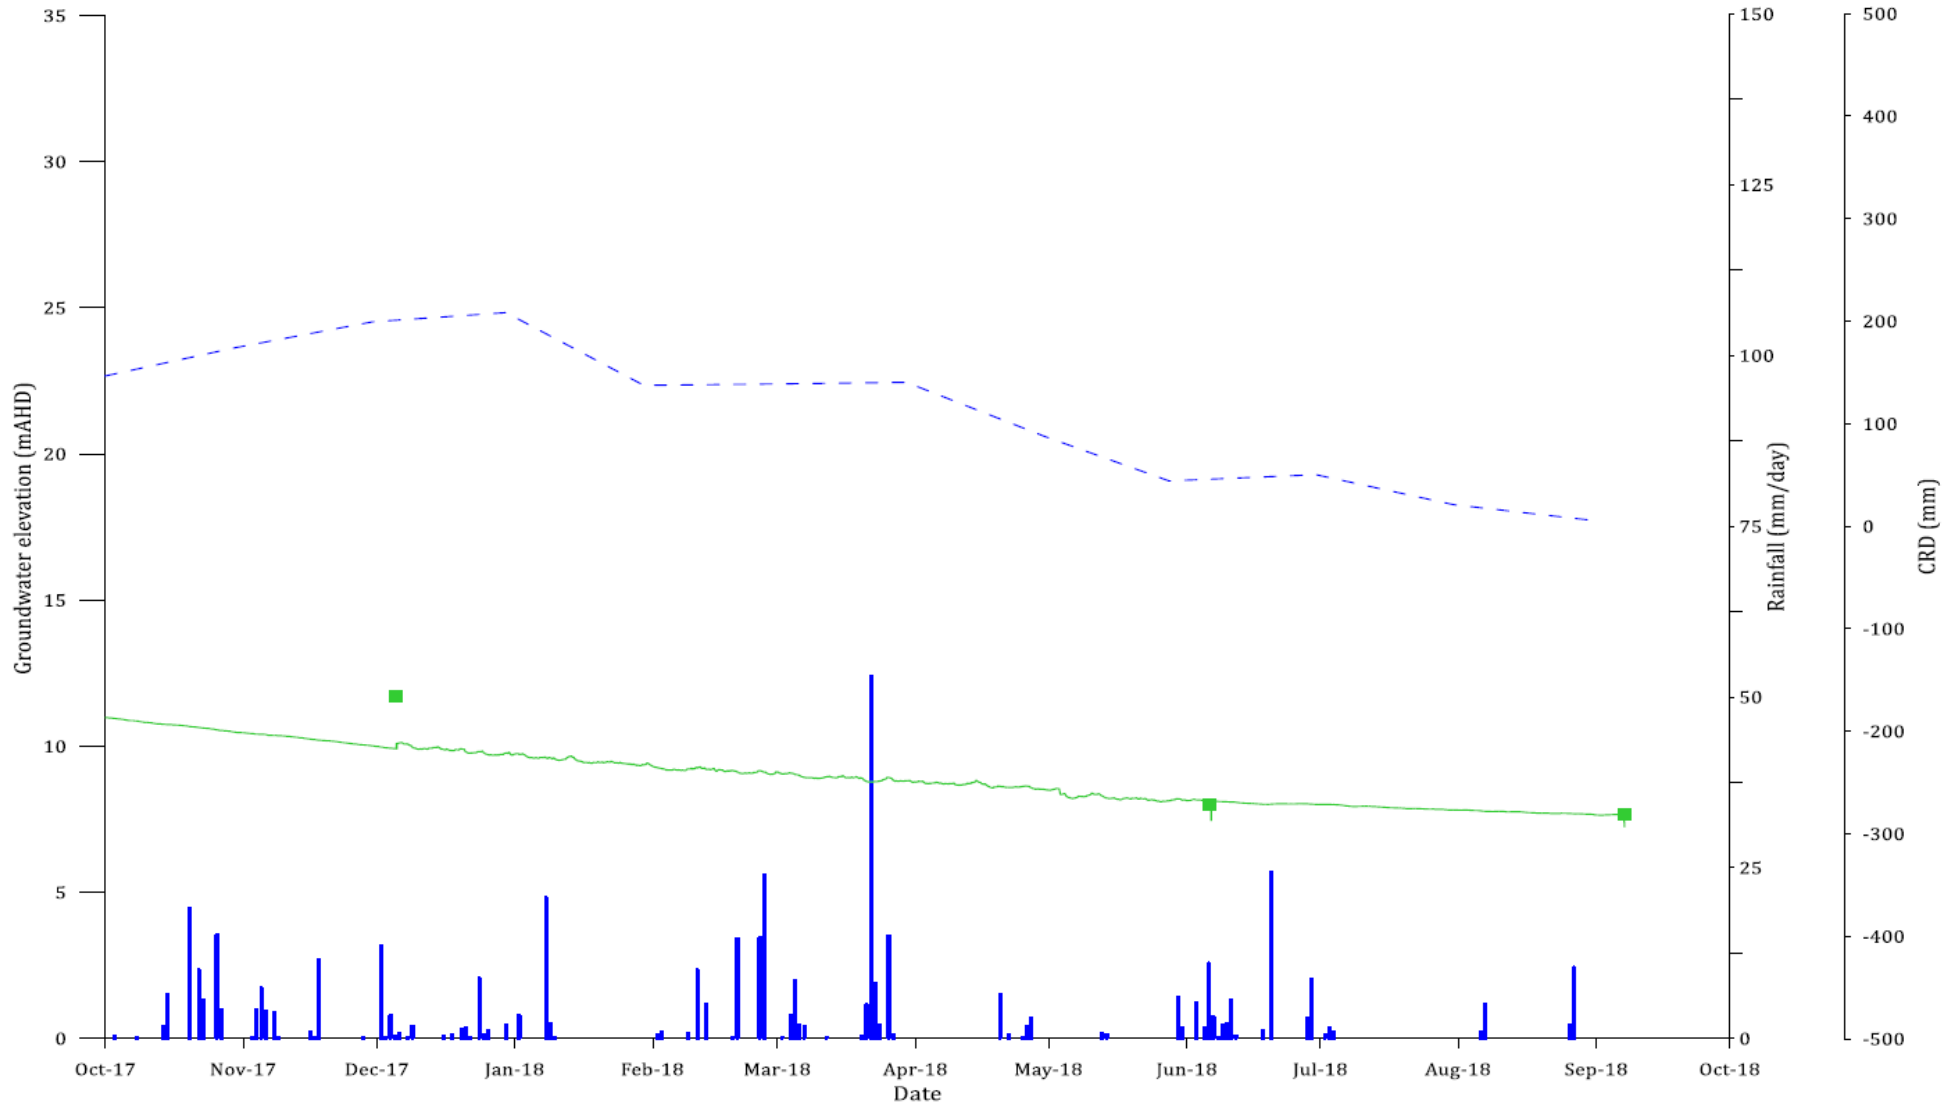
Groundwater Monitoring

■ ■ ■ MB01 manual — MB01 PT Permian ■ Rainfall (mm/day) - - - CRD

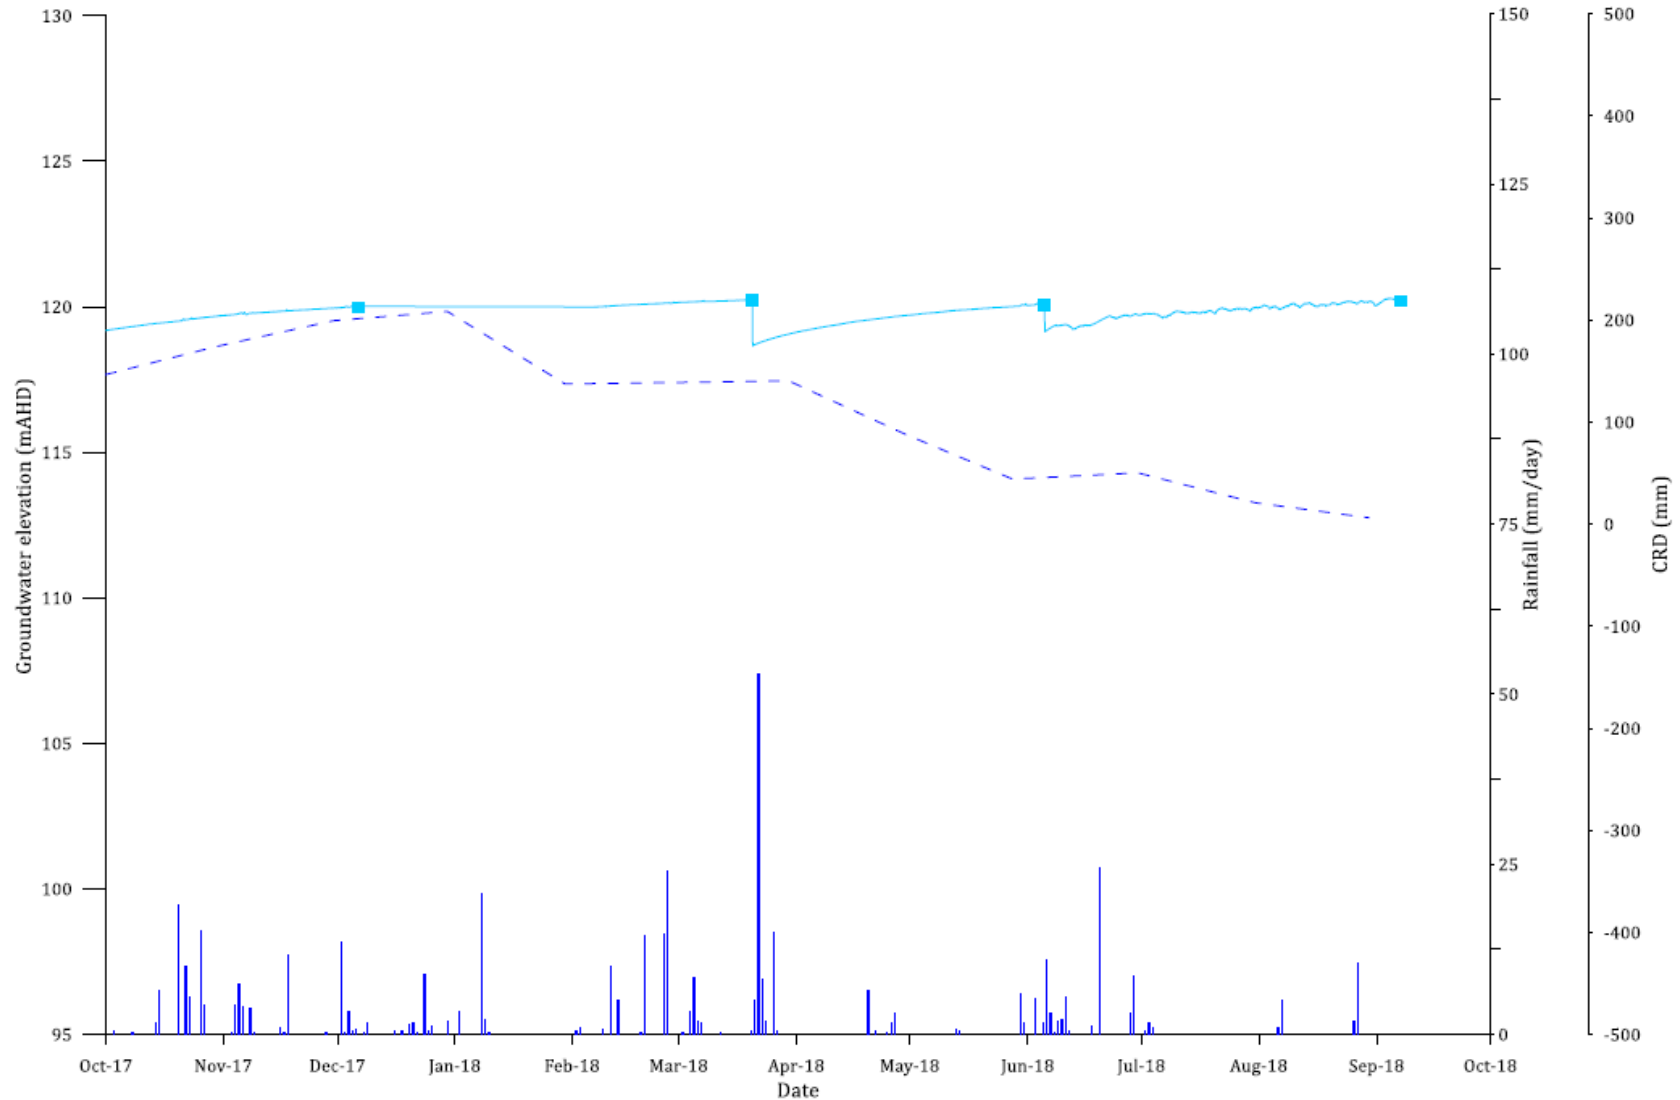
Groundwater Monitoring

■ ■ ■ MB02 manual — MB02 PT Permian ■ Rainfall (mm/day) - - - CRD

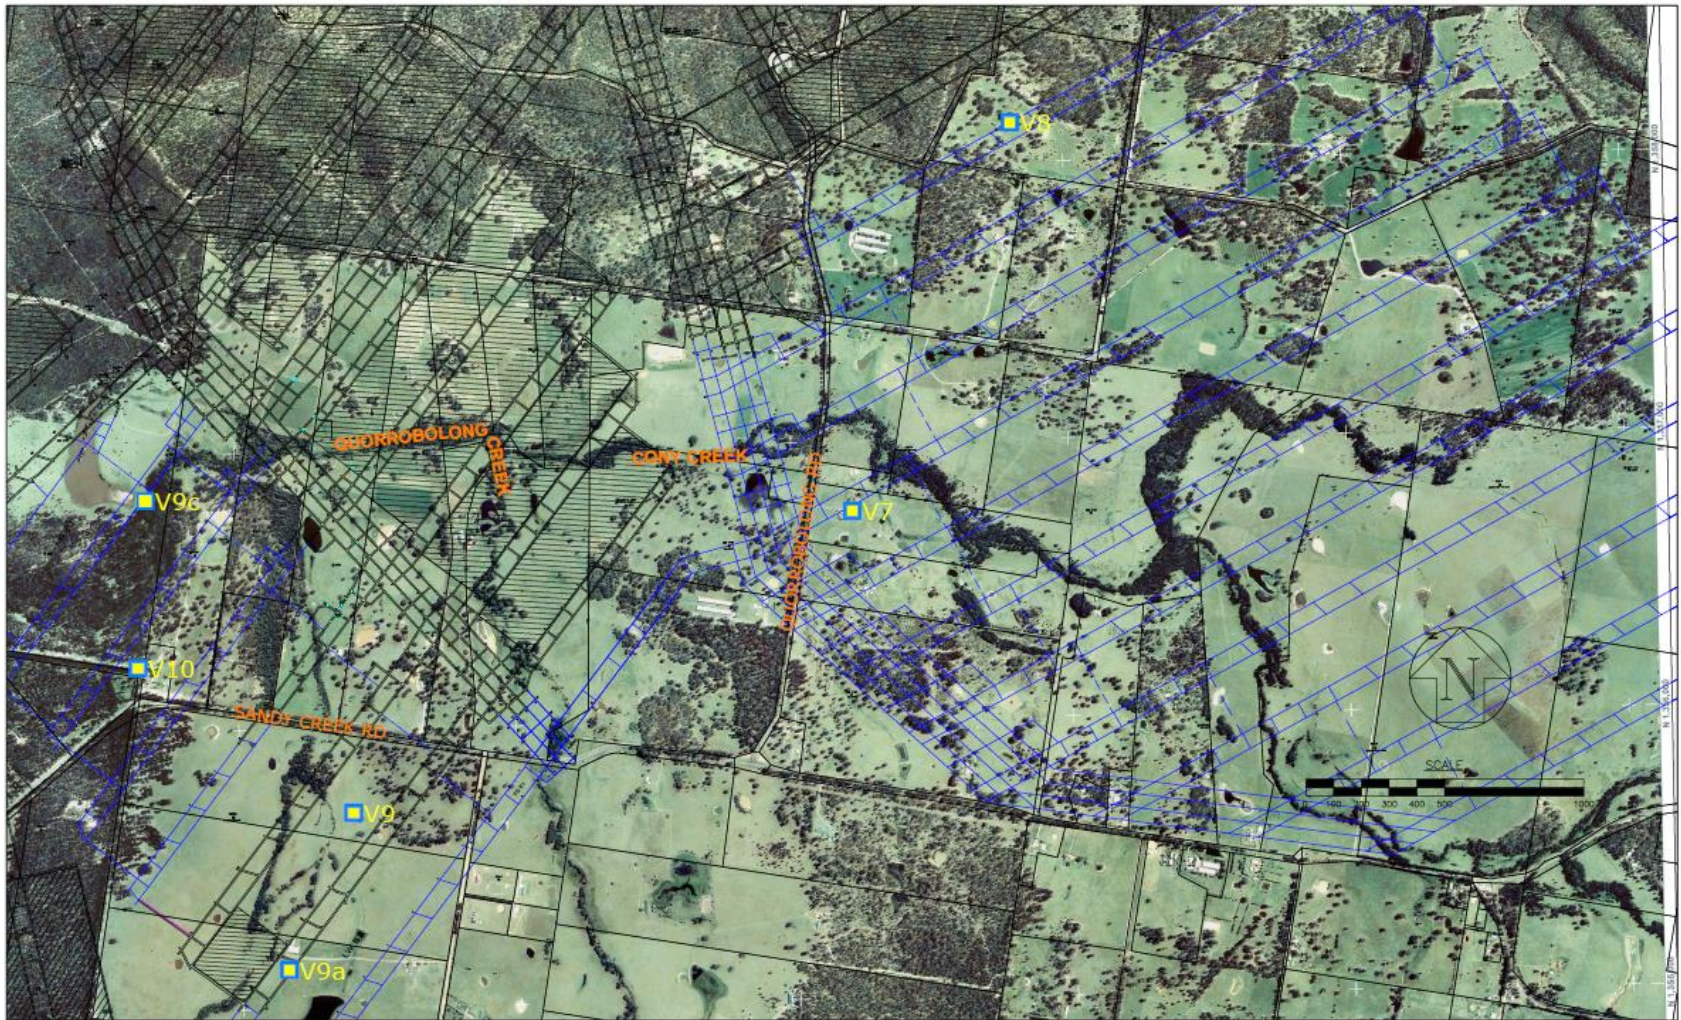
Vibration Monitoring Locations

■ V7 Vibration Monitors

- **Monitor V7 – 345 Quorrobolong Road**
 - Monitoring commenced 11 June 2013
 - 1 new event greater than 1mm/s (1.19mm/s)

- **Monitor V9c – Sandy Creek Road - Austar**
 - Monitoring commenced 19 July 2017
 - 1 new event greater than 1mm/s (1.13mm/s)

- **Monitor V10 – Sandy Creek Road - Austar**
 - Monitoring commenced 28 August 2017
 - No new events greater than 1mm/s

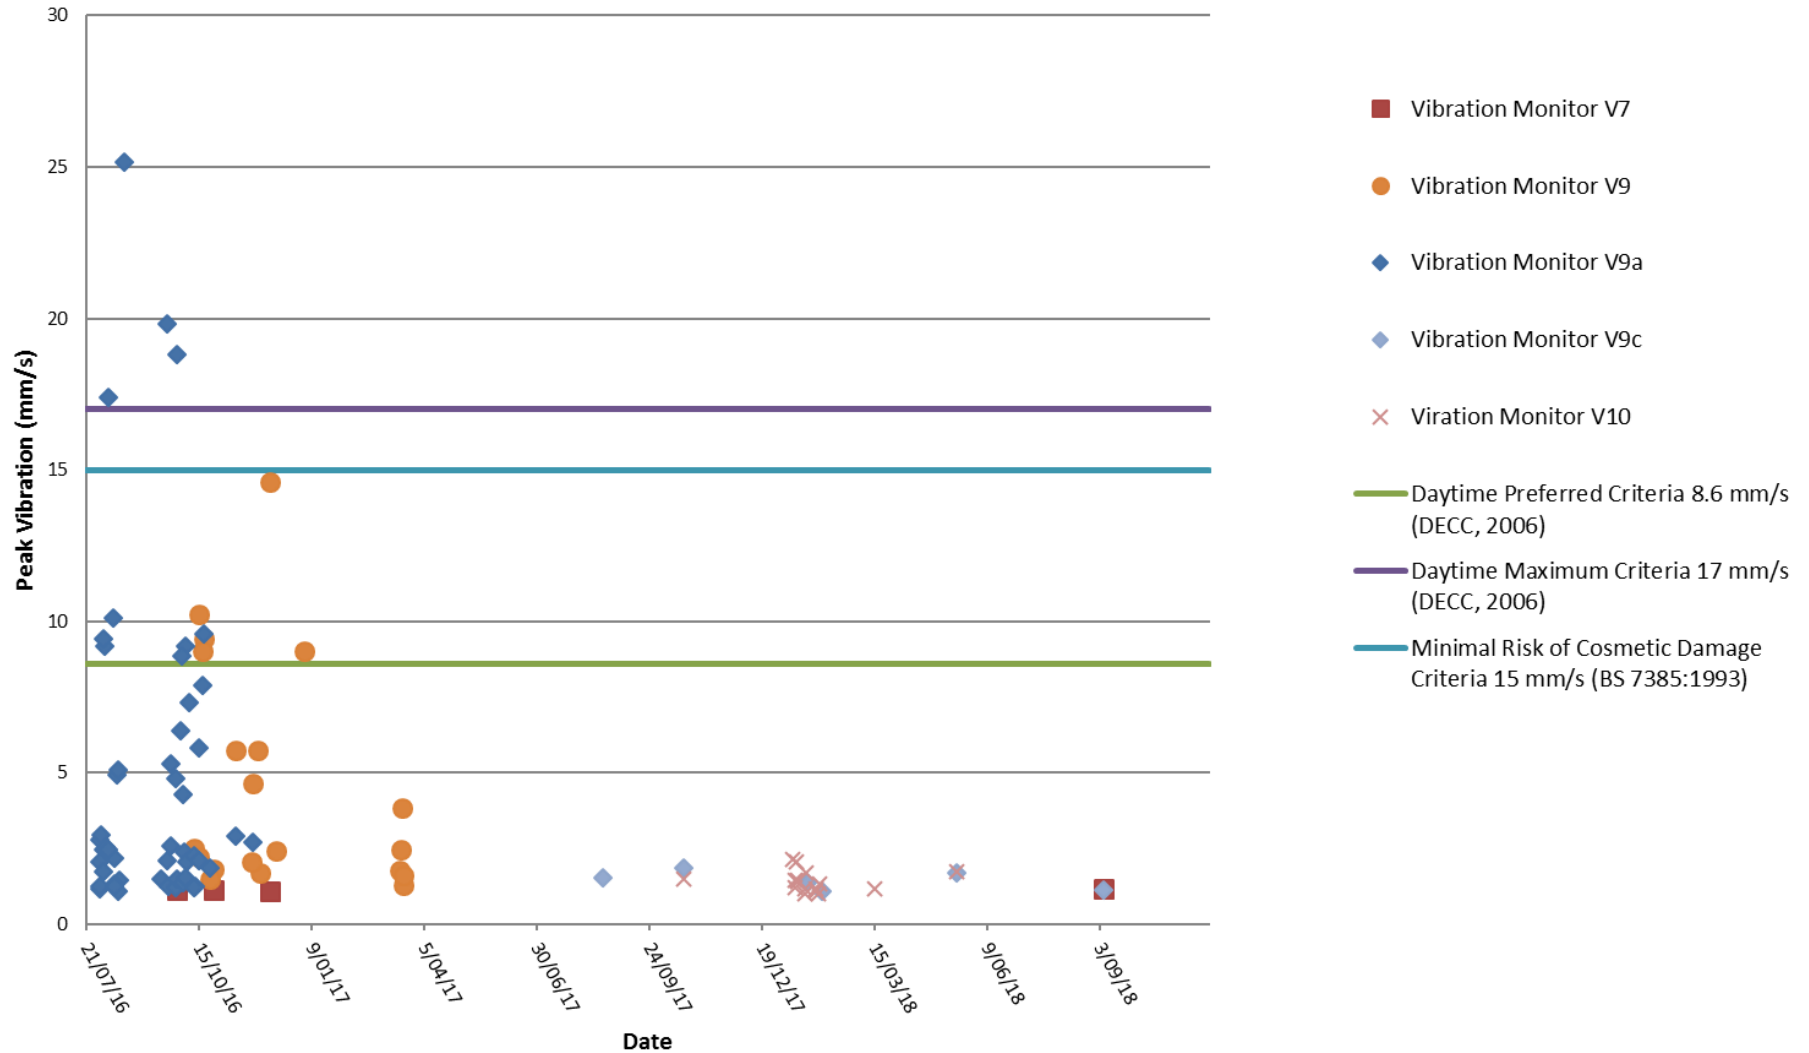
Austar Peak Ground Vibration - Night and Day Combined (Events > 1mm/sec)
