Longwall 208

Lemington Road

Monitoring and Maintenance Plan

December 2024

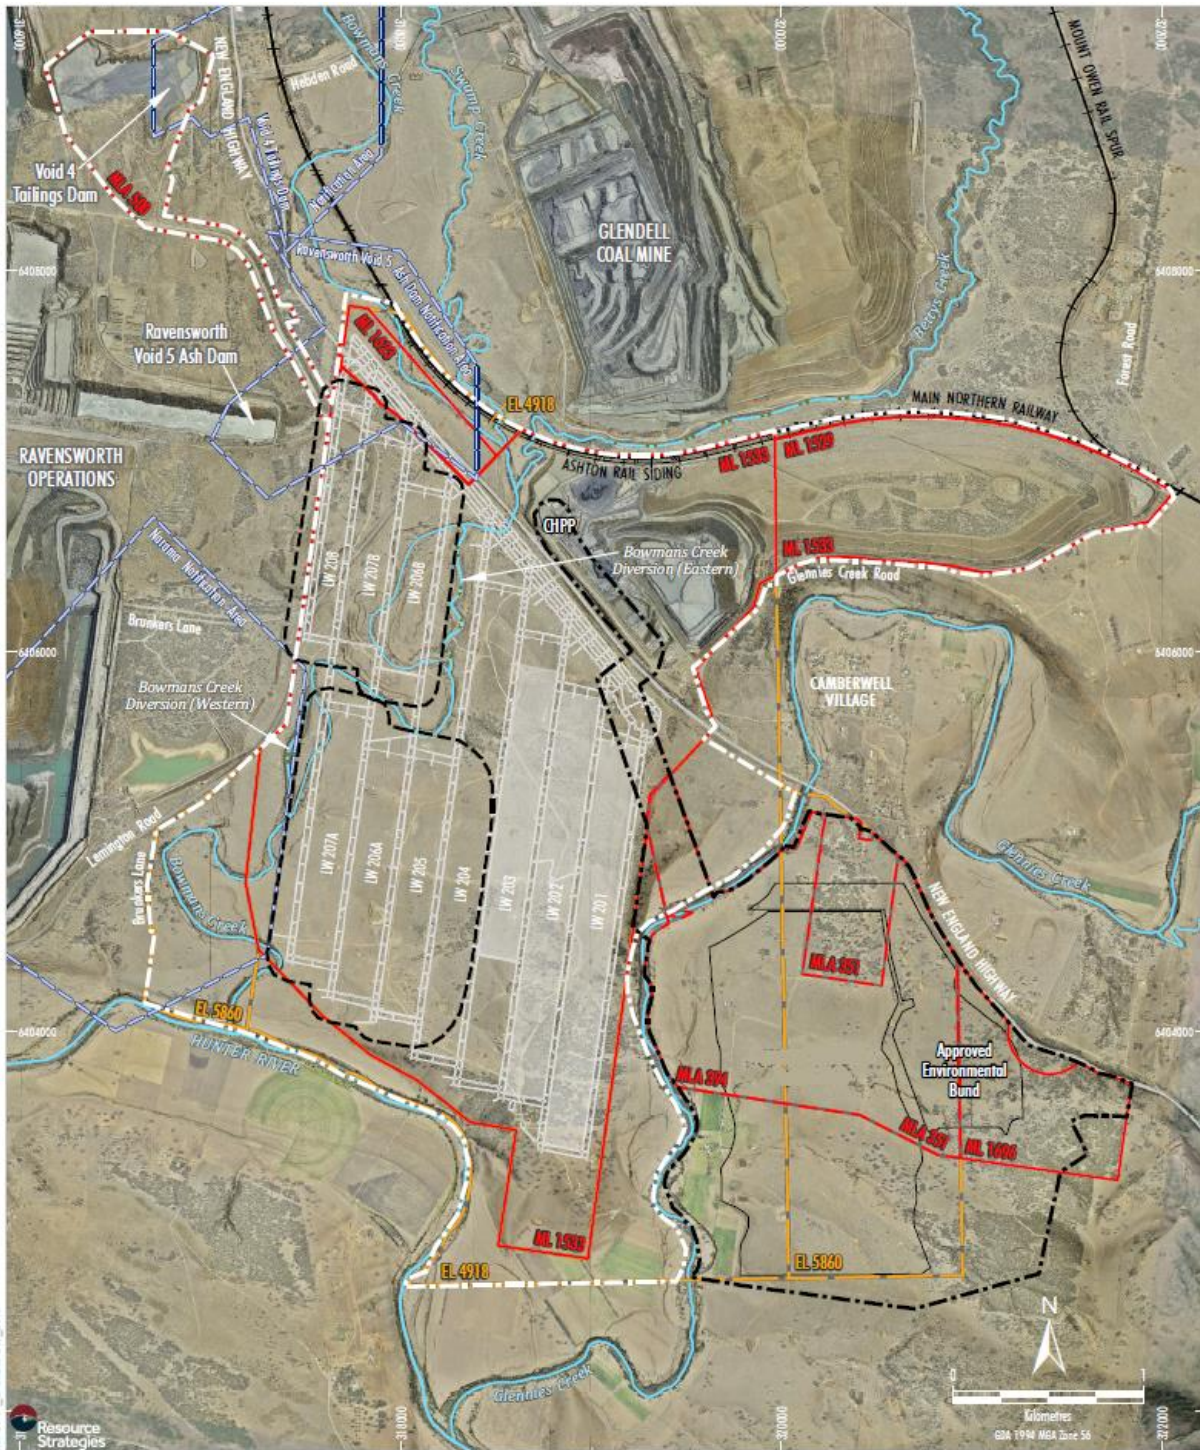
Figure 4 Upper Lower Liddell Seam Longwall Layout

Proposed mining of Longwalls 205 to 208 is shown in **Figure 4**.

The section of Lemington Road planned to be undermined by the extraction of the ULLD Seam Longwall 208 is approximately 500 m long – from Chainage 700m to 1200m as measured from New England Highway see **Figure 4**.

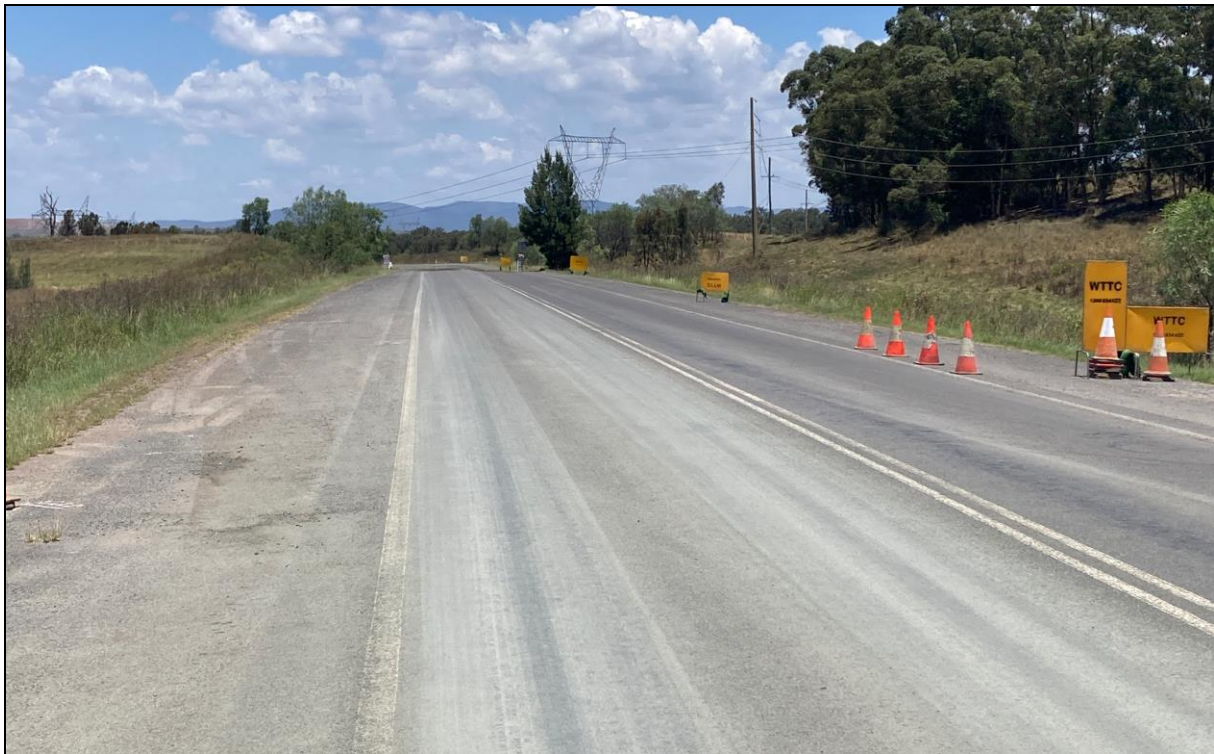
Figure 6 Lemington Road looking South

Lemington Road was diverted and reconstructed during and following mining of Longwalls 7B and 8 in the PG Seam as part of the Ravensworth North Open Cut Mine Project. **Figure 6** shows the road looking north from a position above Longwall 208. Longwall 6B in the PG Seam subsequently mined below a small section of the new road causing low level subsidence above the corner of the panel and minor cracking along the edge of the road. During 2023, Longwall 206B, approximately 60m below Longwall 6B, was the first in the sequence of panels to be mined below Lemington Road in the ULLD Seam. No impacts to Lemington Road pavement were observed from the mining of Longwall 206B and the road remained in a safe and serviceable condition. During 2024, Longwall 207B, approximately 60m below Longwall 7B, was the second in the sequence of panels to be mined below Lemington Road in the ULLD Seam. Impacts to Lemington Road pavement were observed from the mining of Longwall 207B and the road remained in a safe and serviceable condition. On review of monitoring data, subsidence effects and subsidence impacts were less than forecast.
