Monthly Environmental Monitoring Report

Yancoal Mount Thorley Warkworth
October 2024

This report has been compiled to provide a monthly summary of environmental monitoring results for Mount Thorley Warkworth (MTW). This report includes all monitoring data collected for the period 1 October to 31 October 2024.

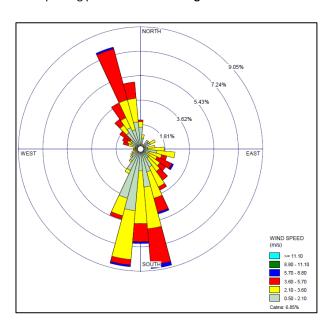
Figure 2: Charlton Ridge Wind Rose - October 2024

Winds from the Northwest and South were dominant during the reporting period as shown in **Figure 2.**

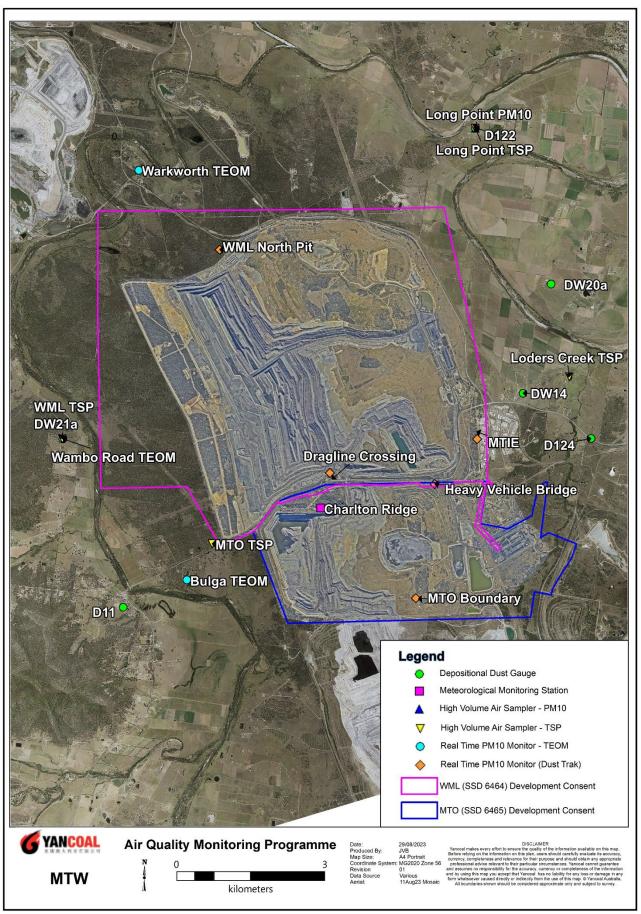
Figure 3: Air Quality Monitoring Locations

Meteorological data is collected at MTW's 'Charlton Ridge' meteorological station (refer to **Figure 3**).

Suspended particulates are measured by a network of High Volume Air Samplers (HVAS) measuring Total Suspended Particulates (TSP) and Particulate Matter <10 μ m (PM₁₀). The location of these monitors can be found in **Figure 3**. Each HVAS was run for 24 hours on a six-day cycle in accordance with EPA requirements.

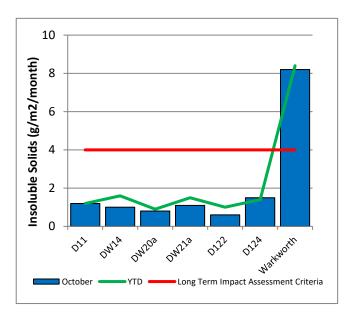
Figure 4: Depositional Dust – October 2024

During the reporting period, the Warkworth monitoring location recorded a monthly result above the long-term impact assessment criteria of 4.0 g/m2 per month. There is no evidence to suggest that the result at Warkworth (8.2 g/m2) is contaminated, as such the result will be included in the annual average calculation.

Figure 4 displays insoluble solids results from depositional dust gauges during the reporting period compared against the year-to-date average and the annual impact assessment criteria.

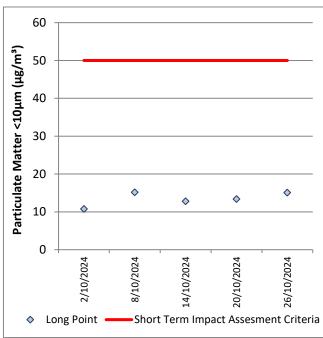
Figure 5: Individual PM10 Results - October 2024

Figure 5 shows the individual PM_{10} results at each monitoring station against the short-term impact assessment criteria of $50\mu g/m^3$.

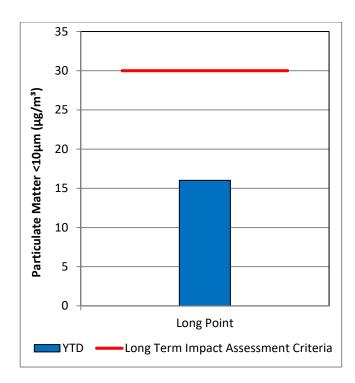
Figure 7: Annual Average PM₁₀ - October 2024

Figure 6 shows the annual average PM10 result against the long-term impact assessment criteria.

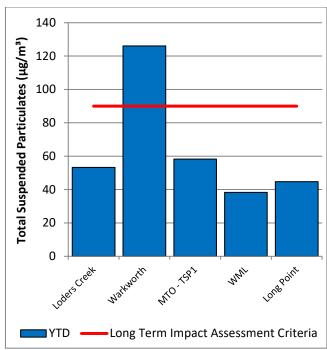
Figure 8: Annual Average Total Suspended Particulates – October 2024

Figure 7 shows the annual average TSP results compared against the long-term impact assessment criteria of $90\mu g/m^3$.

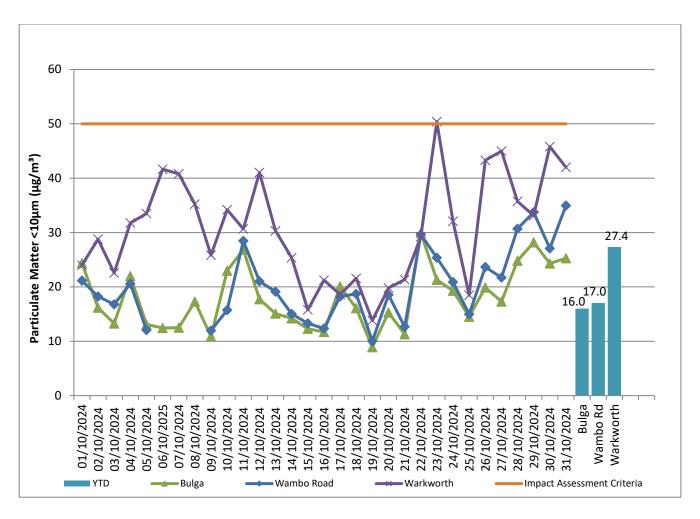
Figure 9: Real Time PM₁₀ daily 24hr average (line graphs) and YTD annual average (column graphs) - October 2024

MTW maintains a network of real time PM_{10} monitors. The real time air quality monitoring stations continuously log information and transmit data to a central database, generating internal alerts when particulate matter levels exceed internal trigger limits.

Results for real time dust sampling are shown in **Figure 8**, including the daily 24-hour average PM_{10} result and the annual PM_{10} average.

On 23 October 2024, the Warkworth TEOM (50.4 $\mu g/m^3$) exceeded the short term (24hr) criteria. The measurement was assessed for MTW's potential contribution based on meteorological conditions on the day resulting in a maximum estimated contribution of 10.7 $\mu g/m^3$, less than a 23% contribution to the result. Accordingly, no further action is required (as per the approved Air Quality Monitoring Programme).

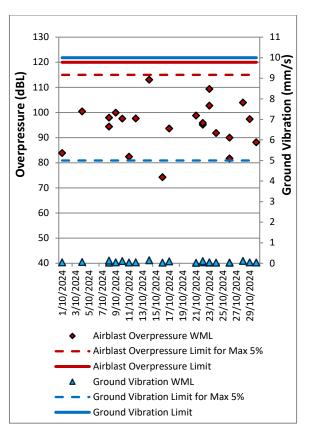
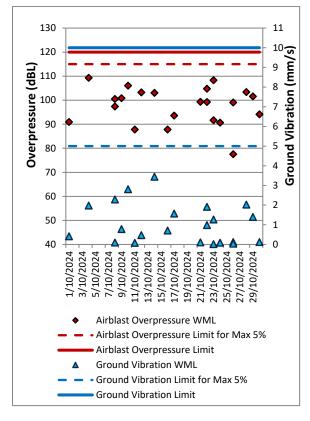
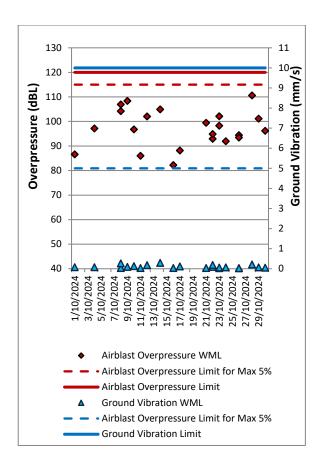
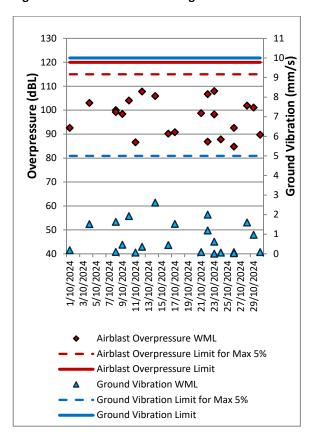
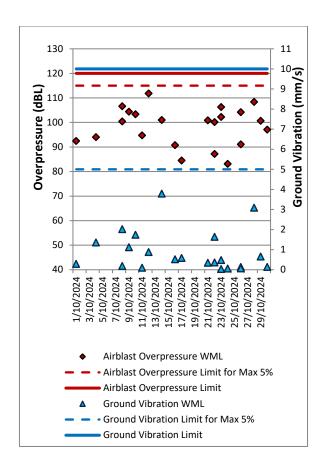
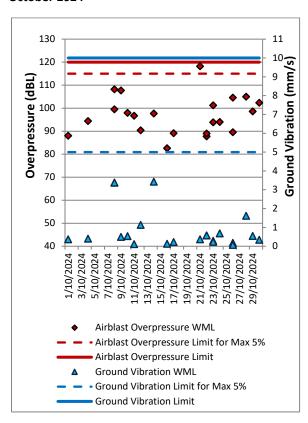
During October 2024, 22 blasts were initiated at MTW. Figure 9 to Figure 14 show the blast monitoring results for the reporting period against the impact assessment criteria. The criteria are summarised in Table 2.

During the reporting period one blast exceeded the 115dB(L) (permissible for 5% of blasts in 12 month period) threshold for airblast overpressure at the Warkworth monitoring location. No blast exceeded the 5 mm/s criteria for ground vibration.

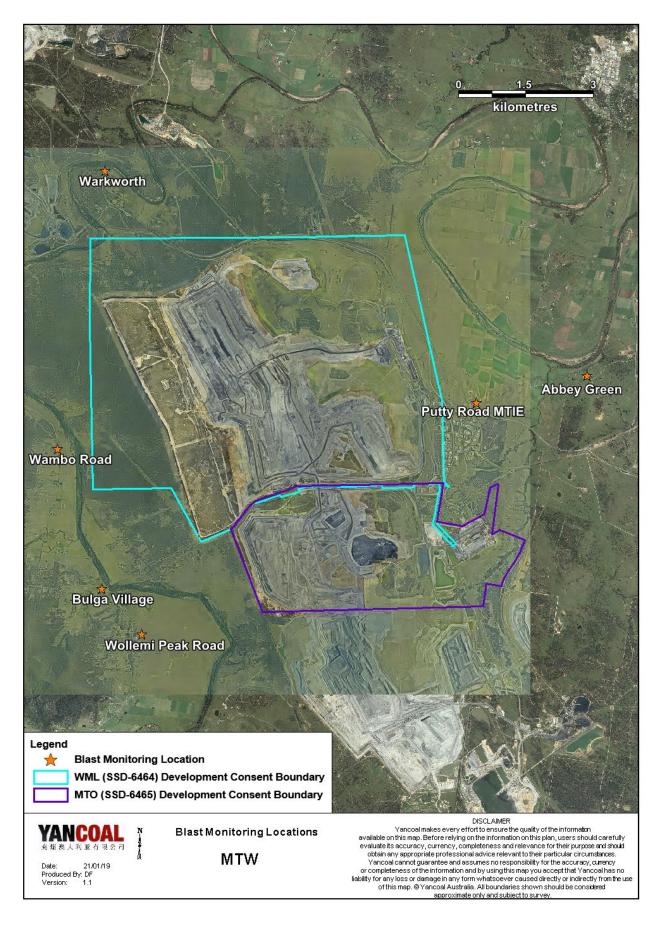
Figure 16: MTW Blast Monitoring Location Plan

MTW have a network of six blast monitoring units. These are located at nearby privately owned residences and function as regulatory compliance monitors.

The location of these monitors can be found in Figure 15.

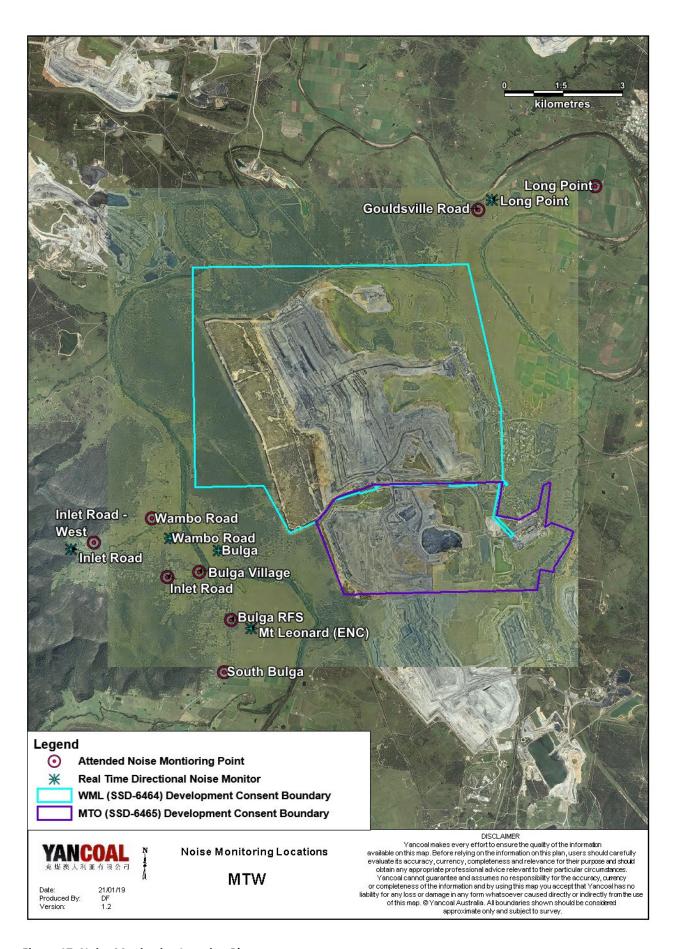
Figure 17: Noise Monitoring Location Plan

Routine attended noise monitoring is carried out in accordance with the MTW Noise Management Plan. A review against EIS predictions will be reported in the Annual Review. The purpose of the noise surveys is to quantify and describe the acoustic environment around the site and compare results with specified limits. Real time noise monitoring also occurs at five sites surrounding MTW. Noise monitoring locations are displayed in Figure 16.

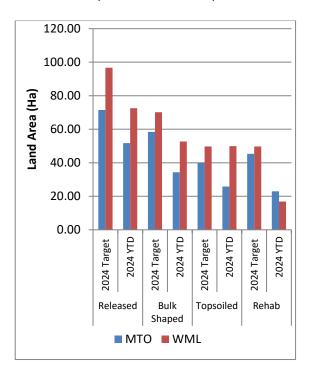
Figure 19: Rehabilitation YTD - October 2024

During October 2024, 17.9 Ha of land was released, 8.0 Ha was bulk shaped and 7.9 Ha was topsoiled.
